GEOTECHNICAL ASSESSMENT OF THE ASBESTOS WASTE CONSOLIDATION SITE AT THE OLD EVERITE FACTORY BRACKENFELL, CAPE TOWN

- TOWARDS RE-ENGINEERING FOR LAND RELEASE -

Report Number J-531B-11

4 December 2011

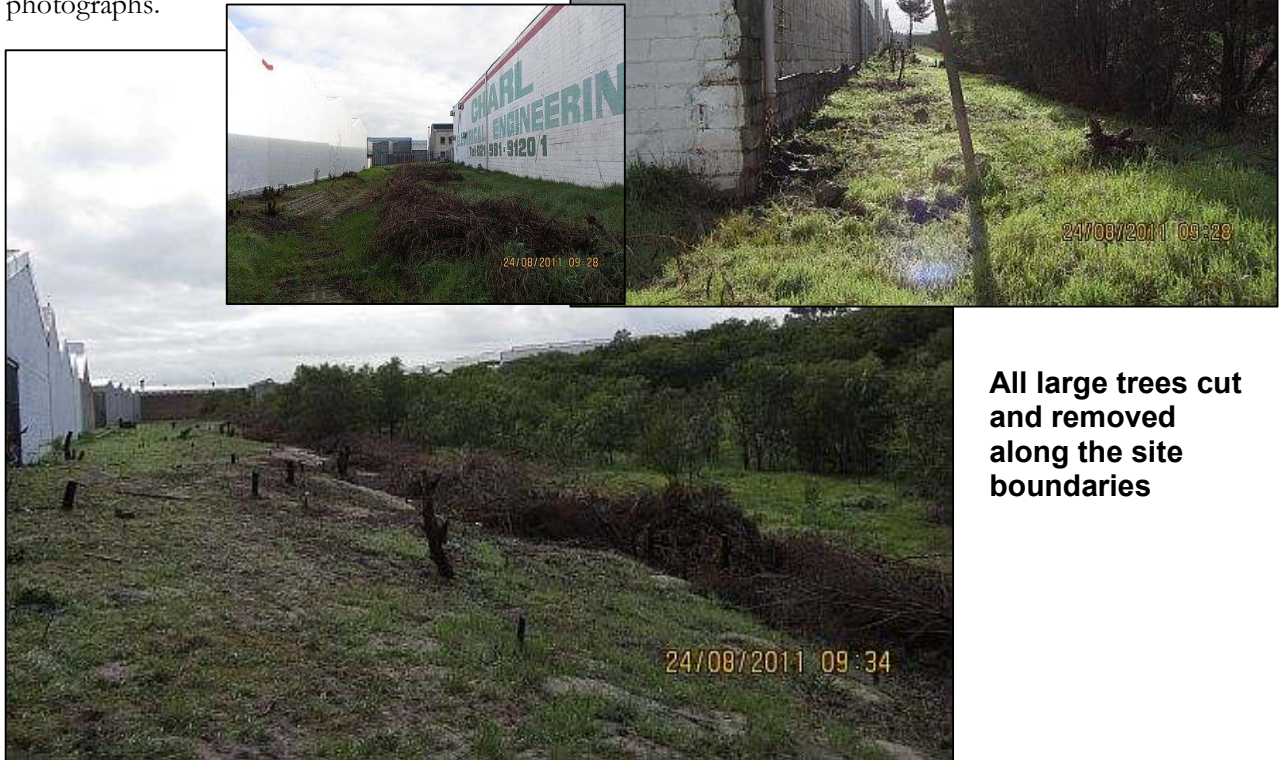
All large trees cut and removed along the site boundaries

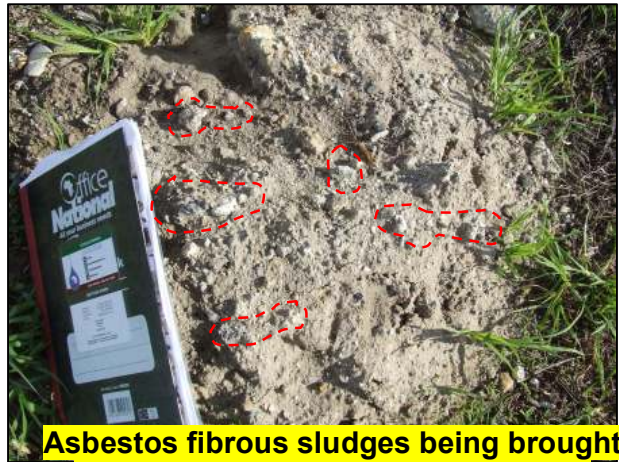
Evidence on site has shown that the asbestos wastes are being brought to surface by considerable mole activity – see photographs. —————→

Asbestos fibrous sludges being brought to surface by intensive mole activity

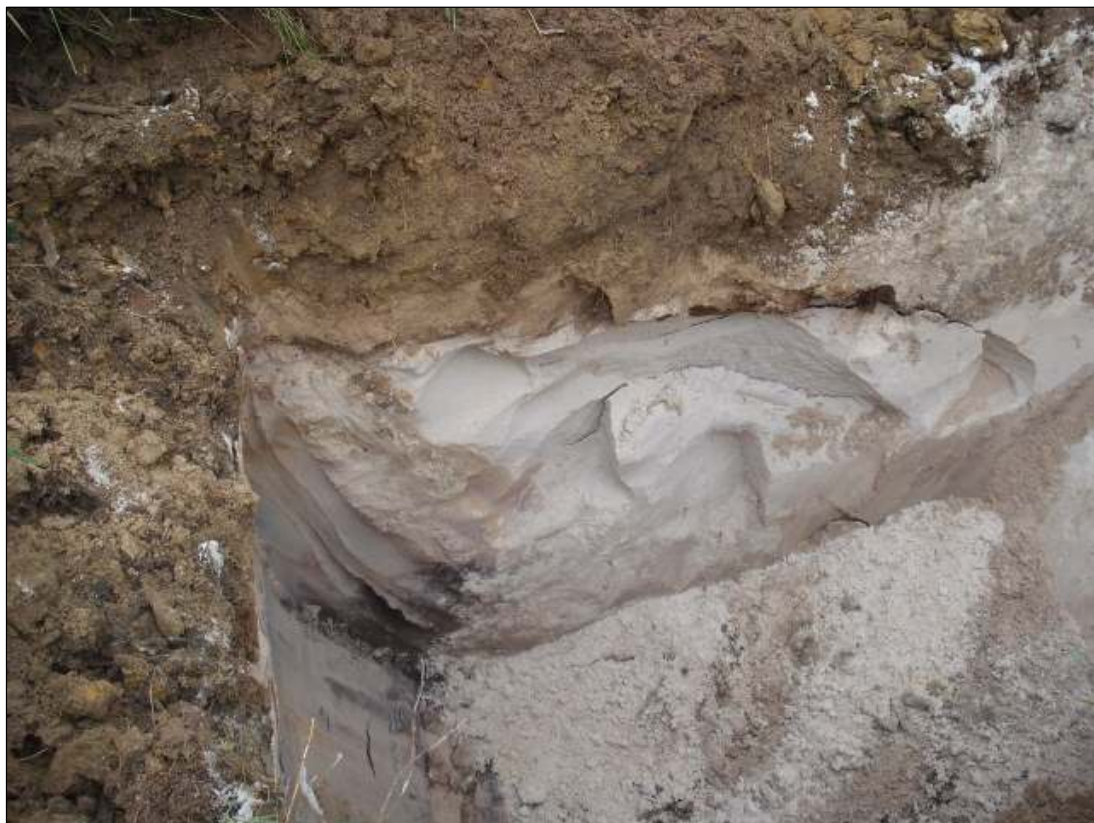
View of *in-situ* sand below fill in IP221.

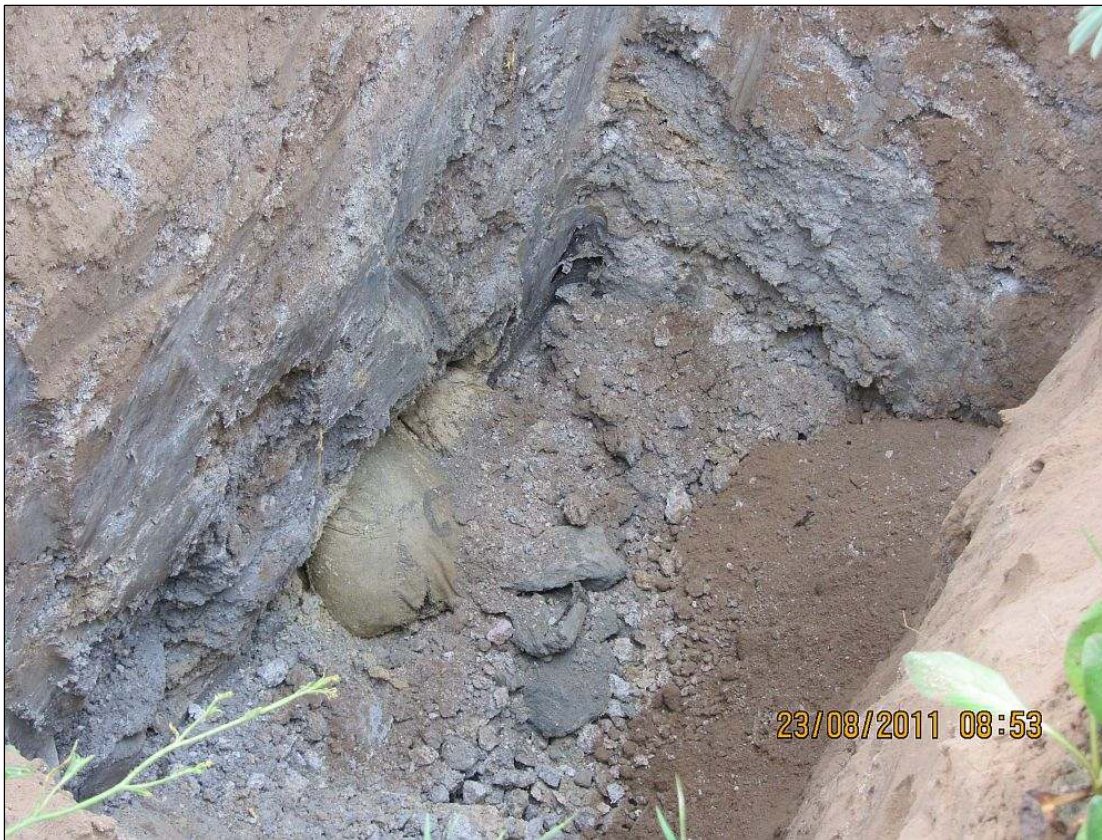
View of ASBESTOS SLUDGE in IP203. Note bags filled with ASBESTOS SLUDGE (slurry) at base of inspection pit.

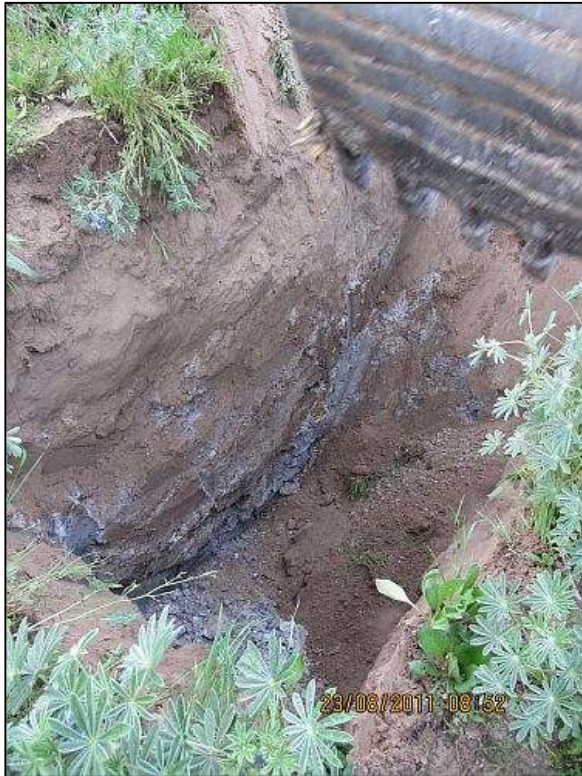
View of asbestos waste being excavated from IP212. Note the loose consistency of the fill and sidewall collapse of inspection pit.

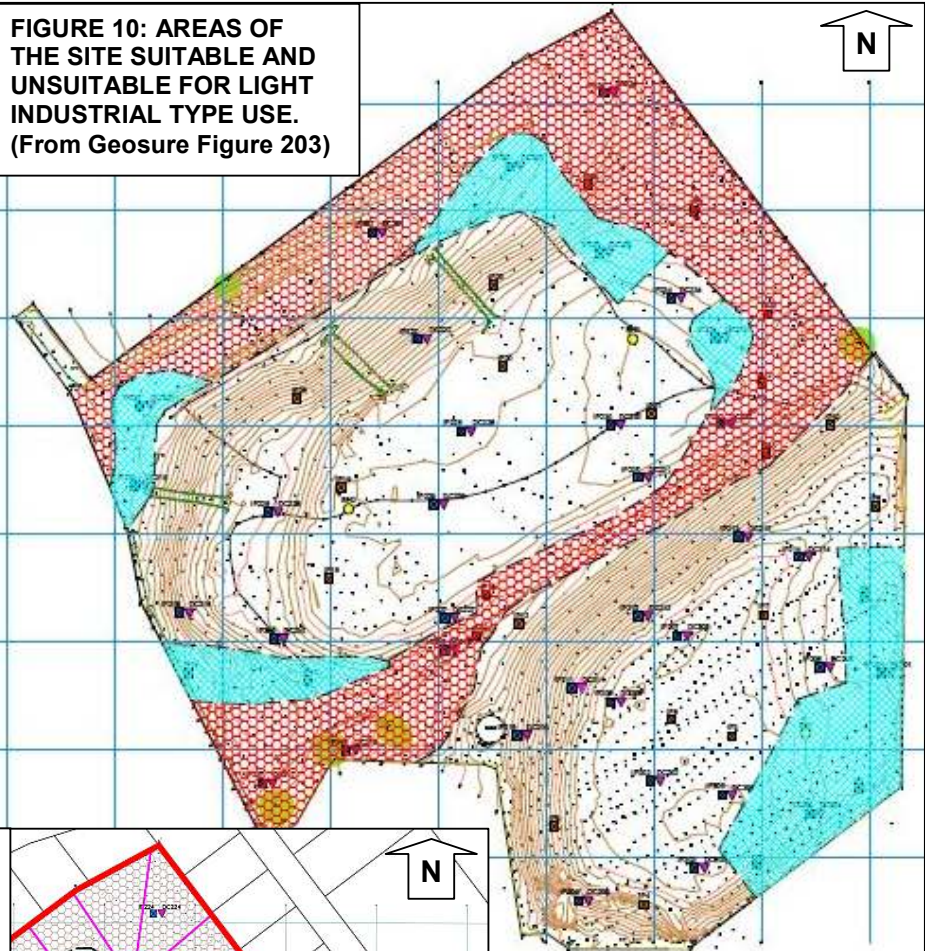
FIGURE 10: AREAS OF THE SITE SUITABLE AND UNSUITABLE FOR LIGHT INDUSTRIAL TYPE USE.
(From Geosure Figure 203)

All white shaded areas shown in Figure 10 alongside are considered unsuitable for normal industrial development due to unfavourable founding conditions i.e. compressible sludges. Any development in these areas will be costly due to the need to pile the foundations and slabs.
