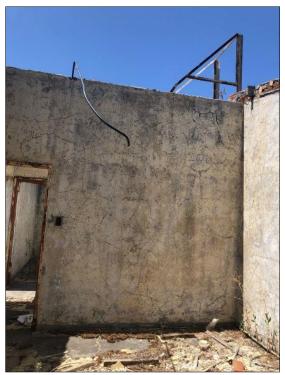
Figure 4 South-western row of derelict cottages on the site

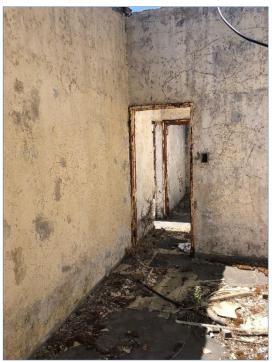
Figure 6 Closer view of derelict cottages, from the outside (1)

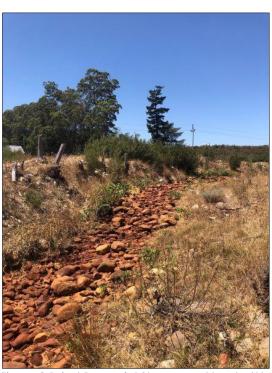
Figure 16 Berm adjacent to the stream

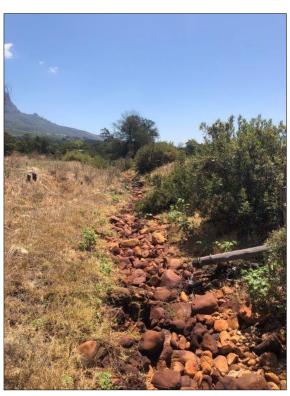
Figure 8 Dried Perennial Stream and banks (1)

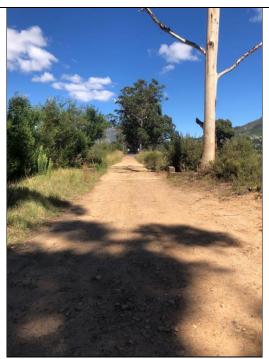
Figure 15 Stream 11 crossing just outside Boschendal Estate
