BOSCHENDAL RETREAT

Farm 1674/11

Paarl

INSPECTION OF EXISTING BUILDINGS.

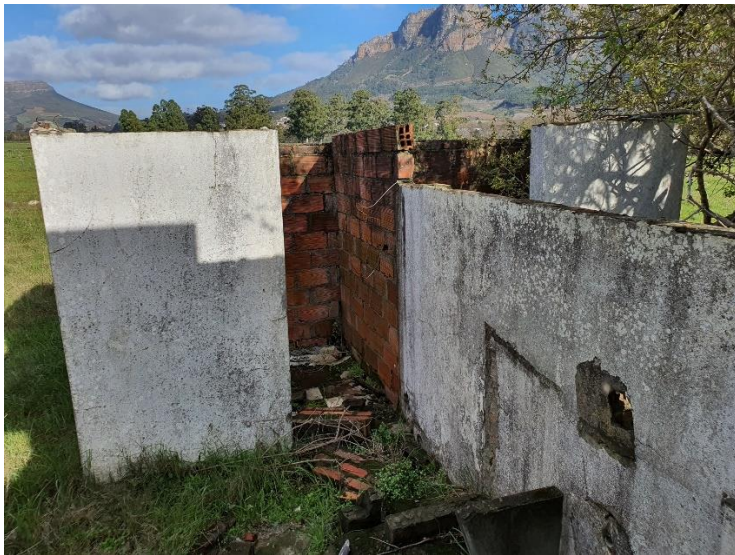
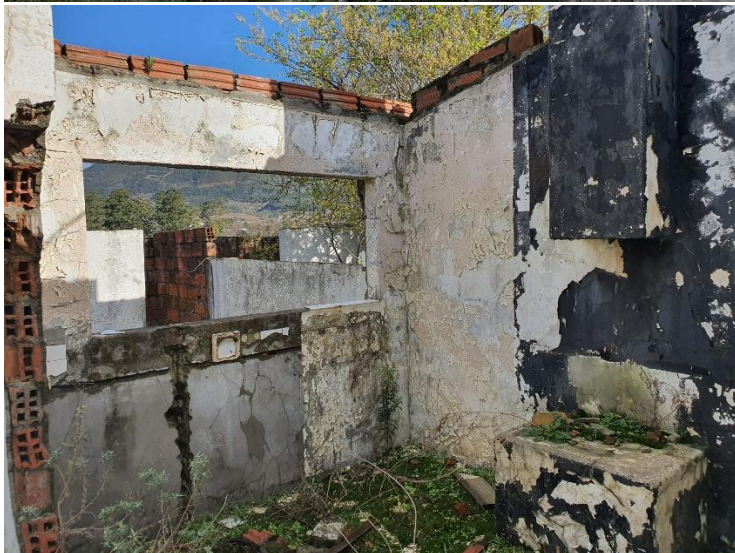
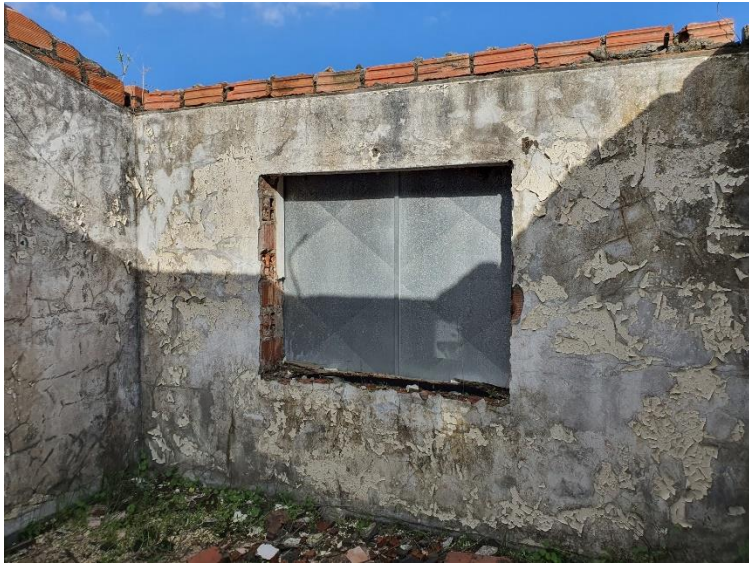
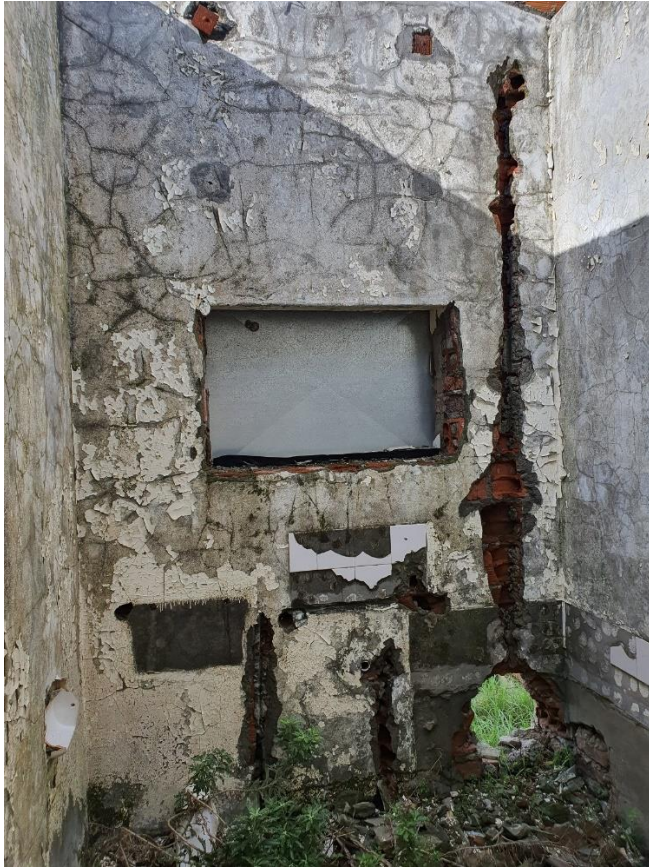
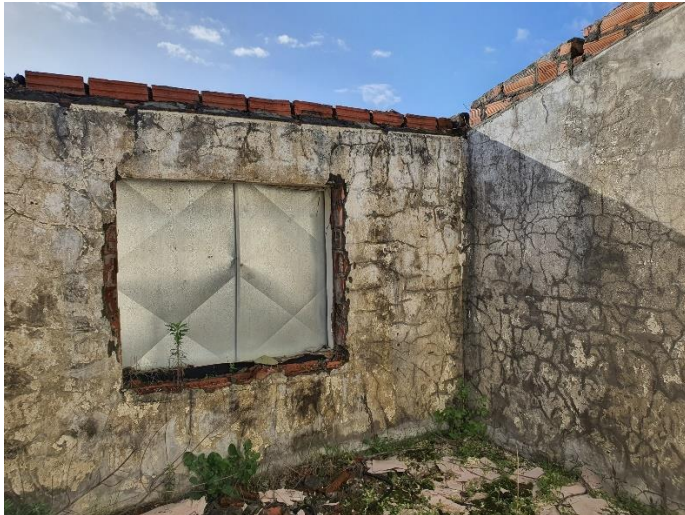
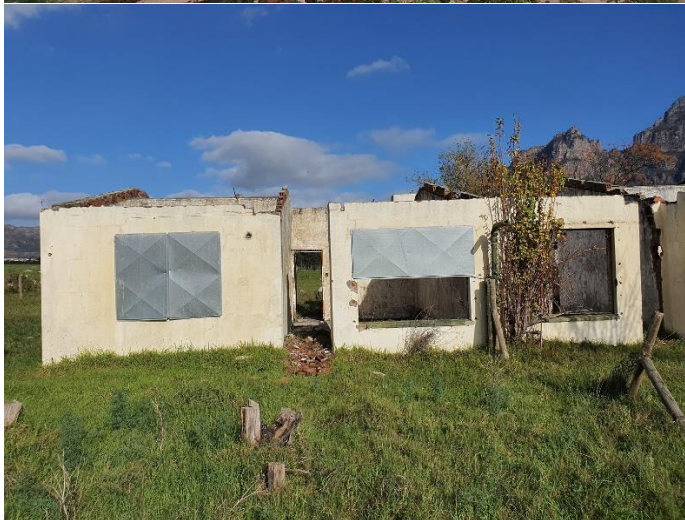
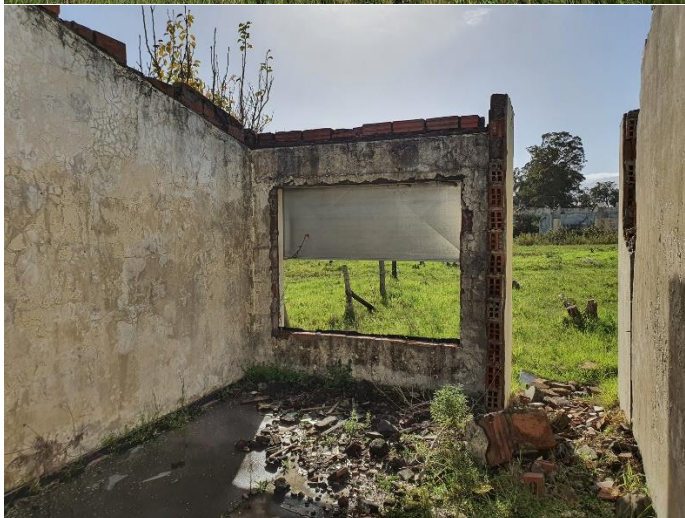
The current status of the buildings is as shown on the photographs below.

The photographs are a good representation of the condition of all 8 buildings.
