**TERRESTRIAL ECOLOGY COMPONENT  
CONTEXTUAL ANALYSIS  
OF ERF 212 AND ERF 242,  
BISHOPSCOURT**

On behalf of the City of Cape Town

Prepared by: Indigenous Vegetation Consultancy  
P.O. Box 22750  
Scarborough  
7975

July 2003

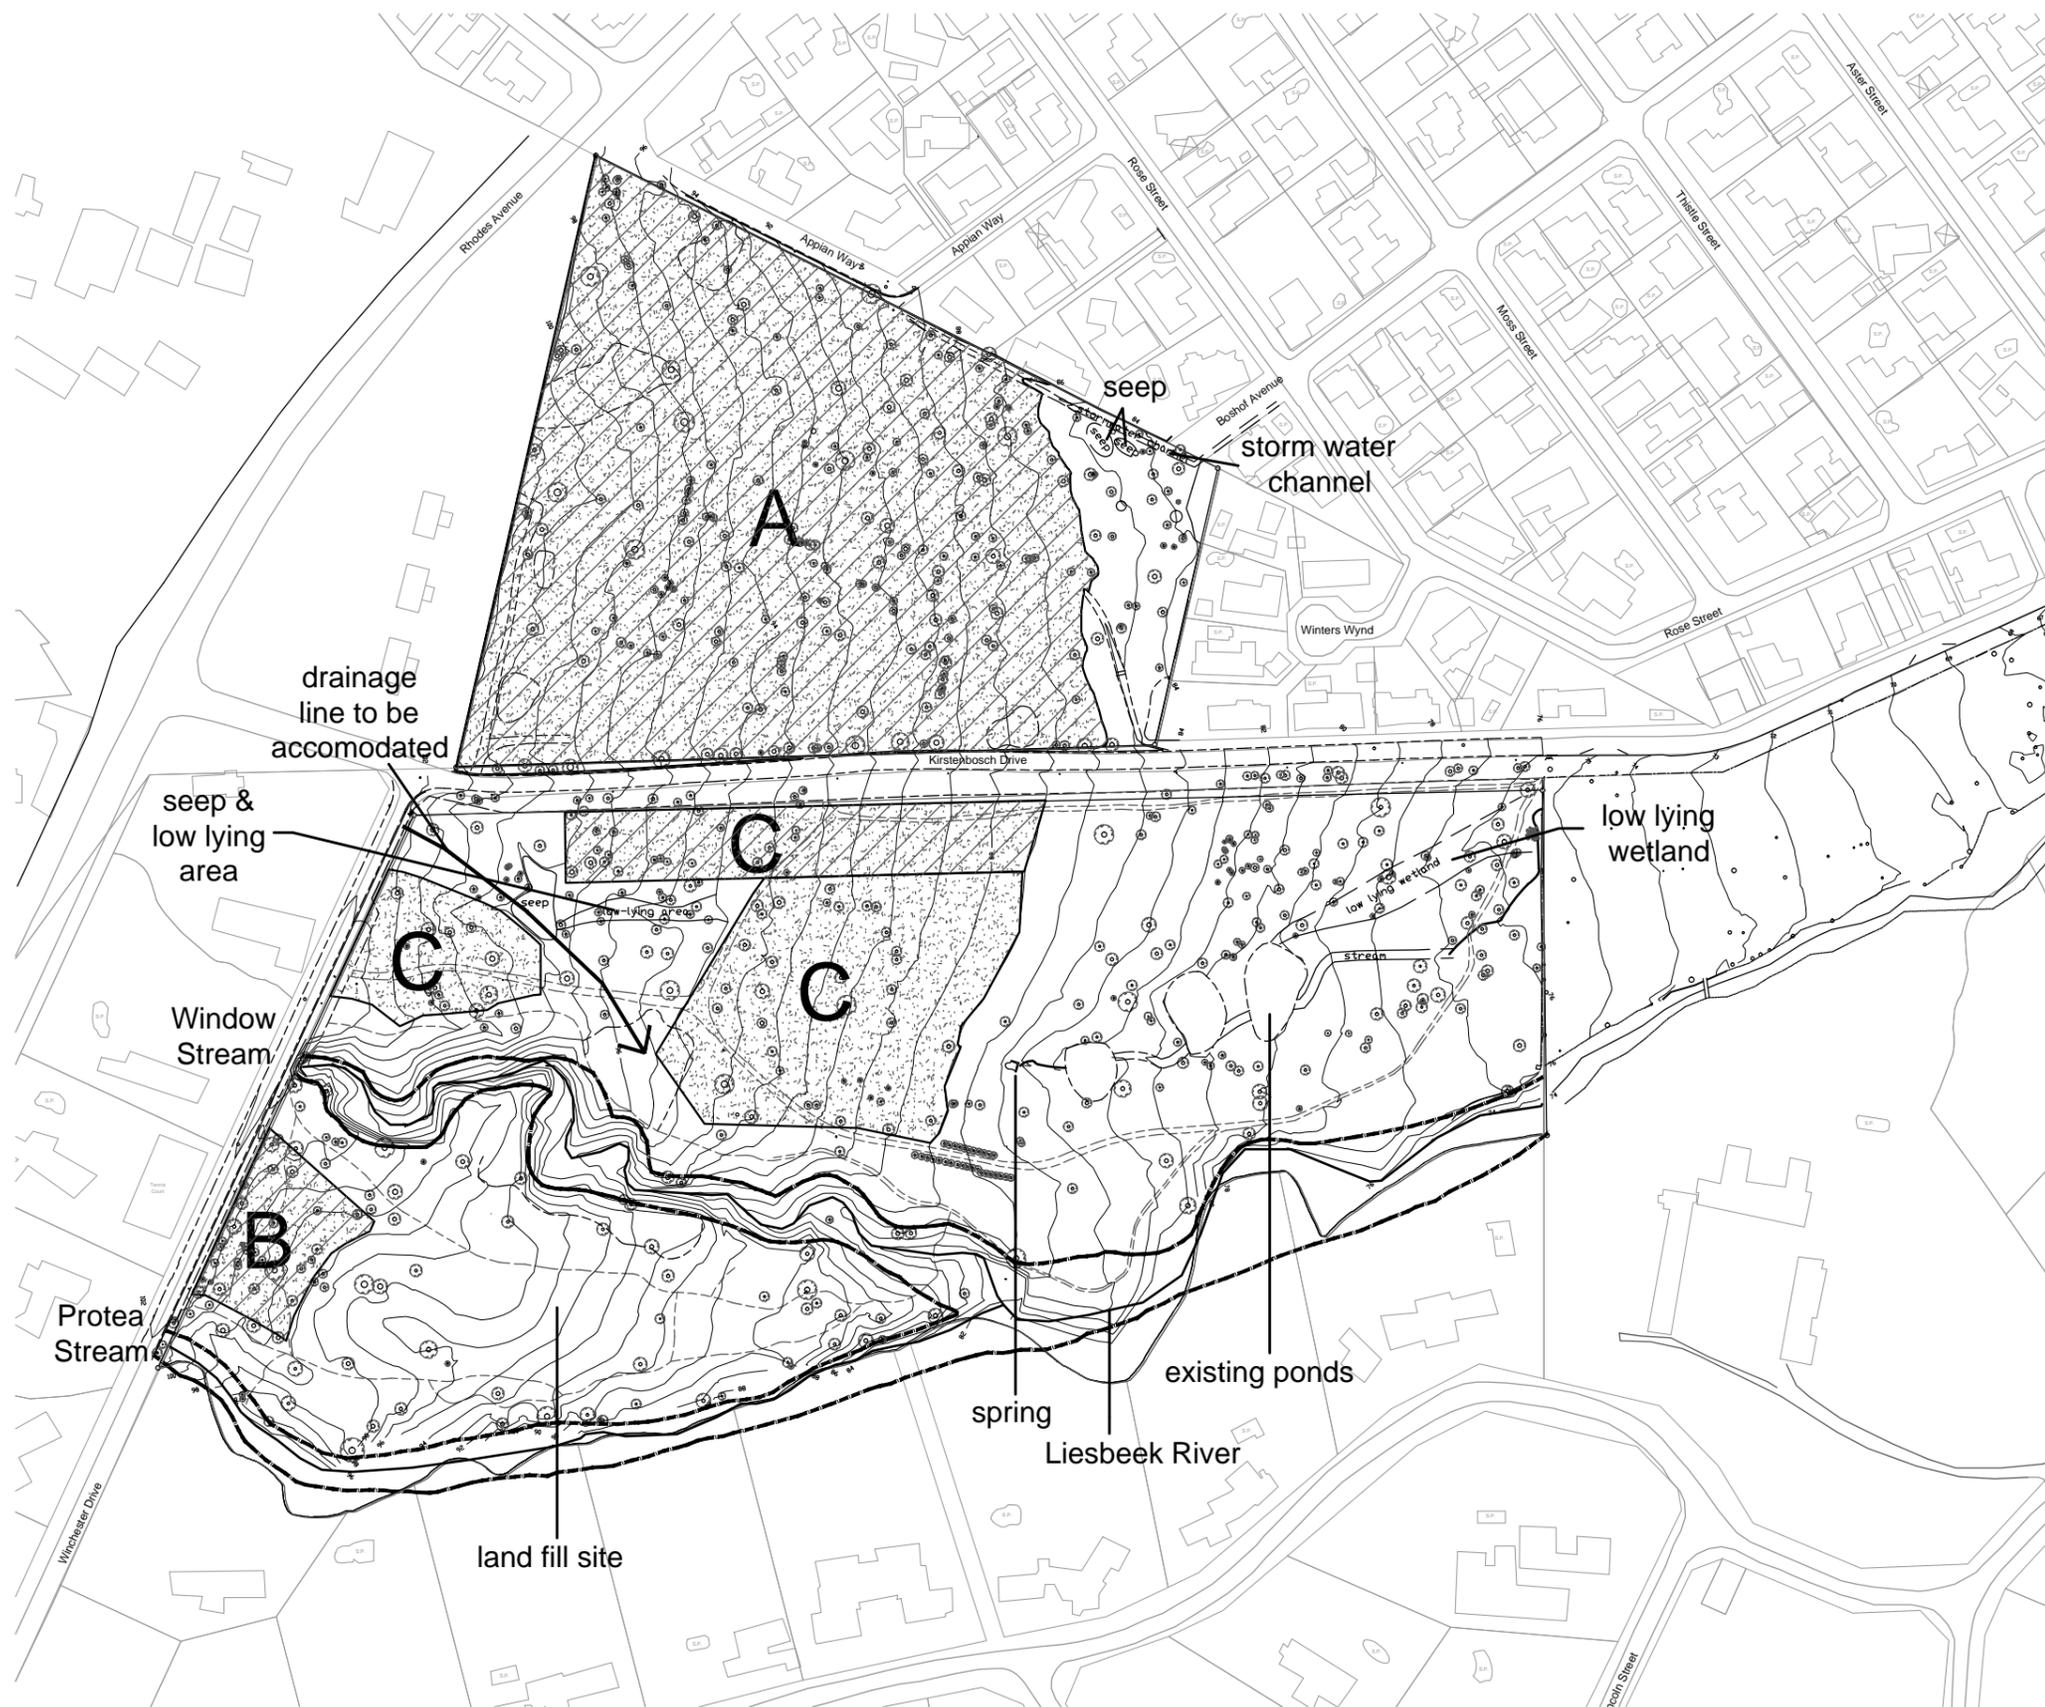
Environmental constraints and Development options

- Buffer zones
- Development Footprint: Option 1
- Rivers
- No-build Area
- Development Footprint: Option 2
- 1:100 Year floodline

- On Erf 242 no development of any description should be allowed below (to the east of) the 86m contour.
- On Erf 212 between Kirstenbosch Drive and Window Stream, no development of any description should be allowed below (to the east of) the 87m contour.
- On Erf 212 between Window and Protea streams, no development to the east of the 98m contour should be allowed.

The first two setback lines listed above are based on water catchment and drainage concerns and issues (refer to the Fresh Water Study component), while the third setback line is based on the presence of the landfill between the two streams. This landfill<sup>6</sup> reduces the development potential of this part of Erf 212 since no buildings may be developed on top of a landfill.

This option is described in more detail in the Fresh Water Study component. Erf 242 is proposed for almost total development with only the requisite set-back lines and storm-water drainage requirements attended to. Erf 212 should remain largely as it is with the exception of a single row of housing on Kirstenbosch Drive, extending from the 91m contour westwards to Winchester Drive to roughly the 98m contour; and another single row of housing along Winchester Drive between the Window and Protea streams to the west of the 98m contour. Both of these single rows of housing are envisaged as having direct access onto Kirstenbosch and Winchester Drive in order to reduce the need for increased infrastructure and surface hardening.

This option is also described in more detail in the Fresh Water Study component. Erf 242 is again proposed for almost full development (excluding set-back lines) while Erf 212 between Kirstenbosch Drive and Window stream, between the 98m and 87m contours may be considered for nearly total development. Such development might include market-gardening areas, sport facilities or similar infrastructure as well as housing.
