**ASBESTOS ASSESSMENT FOR
CHAND ENVIRONMENTAL
CONSULTANTS:**

**EVERITE SITE, BRACKENFELL,
CAPE TOWN**

**ASBESTOS ASSESSMENT:
CHAND ENVIRONMENTAL CONSULTANTS.
EVERITE SITE, BRACKENFELL, 1ST, 3RD, 8TH and 10th
SEPTEMBER 2020**

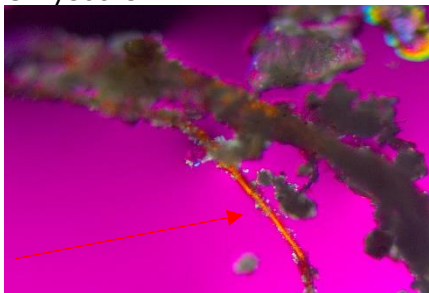
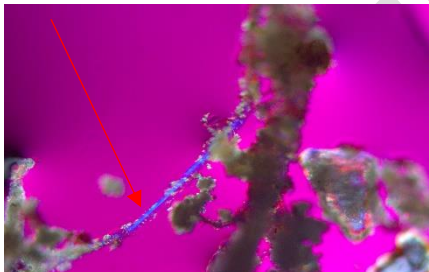
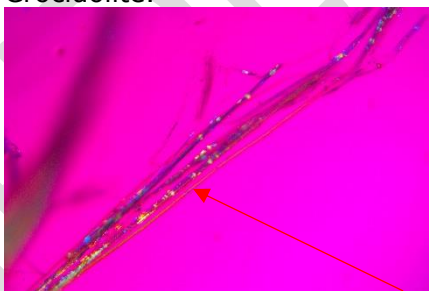
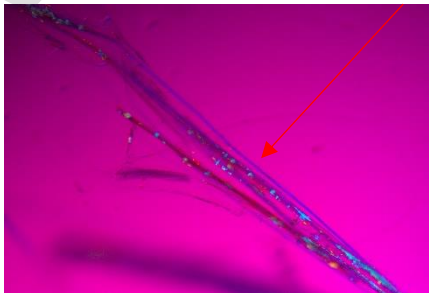
Sample No:	Samples Received	Date of sample analysis	Sample Description	Comments	Standard
2020-324-BS1	07.08.2020	07.09.2020	<p>Bulk Sample</p> <p>Chrysotile.</p>

Positive for asbestos content. The type of asbestos identified is Chrysotile and Crocidolite.	HSG 248.

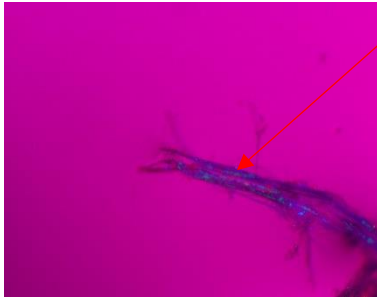
Sample No:	Sample Date	Date of sample analysis	Sample Description	Comments	Standard
2020-324-BS7	07.08.2020	07.09.2020	Bulk Sample Crocidolite.

Positive for asbestos content. The type of asbestos identified is Crocidolite.	HSG 248.
2020-324-BS8	07.08.2020	07.09.2020	Chrysotile.

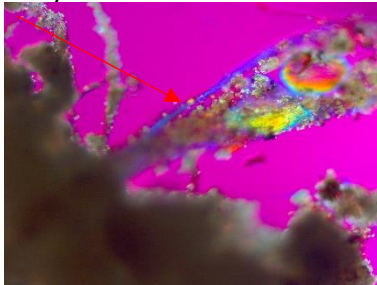
Sample No:	Sample Date	Date of sample analysis	Sample Description	Comments	Standard
2020-324-BS9	07.08.2020	07.09.2020	Bulk Sample Chrysotile.

Positive for asbestos content. The type of asbestos identified is Chrysotile.	HSG 248.
2020-324-BS10	07.08.2020	07.09.2020	Bulk Sample Crocidolite.

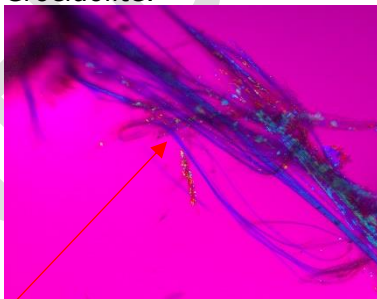
Positive for asbestos content. The type of asbestos identified is Crocidolite.

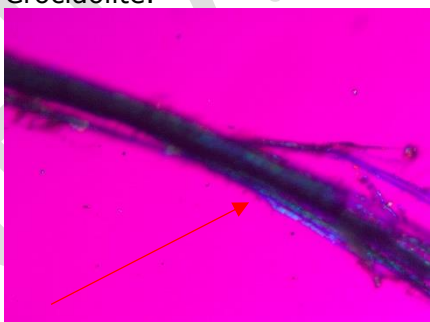
Positive for asbestos content. The type of asbestos identified is Chrysotile and Crocidolite.	HSG 248.

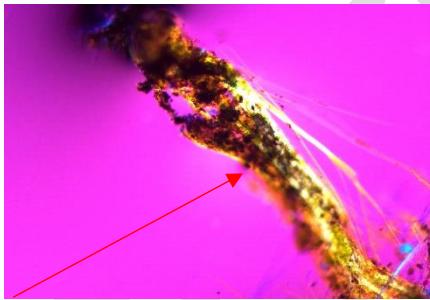
Sample No:	Samples Received	Date of sample analysis	Sample Description	Comments	Standard
2020-324-BS65	07.08.2020	22.09.2020	Bulk Sample Chrysotile.

Positive for asbestos content. The type of asbestos identified is Chrysotile.	HSG 248.
2020-324-BS66	07.08.2020	22.09.2020	Bulk Sample Chrysotile.

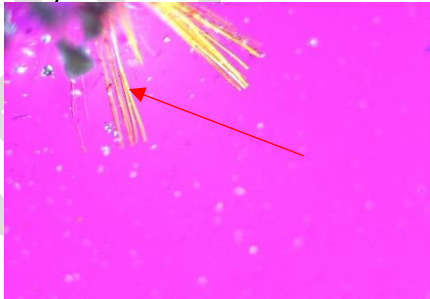
Positive for asbestos content. The type of asbestos identified is Chrysotile.	HSG 248.

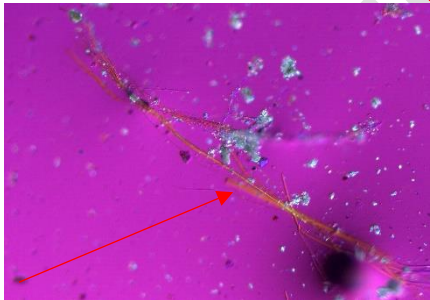
Sample No:	Samples Received	Date of sample analysis	Sample Description	Comments	Standard
2020-324-BS74	07.08.2020	22.09.2020	Bulk Sample Chrysotile.

Positive for asbestos content. The type of asbestos identified is Chrysotile.	HSG 248.
2020-324-BS75	07.08.2020	22.09.2020	Bulk Sample Chrysotile.

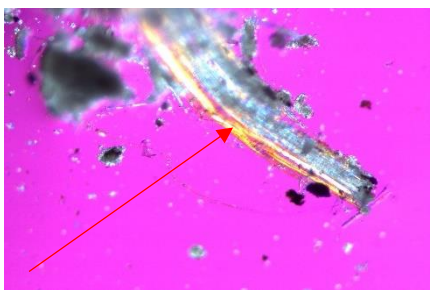
Positive for asbestos content. The type of asbestos identified is Chrysotile.	HSG 248.

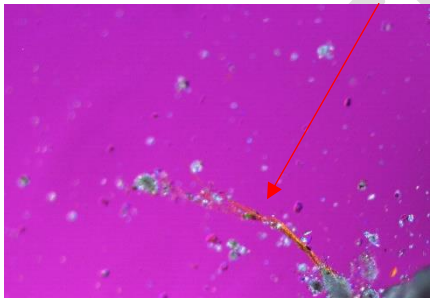
Sample No:	Samples Received	Date of sample analysis	Sample Description	Comments	Standard
2020-324-BS78	07.08.2020	22.09.2020	Bulk Sample Chrysotile.

Positive for asbestos content. The type of asbestos identified is Chrysotile.	HSG 248.
2020-324-BS79	07.08.2020	22.09.2020	Bulk Sample Chrysotile.

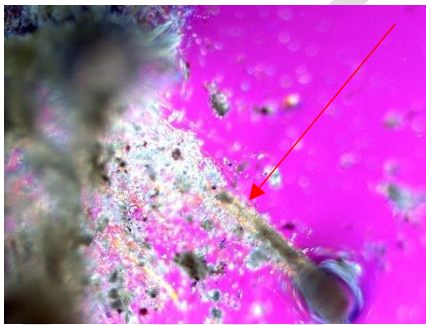
Sample No:	Samples Received	Date of sample analysis	Sample Description	Comments	Standard
2020-324-BS80	07.08.2020	22.09.2020	Bulk Sample Chrysotile.

Positive for asbestos content. The type of asbestos identified is Chrysotile.	HSG 248.

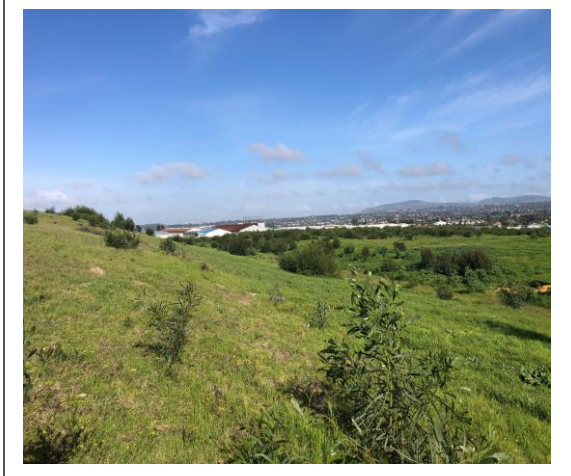
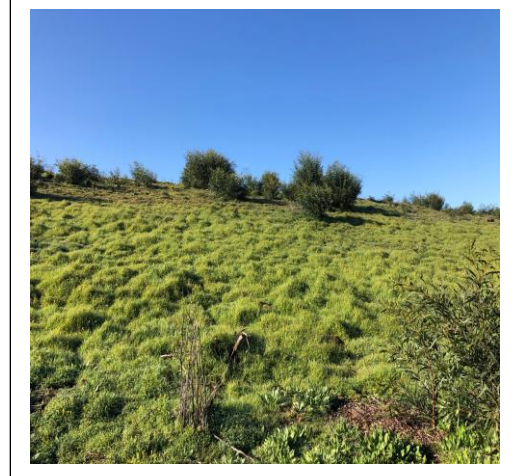
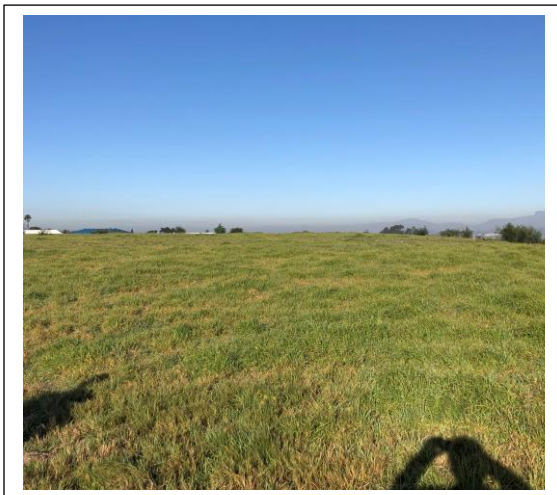
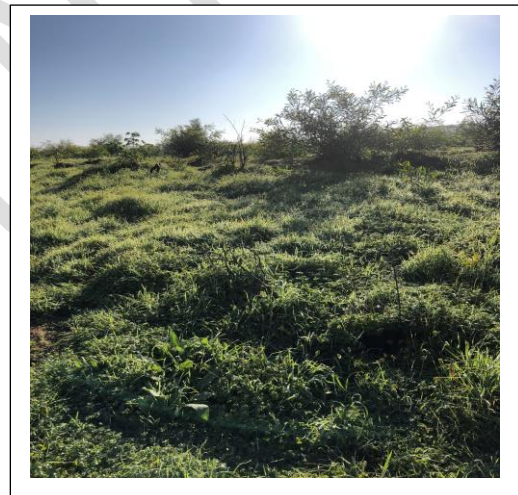
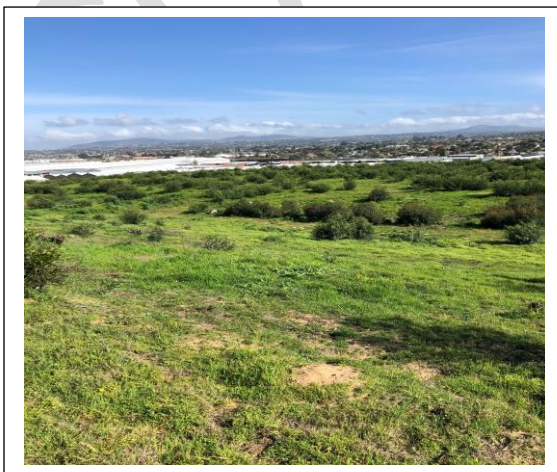
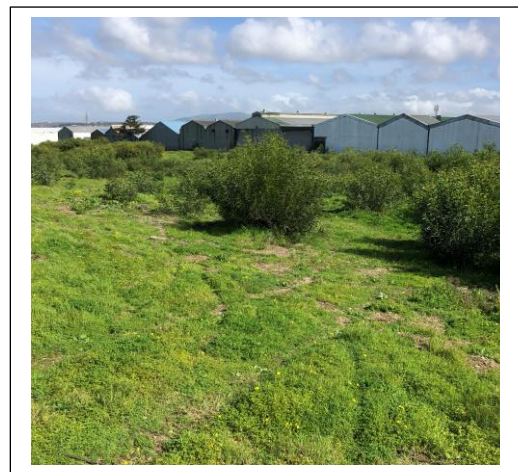
17. PHOTOGRAPHS OF SITE CONDITION.

3. Other areas of the property are compacted with a type of hardcore backfill and clay deposits are visible. (See attached photographs).
4. The property is generally covered with grass and port Jackson bushes that serves to encapsulate any asbestos that may become airborne at this moment in time. (See attached photographs).
5. The asbestos observed is in the form of a conglomerate of loosely bound asbestos debris. There are also numerous amounts of asbestos chip (Debris for asbestos items eg, Roof sheets, gutters and rainwater pipes etc.)

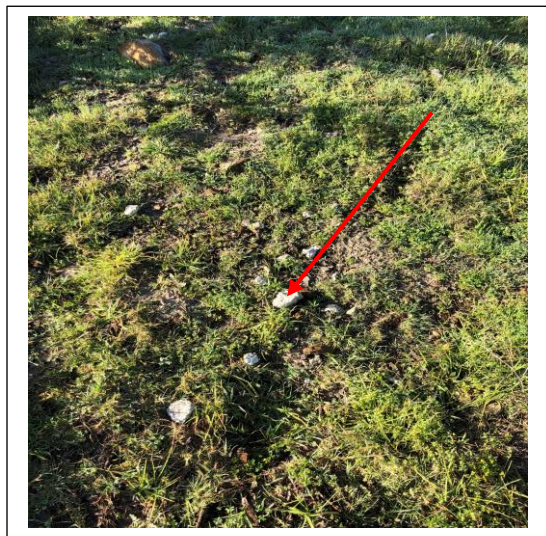
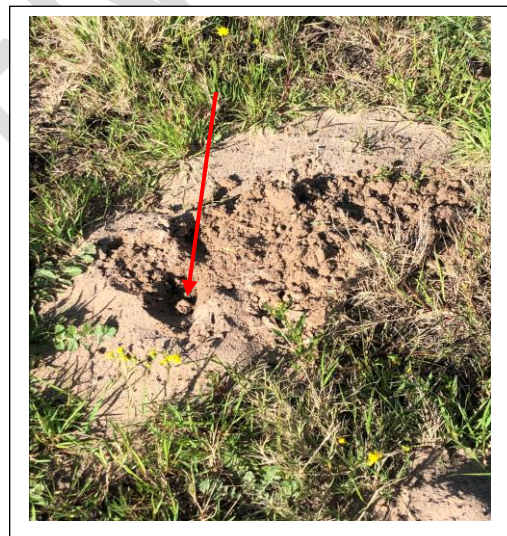
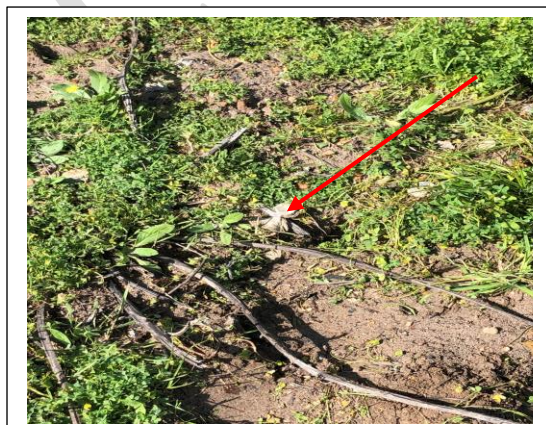
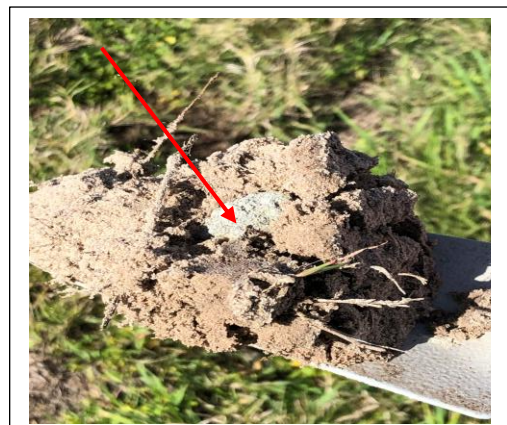
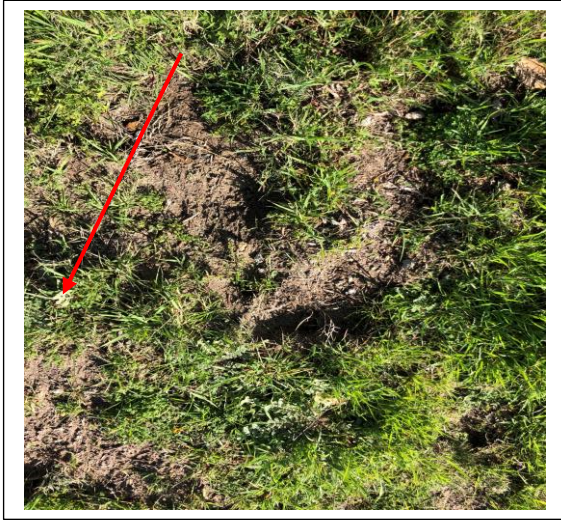
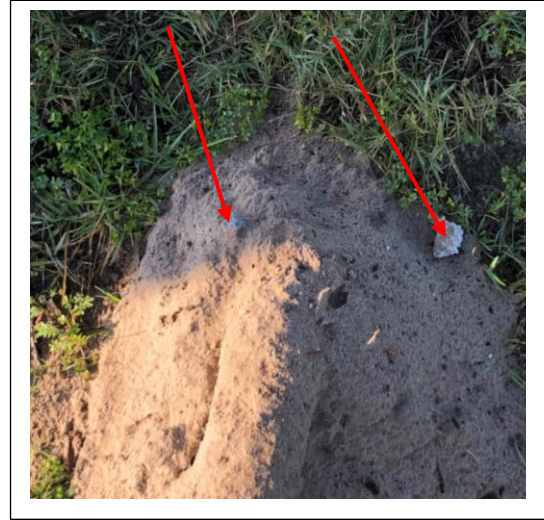
18. PHOTOGRAPHS OF SOIL CONDITIONS WITH ASBESTOS DEBRIS VISIBLE.

1. Sandy areas revealed large quantities of asbestos debris. (due to mole activity). (See attached photographs).
2. The areas where most asbestos debris were observed is the high lying area to the South of the site. There was also asbestos debris observed in the central area of the property. These areas are not compacted soil but generally loose soil. (See attached photographs).

It must be noted that the site is dynamic. With the rain and other weathering, the mole hills spread out taking the asbestos with it. New mole hills come up daily bringing new asbestos with it. With the weathering process the mole hills “flatten” out spreading the asbestos further away from the original mole hill. Guinea fowls too are present on the site and they go to the mole hill to have “sand baths” also spreading the asbestos further.

The asbestos ranges from conglomerates of friable asbestos observed in disturbed soil in non-compacted areas due to mole and bird activity and asbestos chip in other areas. The property is covered with grass and bush growth which serves as an encapsulator, which prevents asbestos fibre release into the environment if not disturbed.

1. Asbestos signage to be placed on all entrances to the site, stating that this is an asbestos site and entrance is prohibited to un-authorized persons.
2. All boundary fencing wall openings must be closed preventing unauthorized access to any persons.

3. Weekly asbestos in air monitoring must be carried out, to determine if the asbestos is airborne or likely to become air borne. This will determine if further control measures may be required.

Asbestos in air samples have been taken on the property which tested negative under normal prevailing weather conditions, and it is of our opinion that no wetting process is required at this moment time. It is however a recommendation that continuous weekly air monitoring for asbestos on the site be carried out to scientifically prove that there is no release of asbestos into the environment, and if asbestos in air is detected, mitigating controls will be recommended. Given the findings of this report is our opinion that the risk of asbestos exposure on the site is high ranked RR18 in accordance with the risk ranking algorithm in this report.
