**FRESHWATER ASSESSMENT FOR THE PROPOSED DECOMMISSIONING AND  
REDEVELOPMENT OF EVERITE ASBESTOS WASTE CONSOLIDATION SITE**

**June 2012**

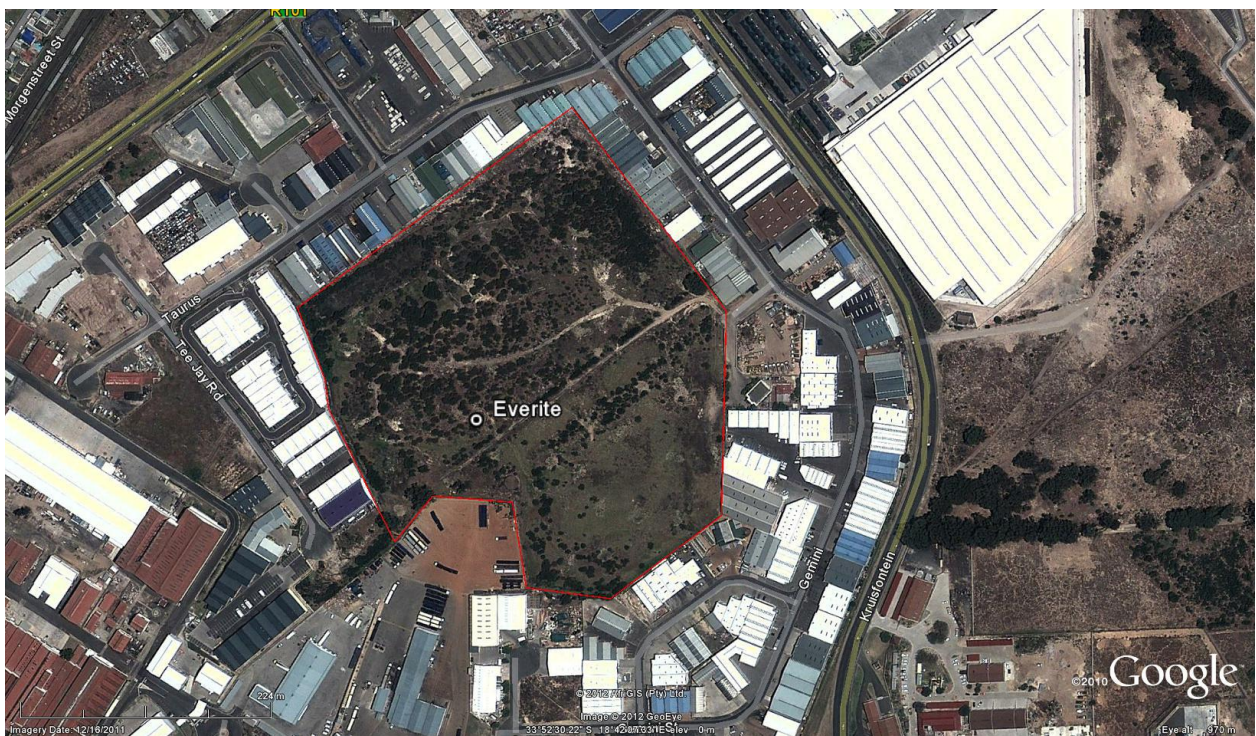
**Figure 1.** Google Earth image of the Everite site

More recent Google Earth images of the site (Figure 1, taken in 2011 as the most recent available Google Earth image) show the site to be invaded by alien plants. The line of trees transecting the site borders a road through the site. The south-eastern half of the site is less disturbed and covered with grasses. No water features are apparent on this portion of the site.

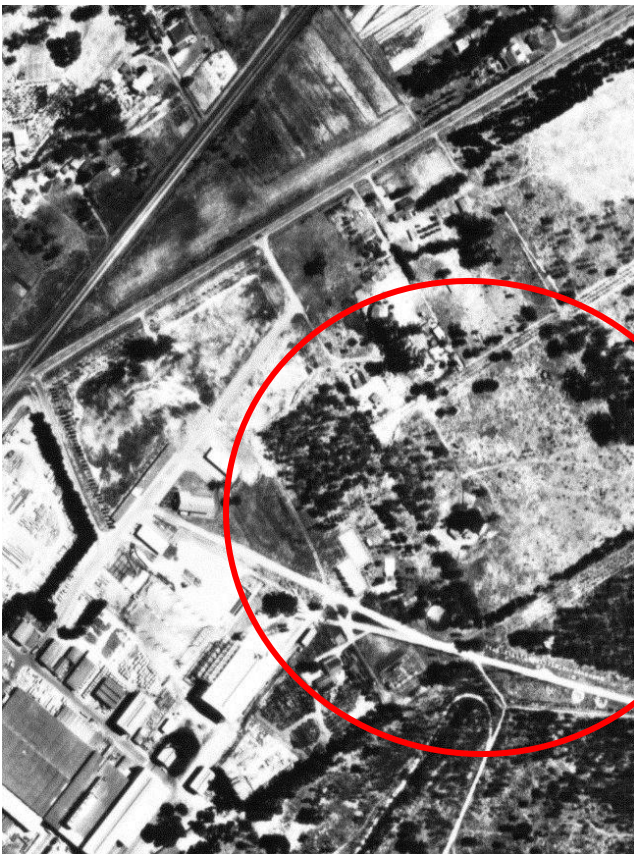
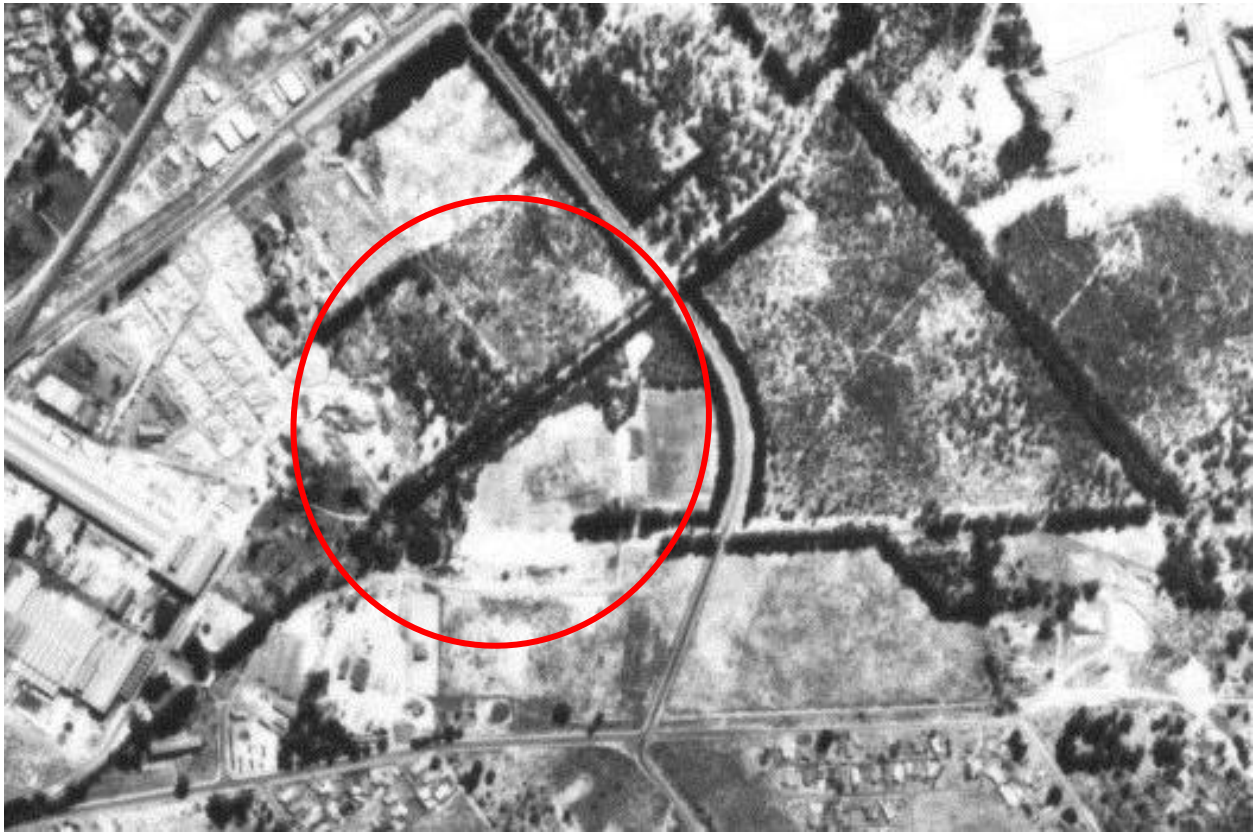
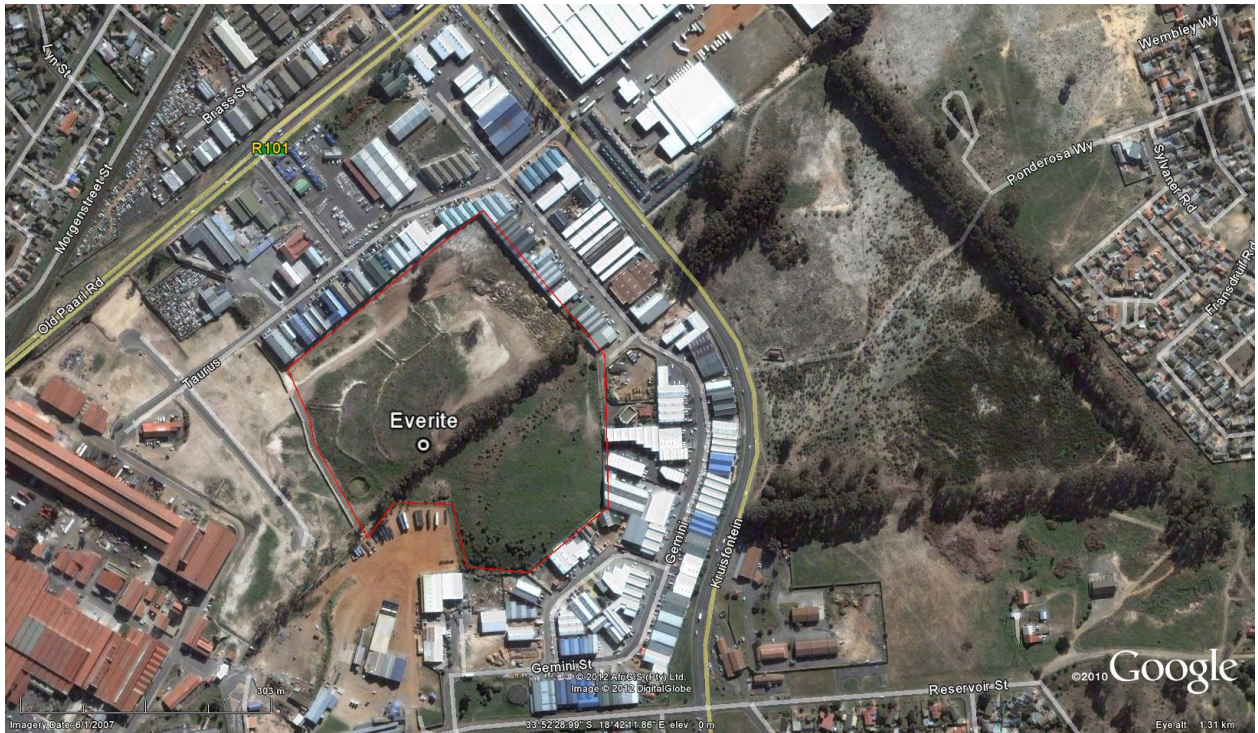
Aerial photographs taken of the area in 1938, 1966, 1983, 2004 and 2007 (Figures 2 to 6) show the gradual development of the site and then its decommission. It can be seen that since 1938 (Figure 2 - the earliest available aerial photograph) the site has been disturbed and cleared of its natural vegetation. No wetland areas are visible on the early photographs of the site. The 2004 Google Earth image of the site shows the clean-up of the site and the development of the drainage channels. The storm water pond is however only clearly visible in the 2004 and 2007 images. From these images, it is clear that the pond was specifically constructed to capture runoff from the drainage channels on the site.

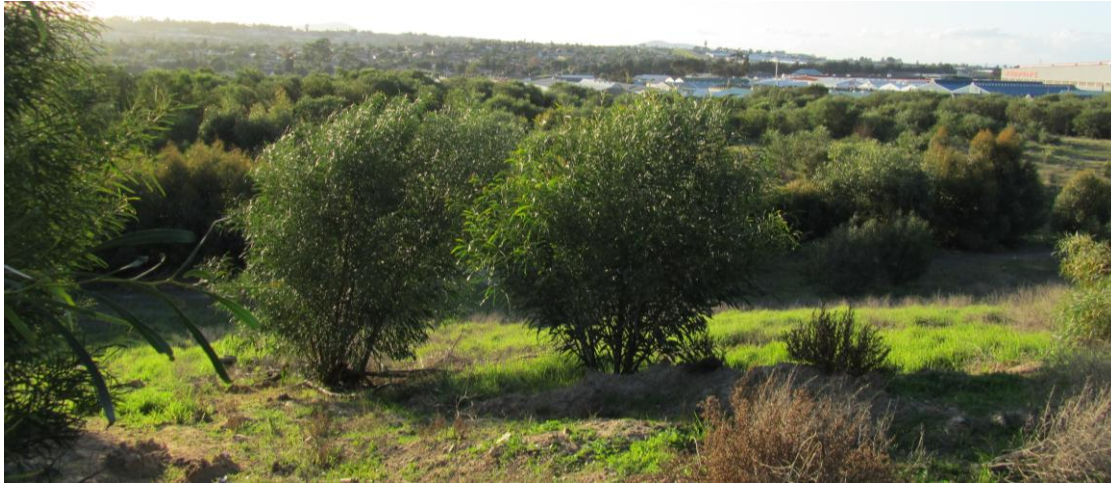
**Figure 8.** The large quarry on the southern portion of the site

The topography of the site varies significantly across the landscape, and the landscape itself is completely transformed as a result of previous activities on the site. The central area of the site is elevated and consists of deep sandy soils (Figure 8). A number of drains have been constructed to channel water from the site into the wetland/storm water pond located in the north western corner of the site. The site largely consists of disturbed soils and invasive alien Port Jackson willows *Acacia saligna* and exotic grasses, as well as some dumping of rubble and litter.

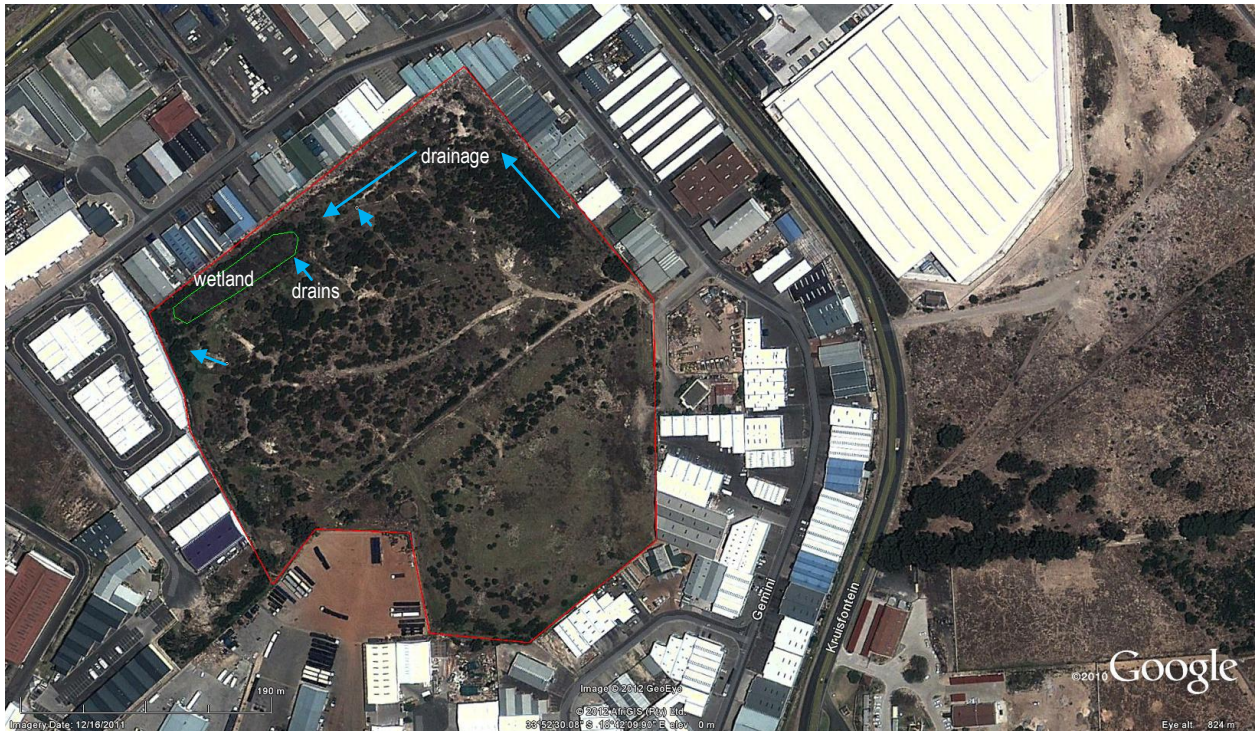
**Figure 13.** Google Earth image of water related features on the site

The proposed development falls on the watershed between the catchments of the Bottelary and Kuils Rivers. These rivers in general flow within an unconfined valley which consists largely of alluvial sands. As a result the rivers are predominantly of a wetland nature. The water related features on the site consist of a number of drainage features which are mostly man made as well as a large storm water pond. These features are discussed in more detail in the following section on Freshwater Assessment.

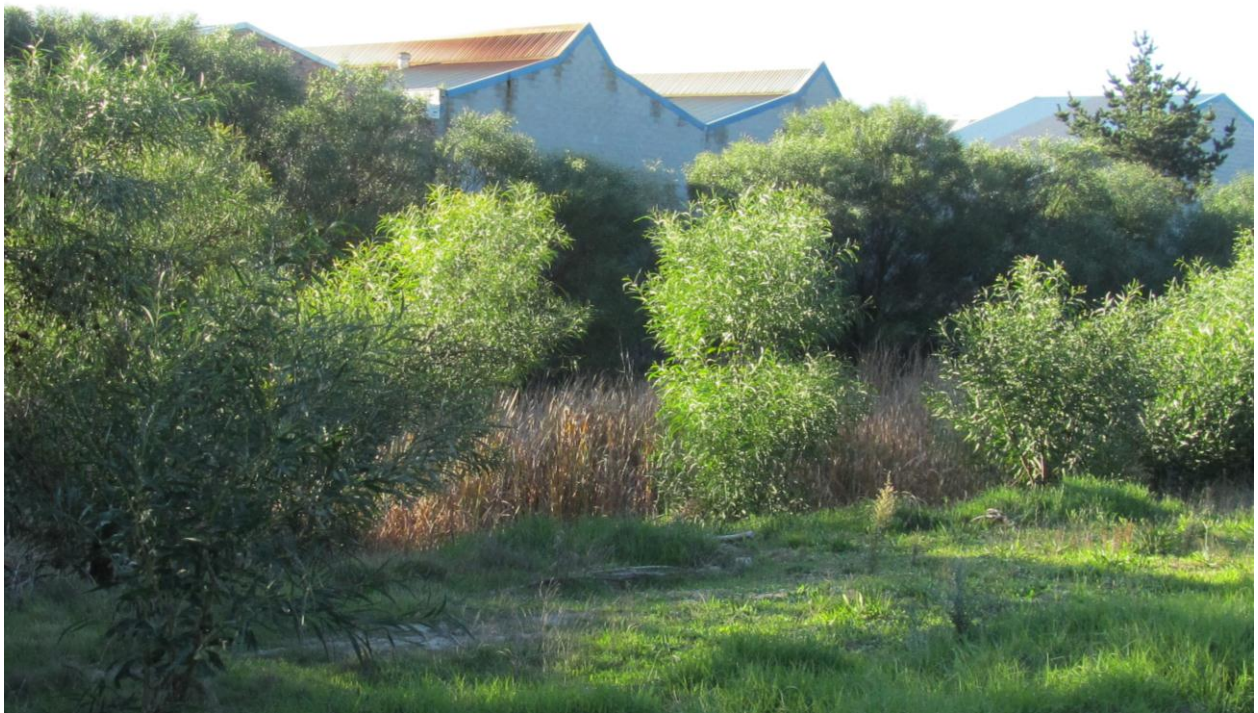
**Figure 15.** View of wetland

- A large wetland area (approximately 2000 m<sup>2</sup>) is located in the north western corner of the site (Figures 15 and 16). This appears to be an artificially created depression specifically constructed to deal with storm water runoff from the site and is located at the lowest point on the site. The wetland area is dominated by bulrush *Typha capensis* which typically grows

within storm water systems that receive a constant flow (low flow) and are often rich in nutrients.

- The storm water pond in the north western corner of the site should be retained and a 15 m buffer retained from the wetland edge. Limited disturbance should be allowed within the buffer zone. The rehabilitation of disturbed areas must take place as soon as possible post construction.

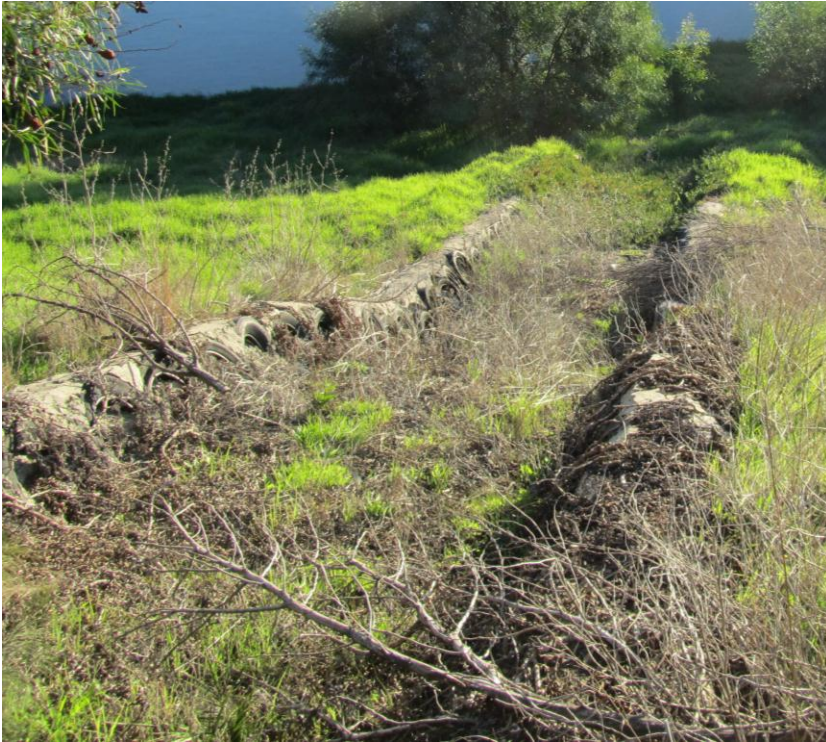
**Figure 16.** View of one of the drains into wetland area

- The central area of the site is elevated and consists of deep sandy soils. A number of drains have been constructed to channel water from the site into the wetland/storm water pond (Figure 17). The site largely consists of disturbed soils and invasive alien Port Jackson willows *Acacia saligna* and exotic grasses, as well as some dumping of rubble and litter.
- Along the outer edge of the northern and eastern portions of the property is a small drainage channel that simply carries runoff from the lower lying areas of the site also into the wetland/storm water pond (Figure 18).

- The intensity of storm water run-off should be reduced where possible through encouraging paving and surfaces that allow for greater infiltration. Storm water discharges should be dissipated before entering the storm water pond and should not be direct piped discharges.

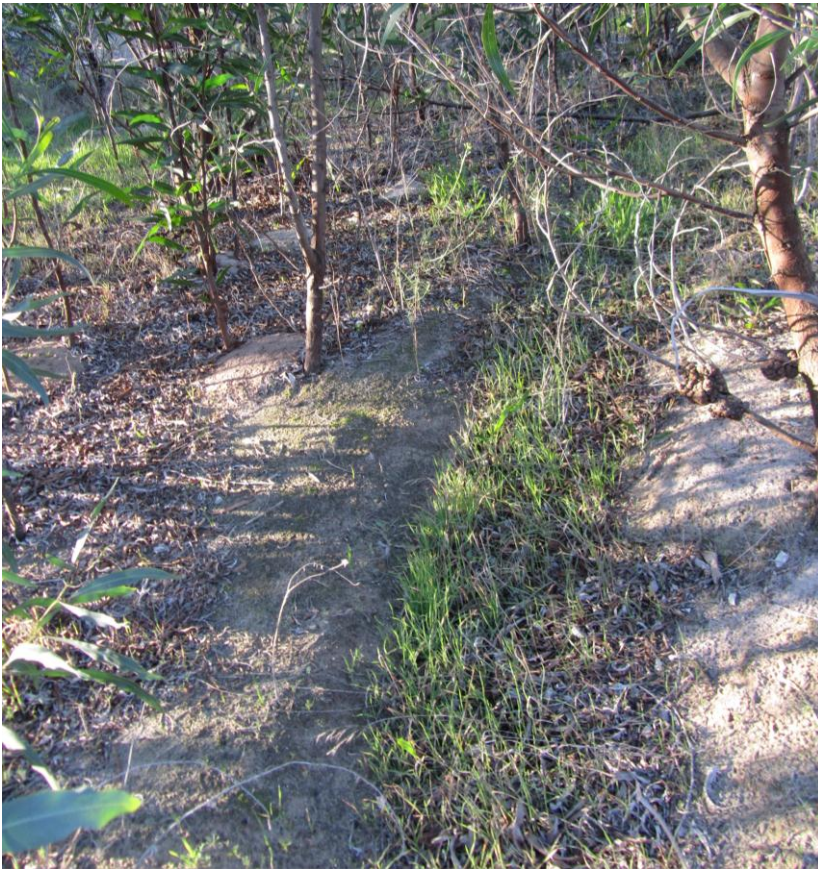
**Figure 17.** View of drainage line

The above-mentioned features were identified as part of a rapid assessment of the wet environments on the proposed site. The drainage line on the site has no particular importance. The wetland/storm water pond has no real significance in terms of biodiversity as it is an overgrown mono stand of bulrush *Typha capensis*.
