Boschendal Estate: Proposed Bertha Retreat Development on Portion 11 of Farm 1674, Paarl Flood Line Study: Revised

#### **MARK OBREE**

CONSULTING ENGINEER ECSA 810323

25 February 2021

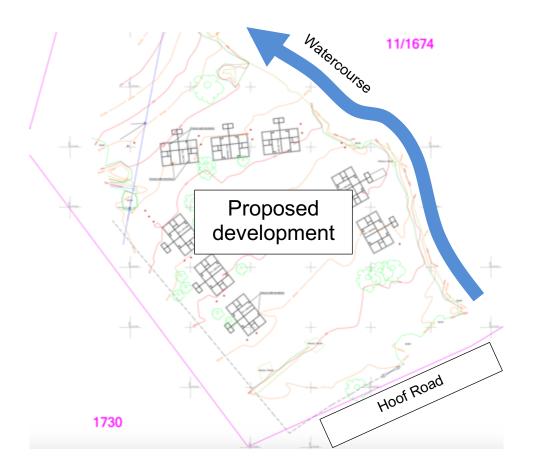
The layout of the proposed development is shown below.

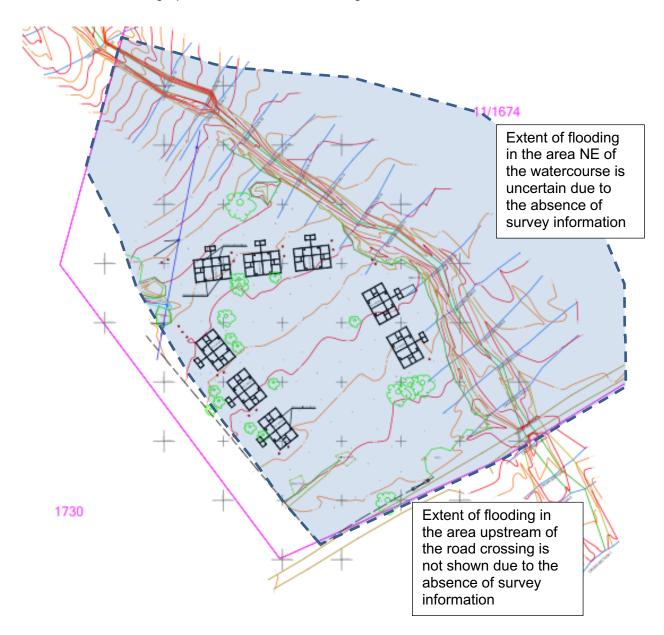
## Annexure D: Flood Lines: Existing

The shaded area on this diagram indicates the extent of the site that is likely to be affected by the 100-year flood due to water bypassing and/or overtopping the existing road crossing. The extent of flooding upstream of the road crossing is not shown.

Due to the topography of the area on either side of the crossing, excess flows (that do not pass through the culverts) will move overland in an uncontrolled manner, with some of this water passing through the site of the proposed development. An indication of the extent of the site that is currently affected by flooding is shown on Annexure D.
