Environmental Impact Assessment of Founders Estate 5 Tented Camp, Boschendal Estate

Freshwater ecosystems

October 2021

DRAFT REPORT

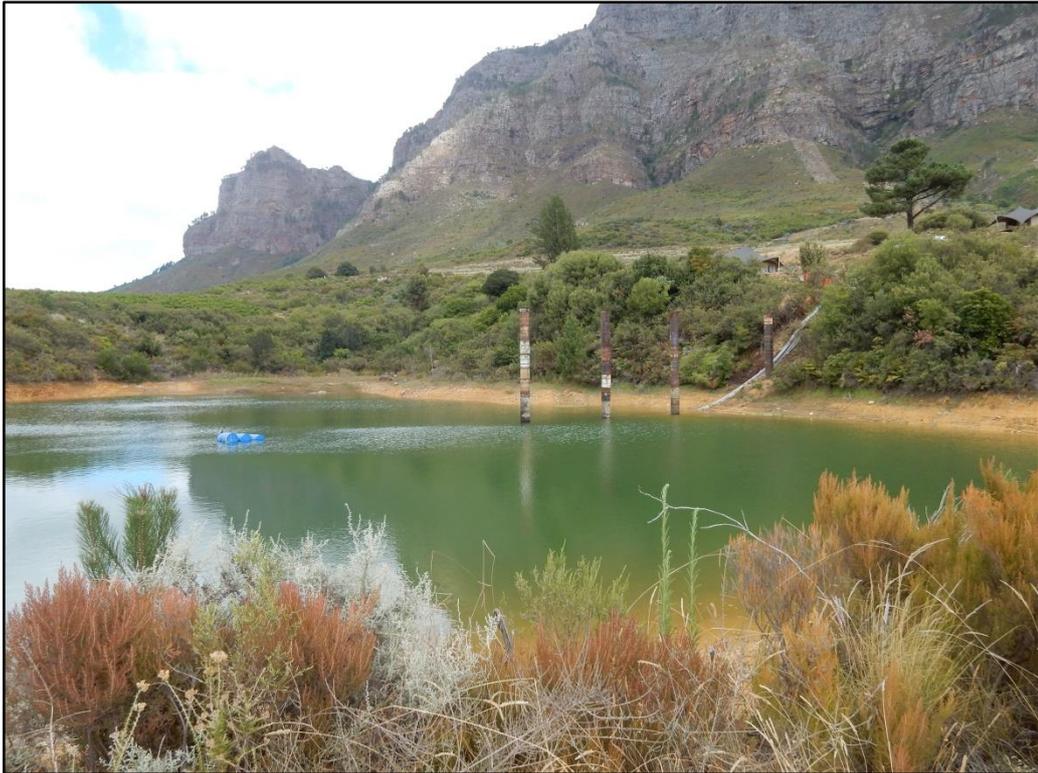
Figure 2.1 Farm dam into which Stream 1 flows. The riparian vegetation around Stream 1 continues around the margins of the dam, and can be seen here. The Tented Camp can be seen in the background.

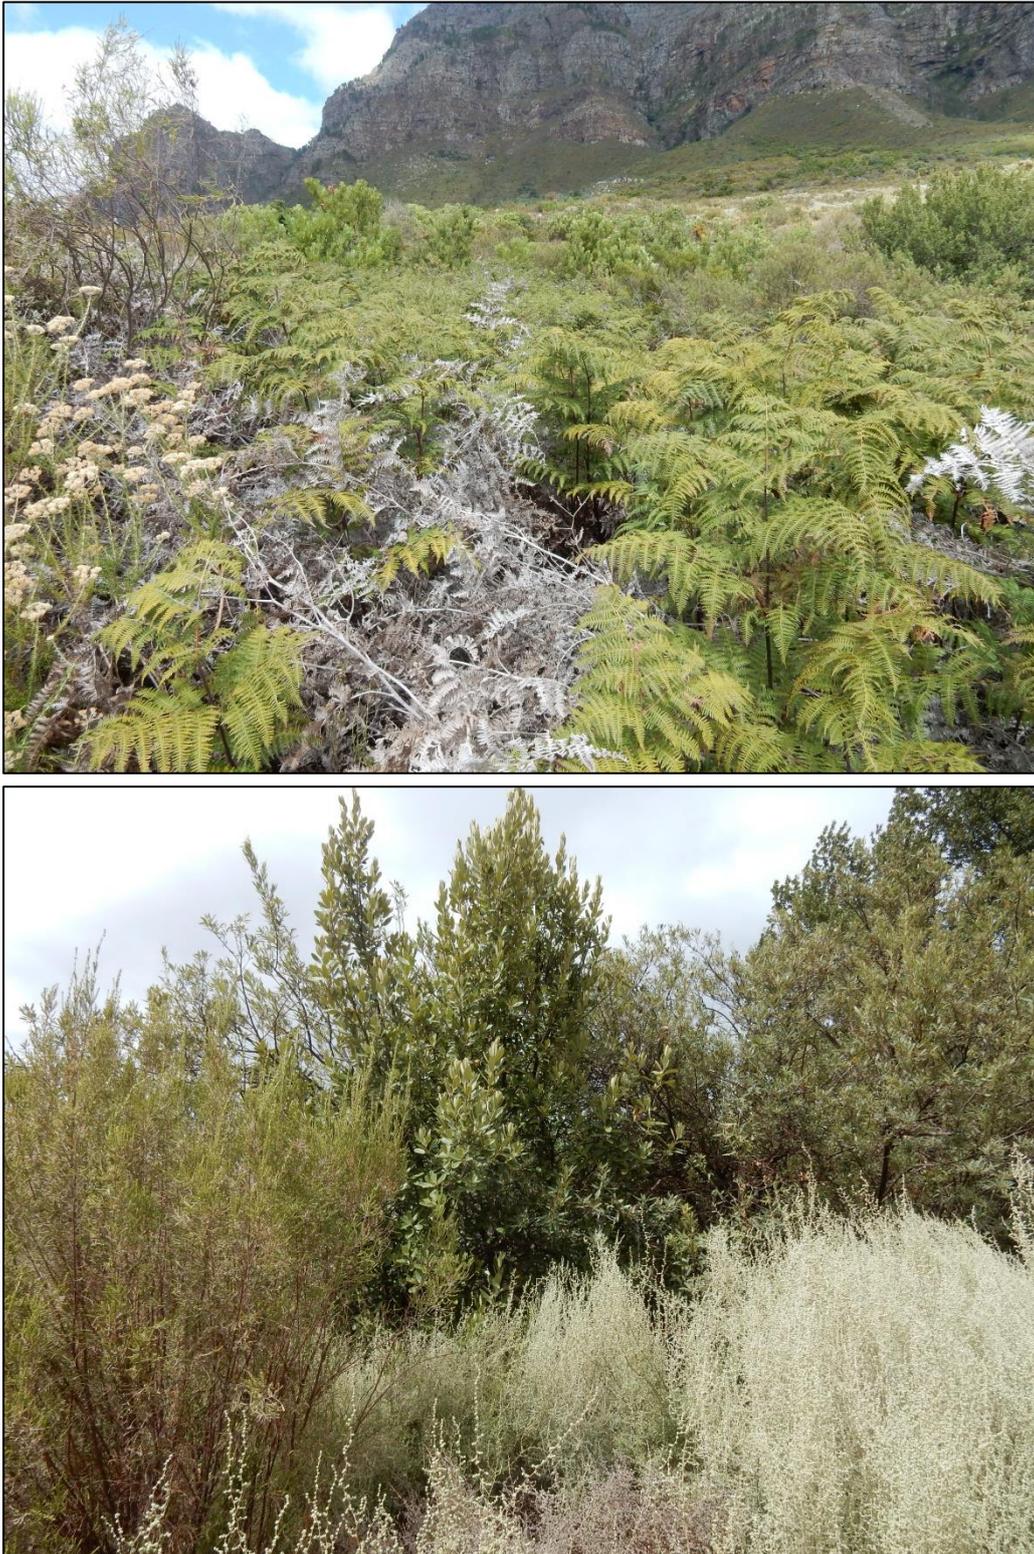
Figure 3.1 (Top) Bracken and (bottom) tree species – *Kiggelaria africana* (middle), *Olea europaea* subsp. *africana* (right) and *Searsia angustifolia* (left) – typical of the riparian areas on the Tented Camp site, Boschendal Estate. The *Seriphium plumosum* (slangbos) in the foreground is characteristic of the more terrestrial vegetation.

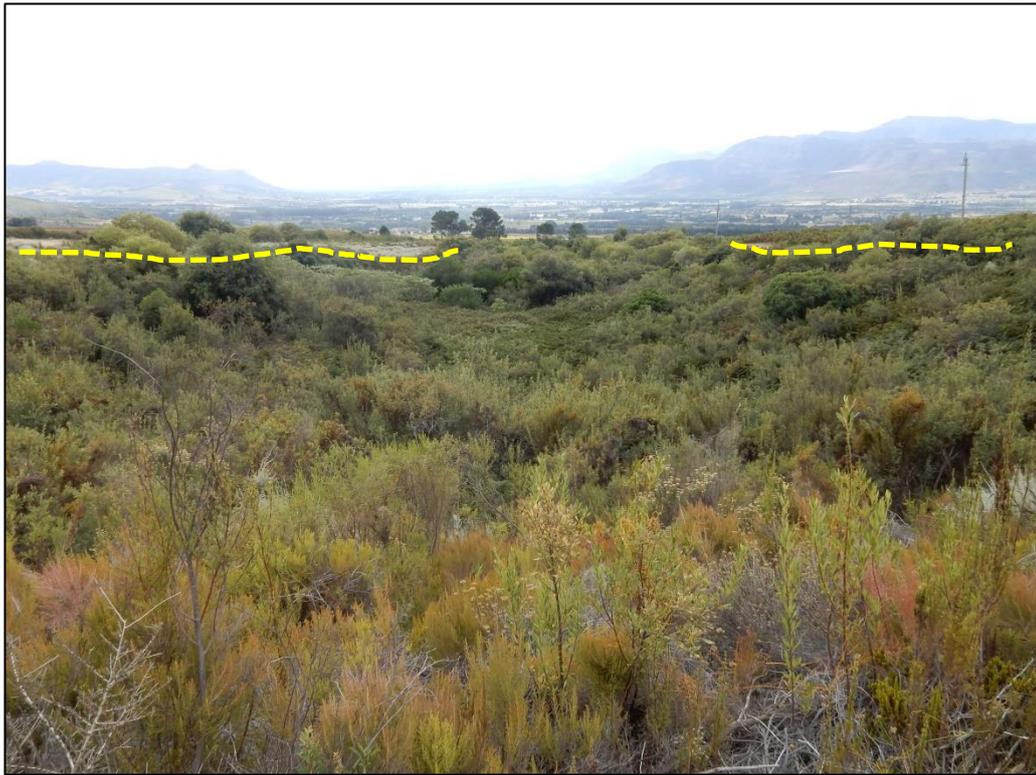
Figure 3.2 Riparian area below the dam wall at the Tented Camp site, showing the clear boundary between riparian and terrestrial vegetation (the pale grey *Seriphium plumosum*) (yellow dashed line).

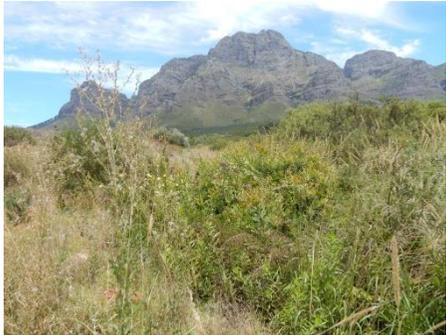
<p>Riparian area of the upper reaches of Stream 1</p>	A	High
Upper Stream 1 (below the farm dam)	Upper foothill stream with associated riparian area	Stream flows below the farm dam for some distance and then is diverted to flow around agricultural fields.

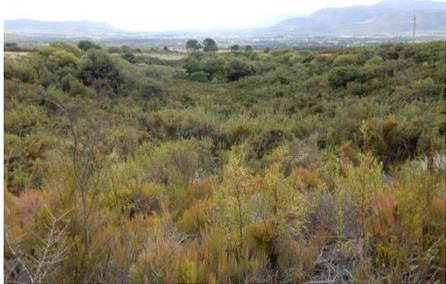
<p>Riparian area in Stream 1 below the farm dam</p>	C	High

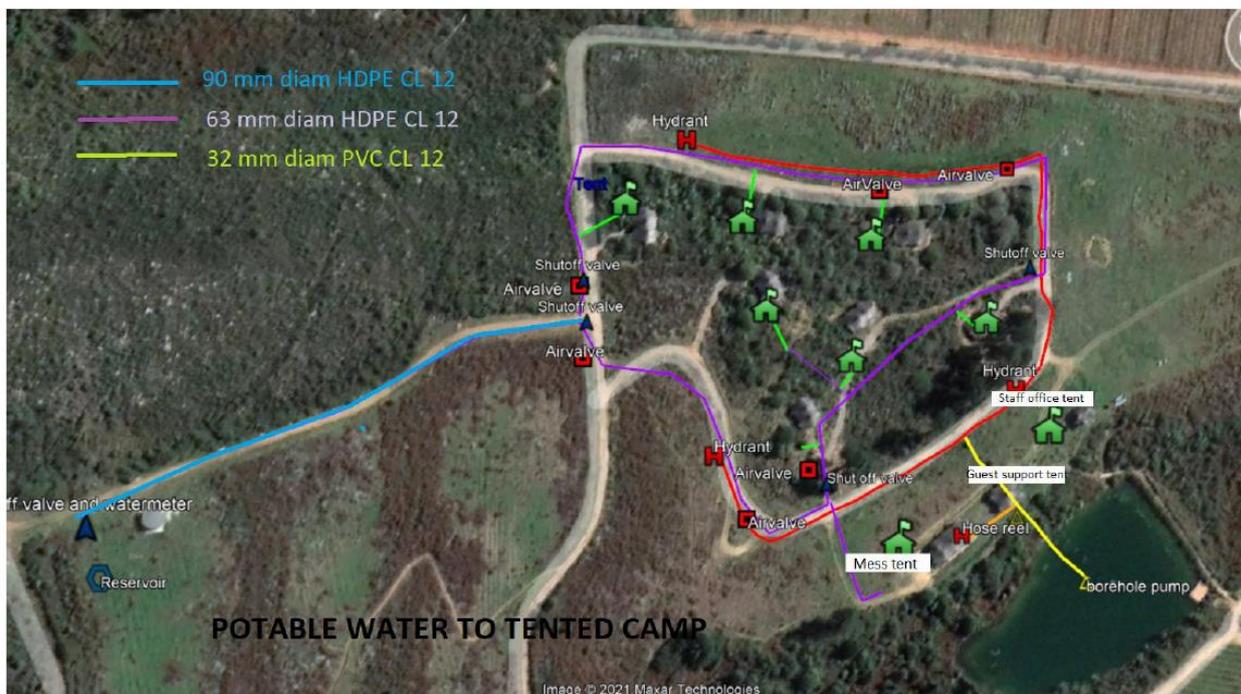
Figure 7.1 Potable water layout for the Tented Camp site.

Potable water is supplied from a reservoir some distance uphill of the site (at 413 mAMSL). A gravity supply line runs from the reservoir to the site, and then splits into the internal network (Figure 7.1). The reservoir and supply line were constructed for the development. Water is supplied to the reservoir from a natural spring close by, that provides a consistent supply of water throughout the year. An in-line aggregate filtration system and water purification system has been installed to improve water quality. A new in-line

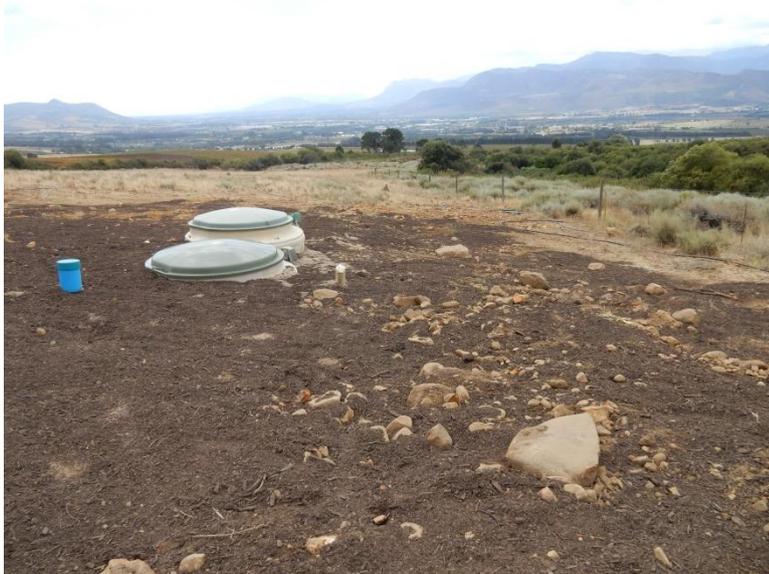
Figure 7.3 Above ground component of the BioDisc domestic sewage treatment plant (BA model), located at the Tented Camp site.

The BioDisc domestic sewage treatment plant is based on a Rotational Biological Contactor. This allows for waste water to go through two stages of treatment, followed by two stages of settlement. Water is rotated and moved through the system with an electric motor. The chemical constituents of the effluent are shown in Table 7.1. While most of the constituents in the effluent are at low levels, the nitrates are higher than the levels required for General Limits, as contained in Schedule 2 of Government Notice 665 of 2013. The receiving environment, i.e. Stream 1, flows into the Berg River below its confluence with the Dwars River, so General Limits are acceptable, however, the nitrates are a concern.

It is recommended that the treated effluent be discharged to a soakaway below each treatment Unit. This will allow for additional treatment of the effluent before it is allowed to seep into the soil and, finally, the watercourse. The soakaway should be located outside of the ecological buffer around the riparian area. It is not recommended that the effluent be discharged directly into the watercourse, riparian area or the dam.
