# ARCHAEOLOGICAL IMPACT ASSESSMENT, 80 LIESBEEK AVENUE, ERF 160695, OBSERVATORY, CAPE TOWN

submitted in terms of Section 38(8) of the NHRA (1999) for  
80 LIESBEEK AVENUE, ERF 160695, OBSERVATORY, CAPE TOWN

Interim First Draft  
15 October 2021

Prepared by Katie Smuts of Rennie Scurr Adendorff for Vidamemoria Heritage Consultants

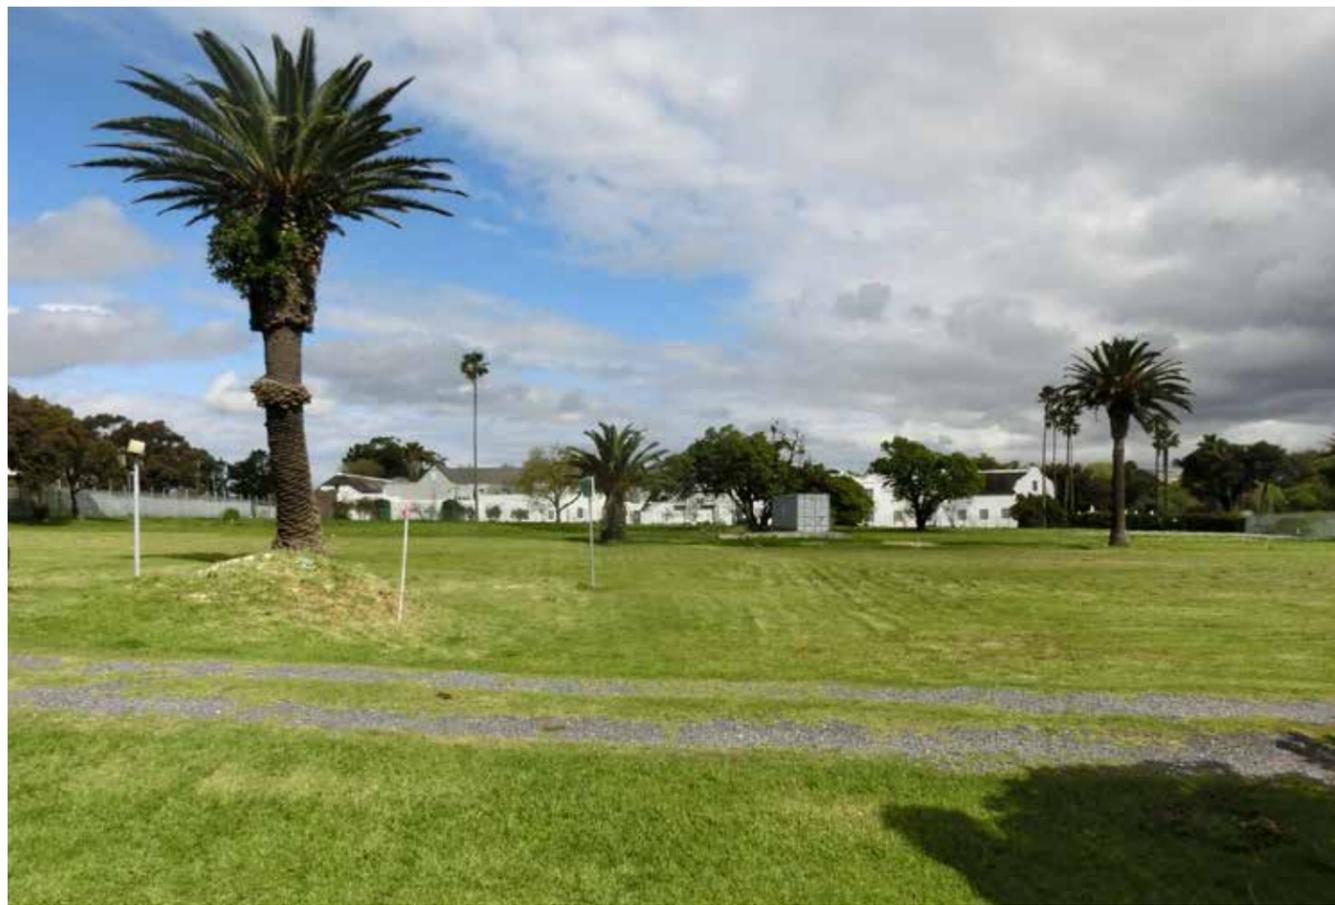
Figure 3. View across site towards Valkenburg Estate, view to south (RSA, 2021)

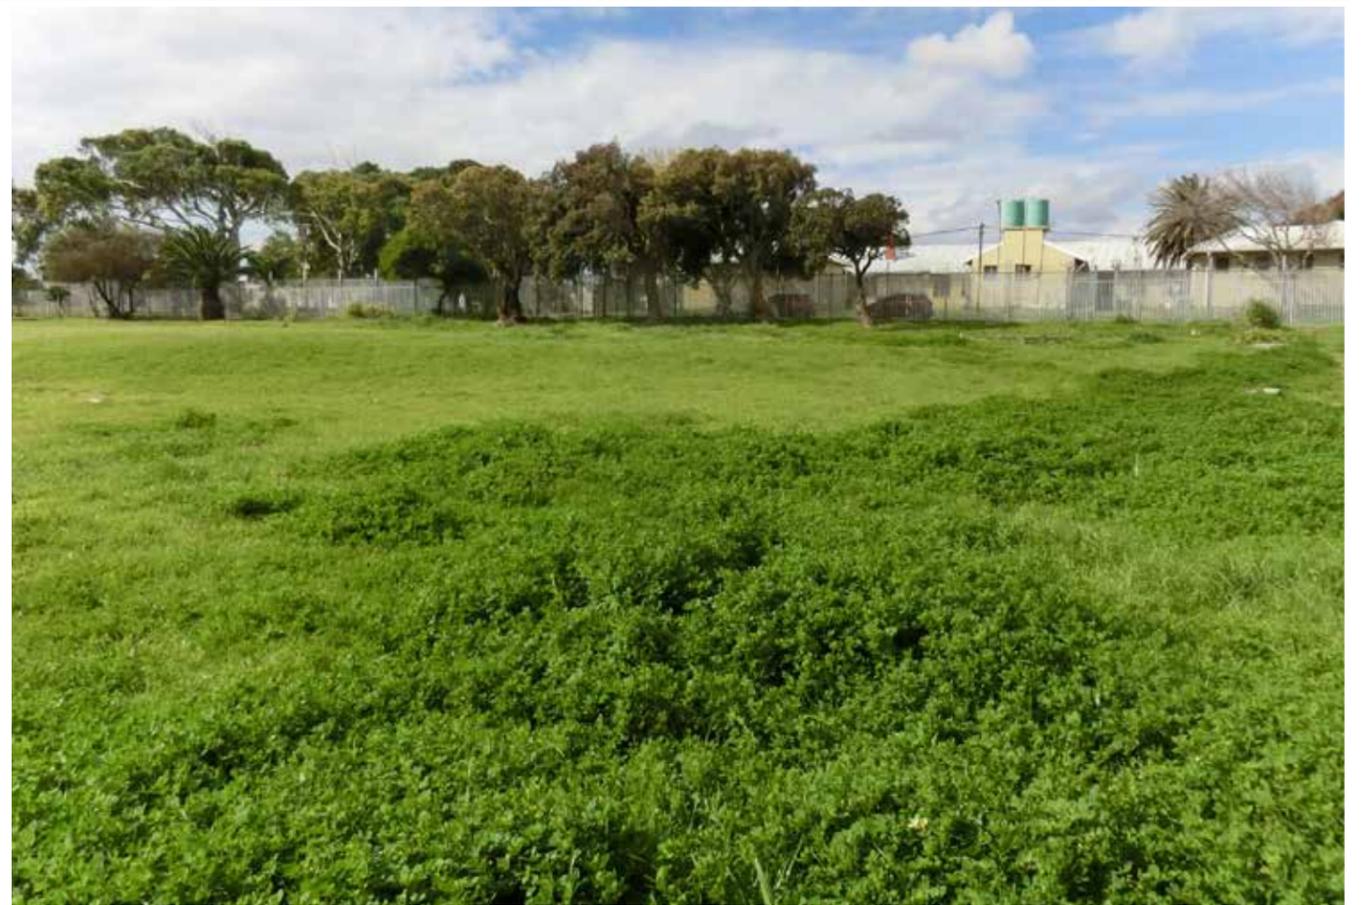
Figure 5. View across site towards Valkenburg Hospital, view to north east (RSA, 2021)

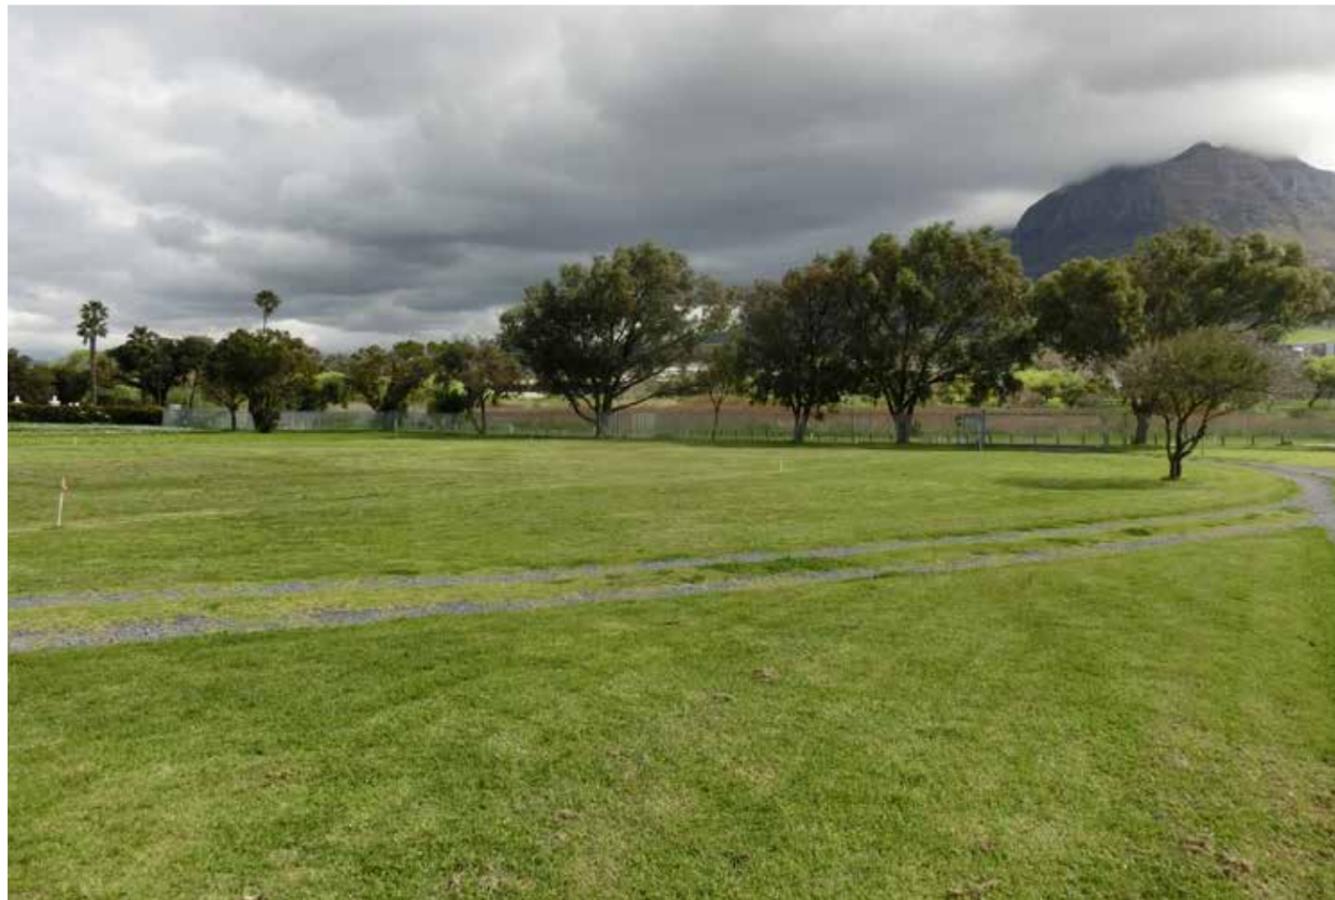
Figure 4. View across site towards Liesbeek Avenue, view to south west (RSA, 2021)

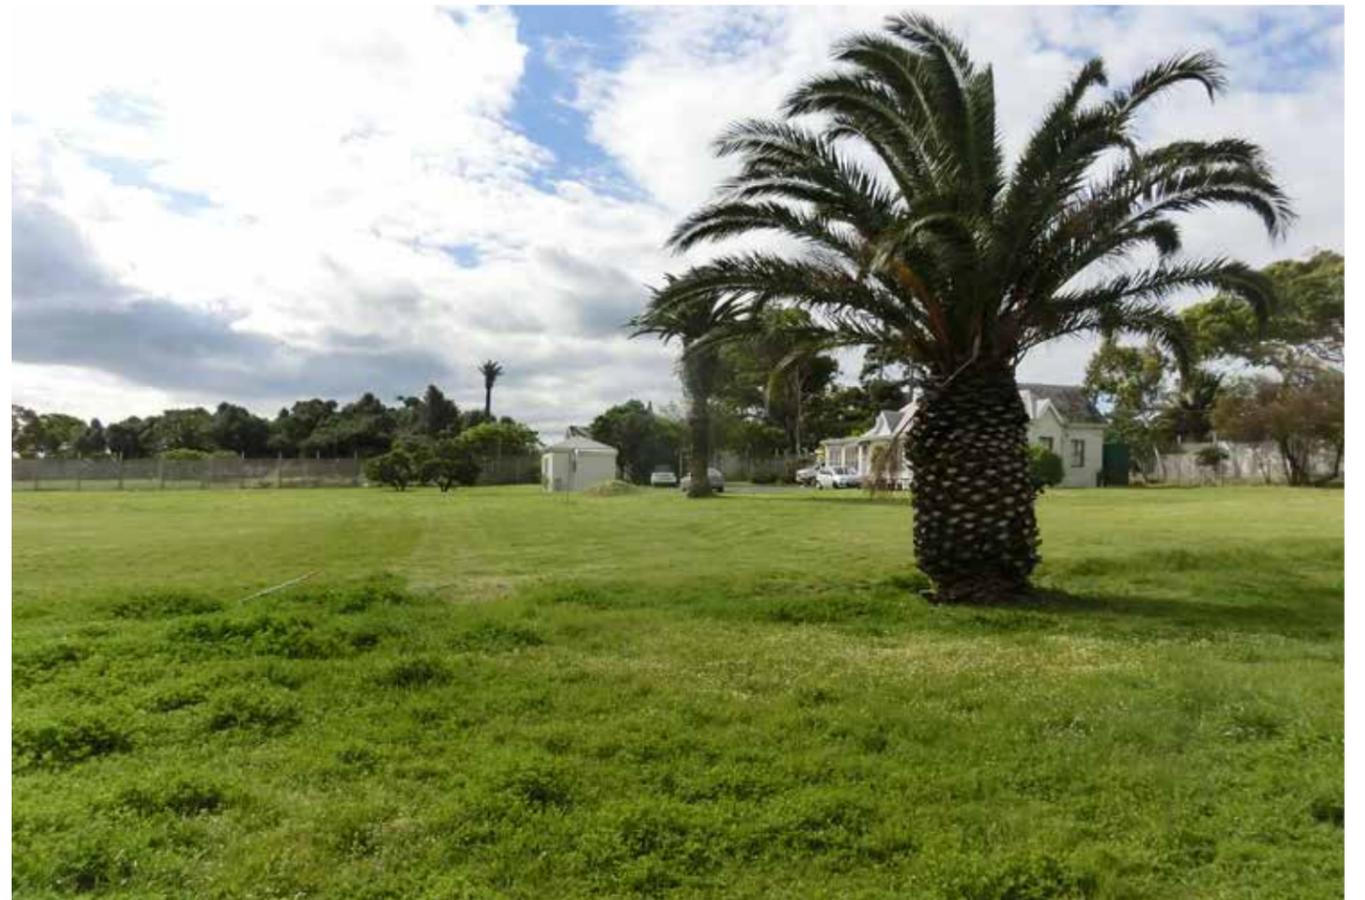
Figure 6. View across site towards Mission Office and guardhouse, view to north (RSA, 2021)

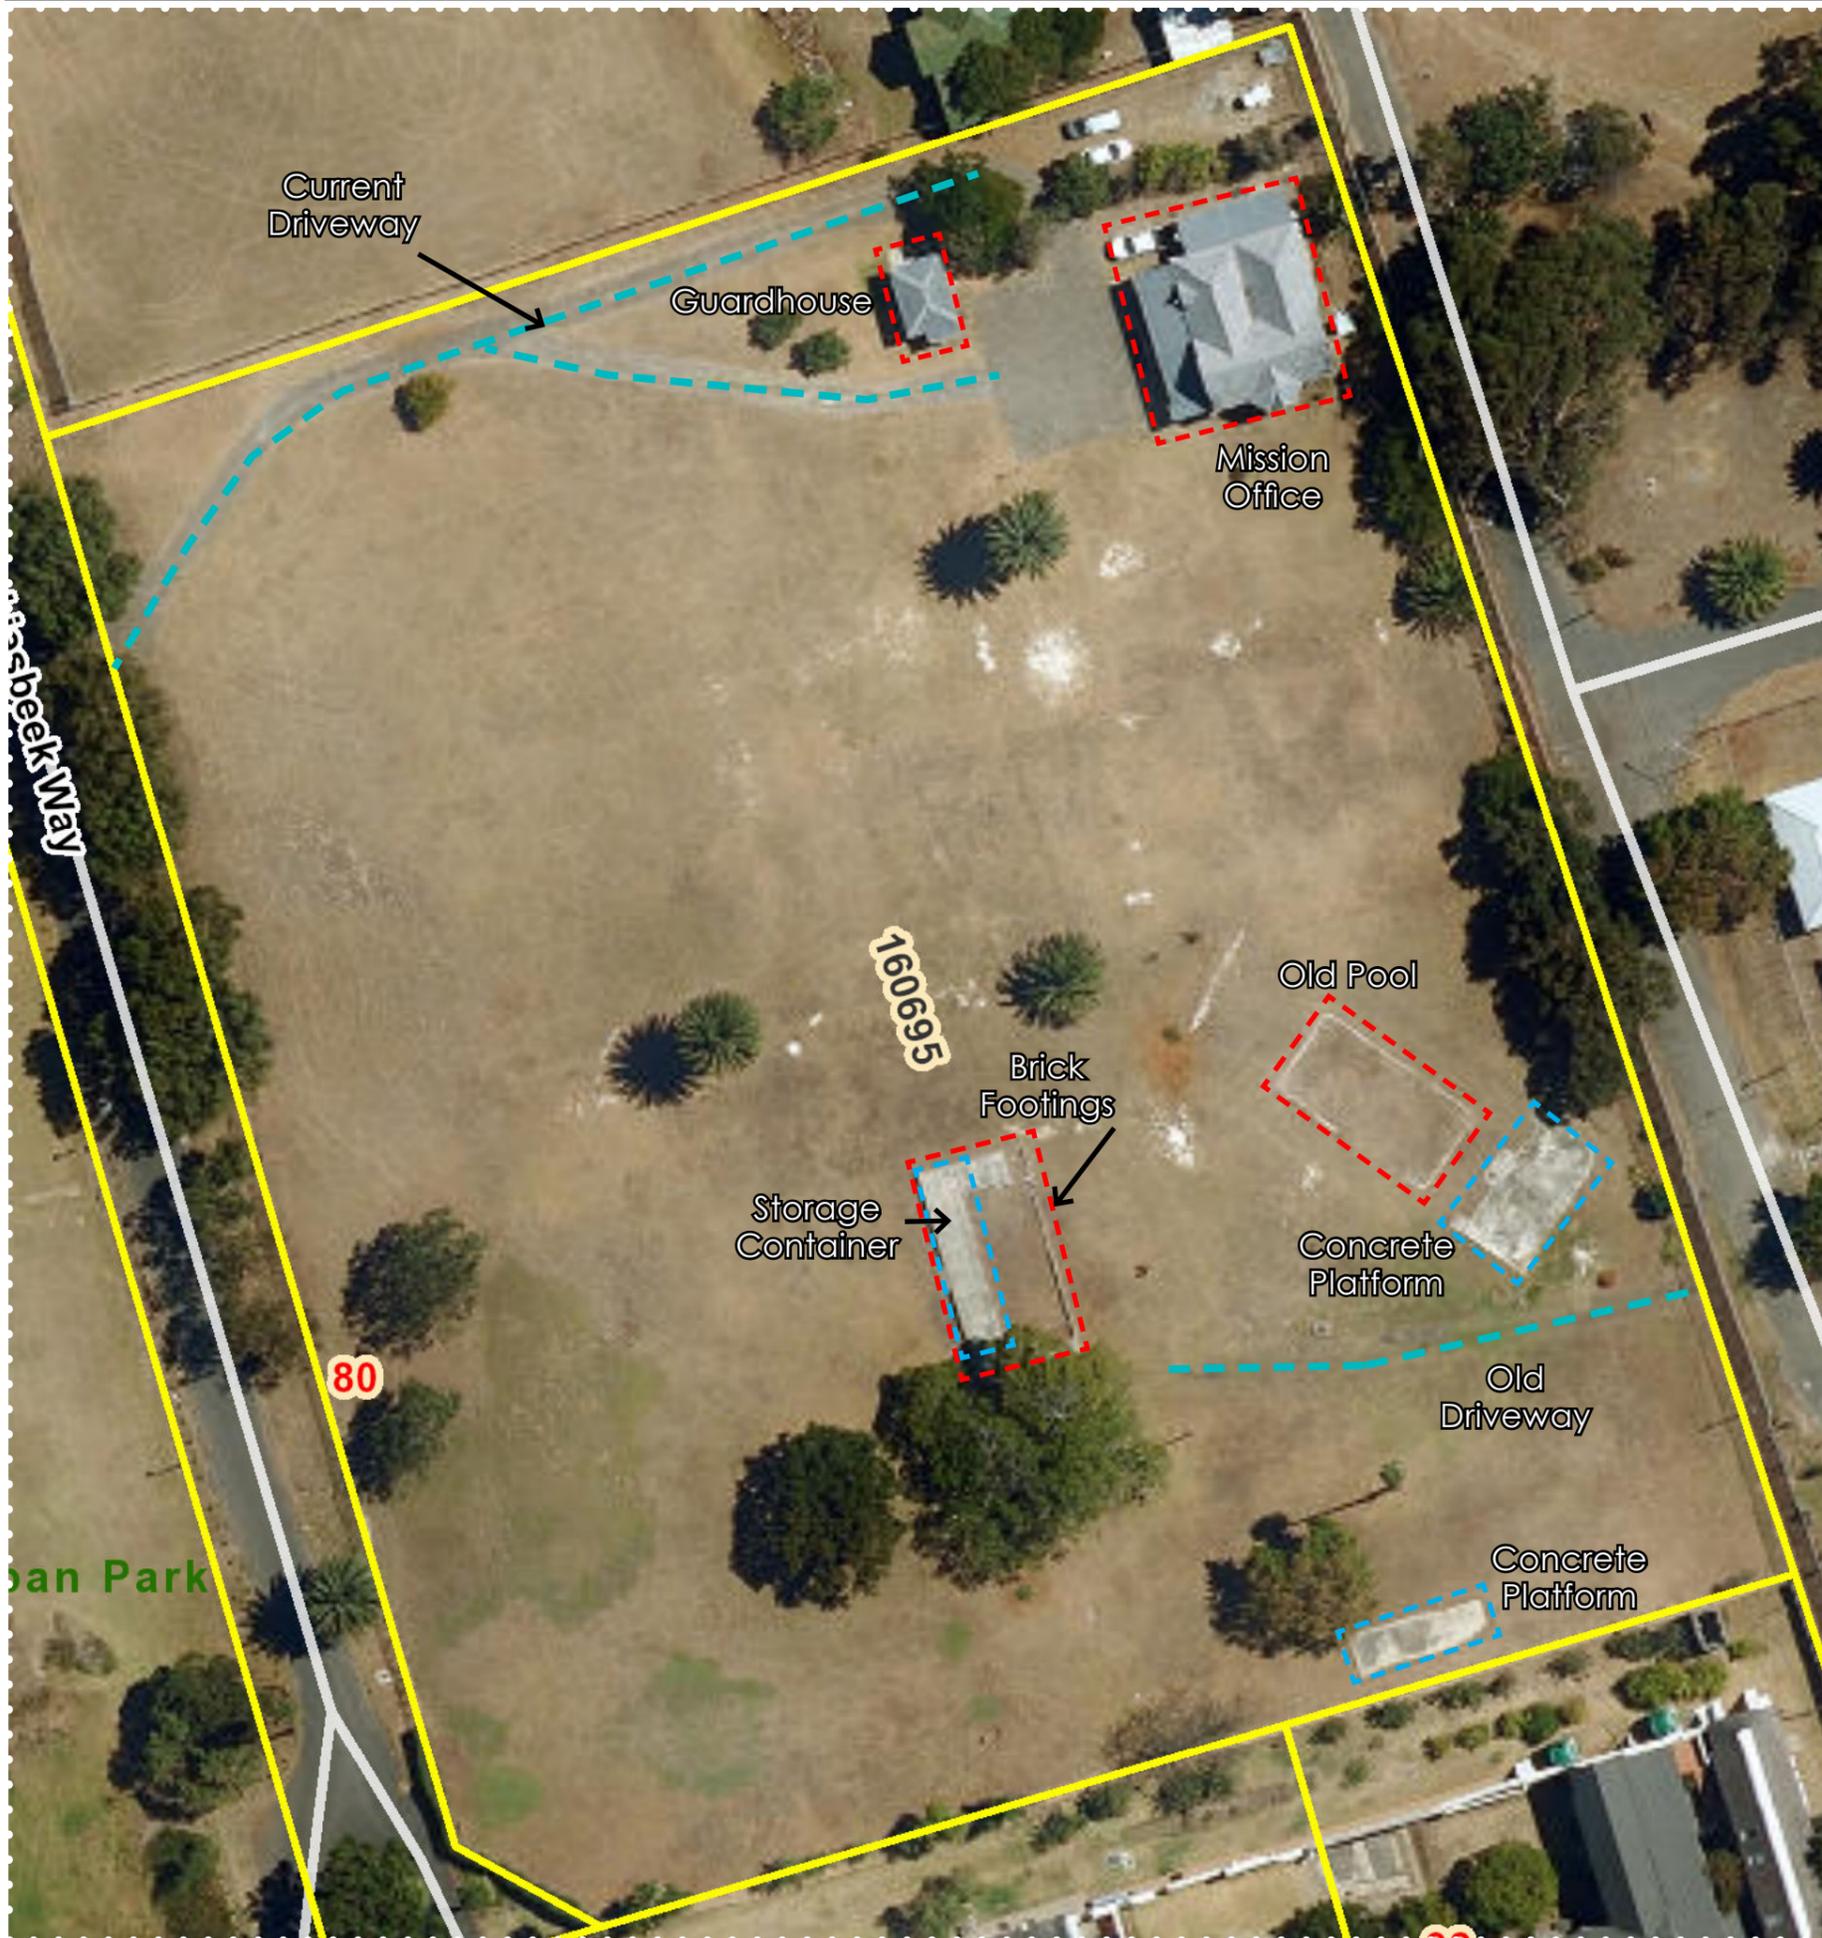
Figure 7. Erf1606954 naming of parts (CoCT EGSViewer, 2021)

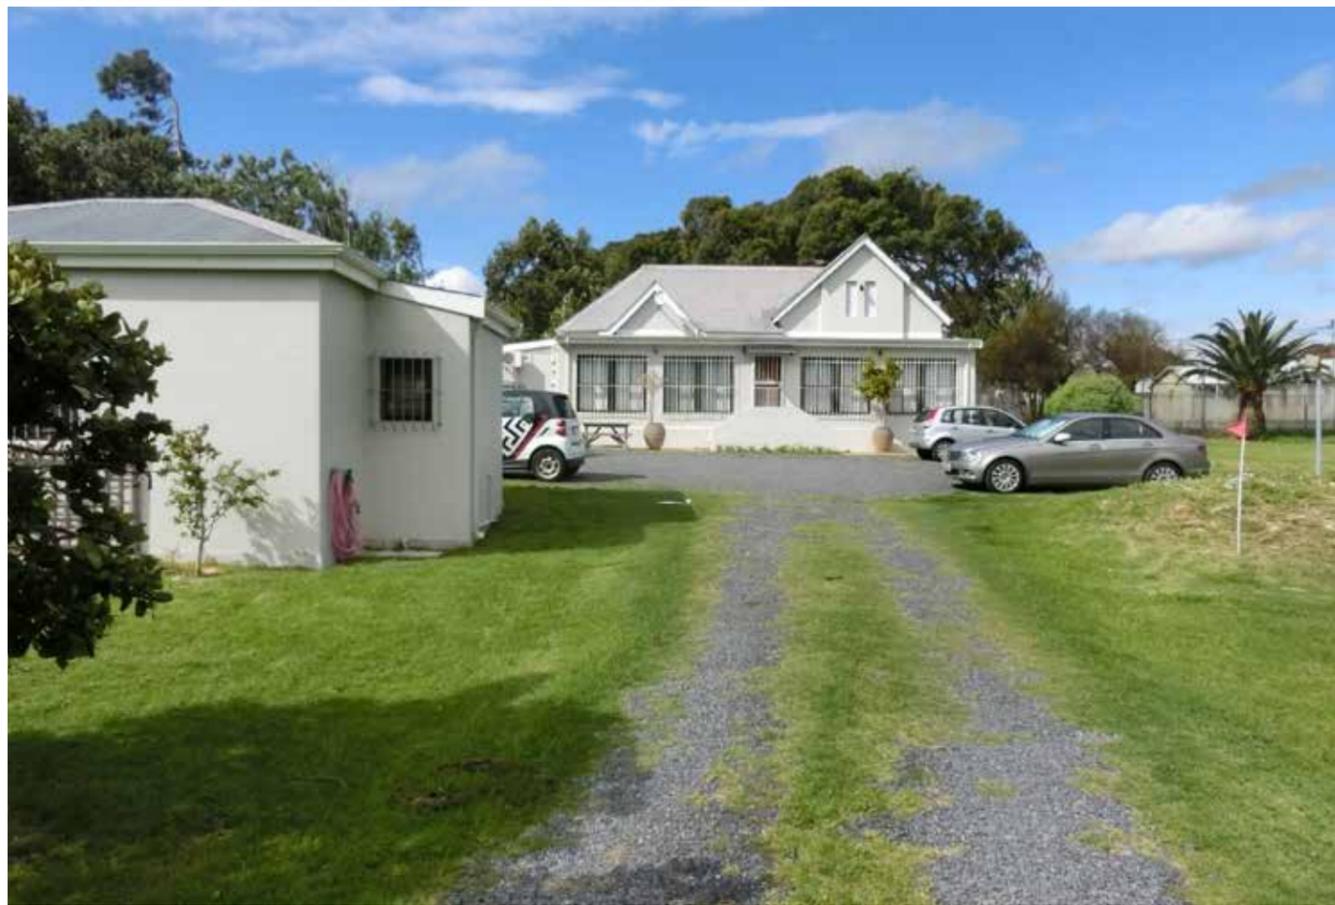
Figure 8. View of Mission Office and guardhouse, view to east (RSA, 2021)

The site survey noted the standing structures, namely the Mission Office and guardhouse at the northern part of site. Neither of these structures constitutes archaeological features, and do not, therefore form part of this assessment.

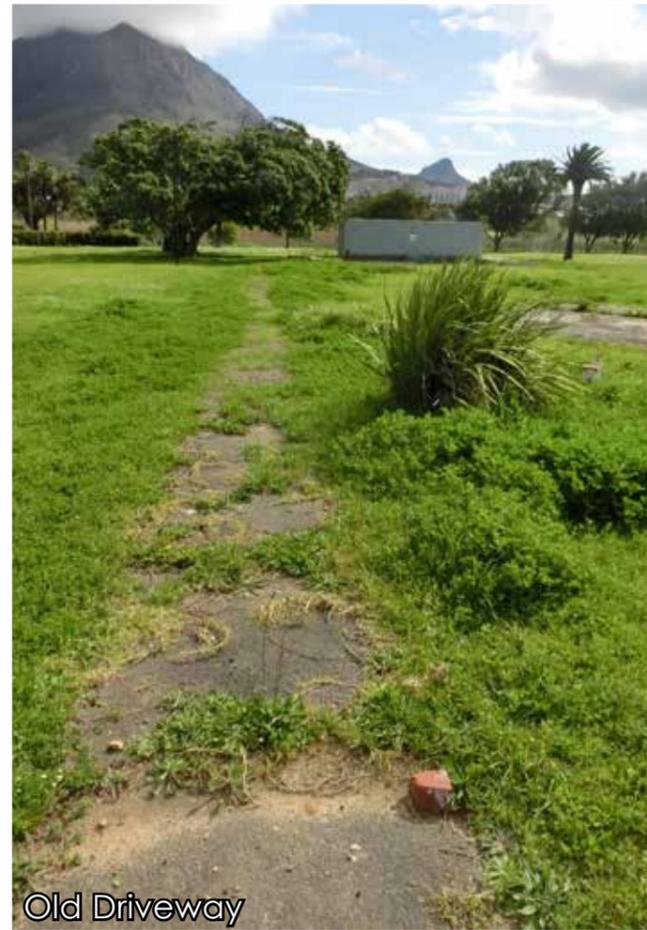
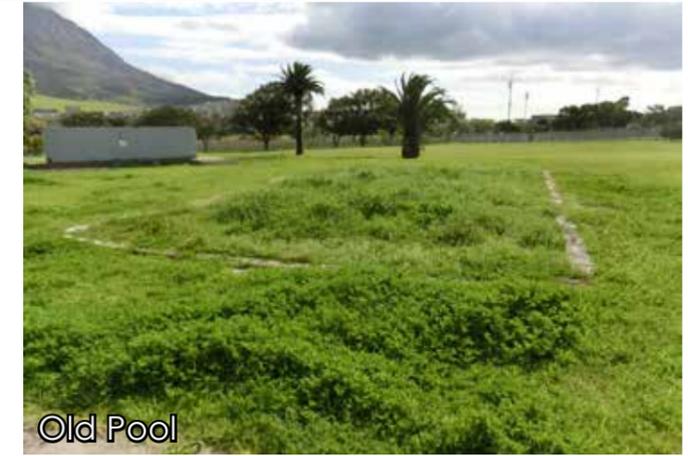
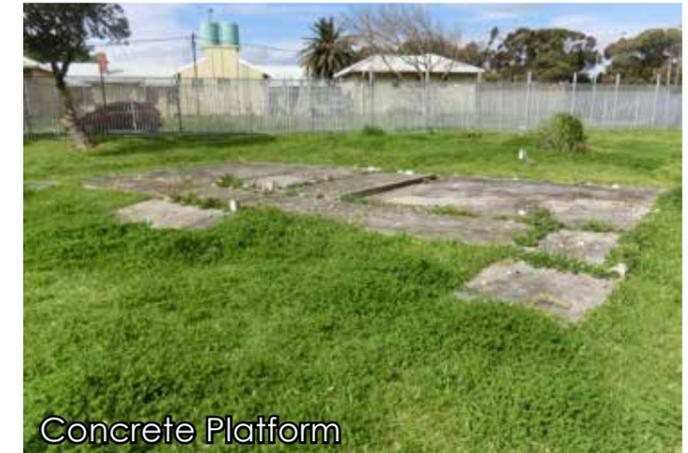
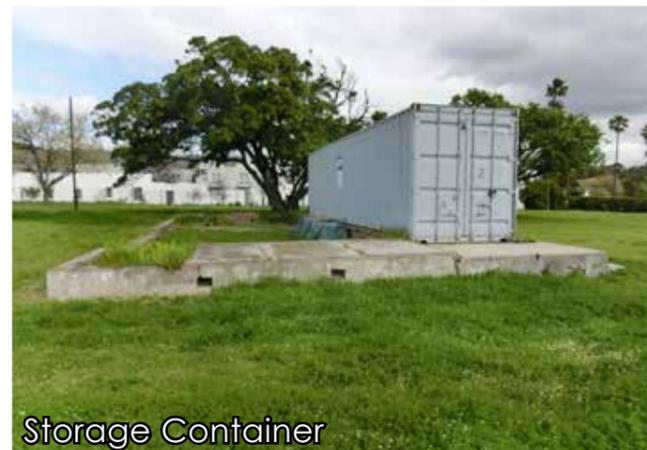
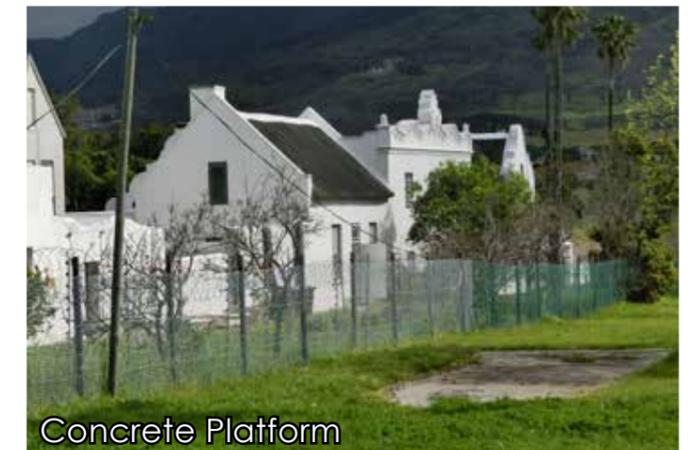
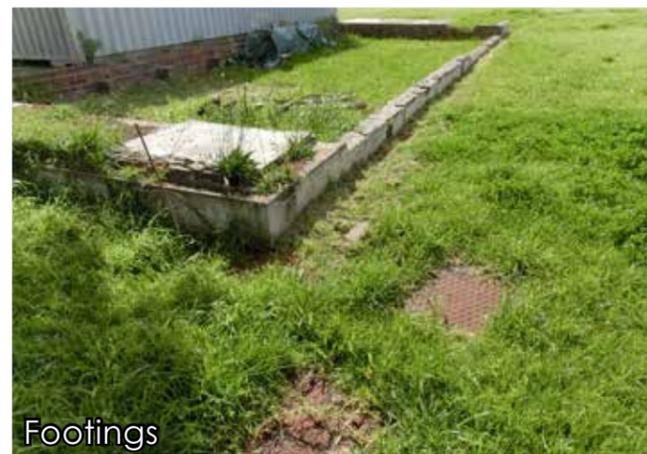
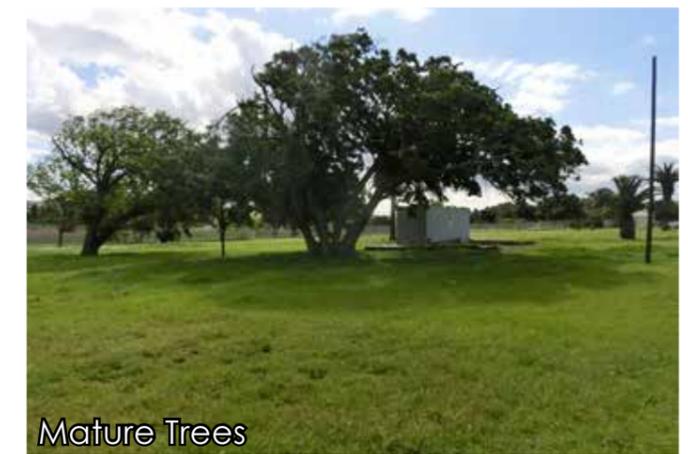
Figure 10. Site features (RSA, 2021)

Old Driveway

Old Pool

Concrete Platform

Storage Container

Footings

Mature Trees

The footings found in the southern portion of site largely correspond with features noted in the 1966 aerial, although these are not present on the 1944 aerial. As ruined structures younger than 100 years, these similarly do not comprise archaeological features, but do form part of the site history and are, therefore, recorded as part of this assessment.

Beyond these C20th features, no other archaeological features or artefact were identified on site, and much of the southern part of site has clearly been subject to extensive trenching for services, as evidenced by the numerous manholes located there, in addition to the disturbances caused by the erection and demolition of structures through time.

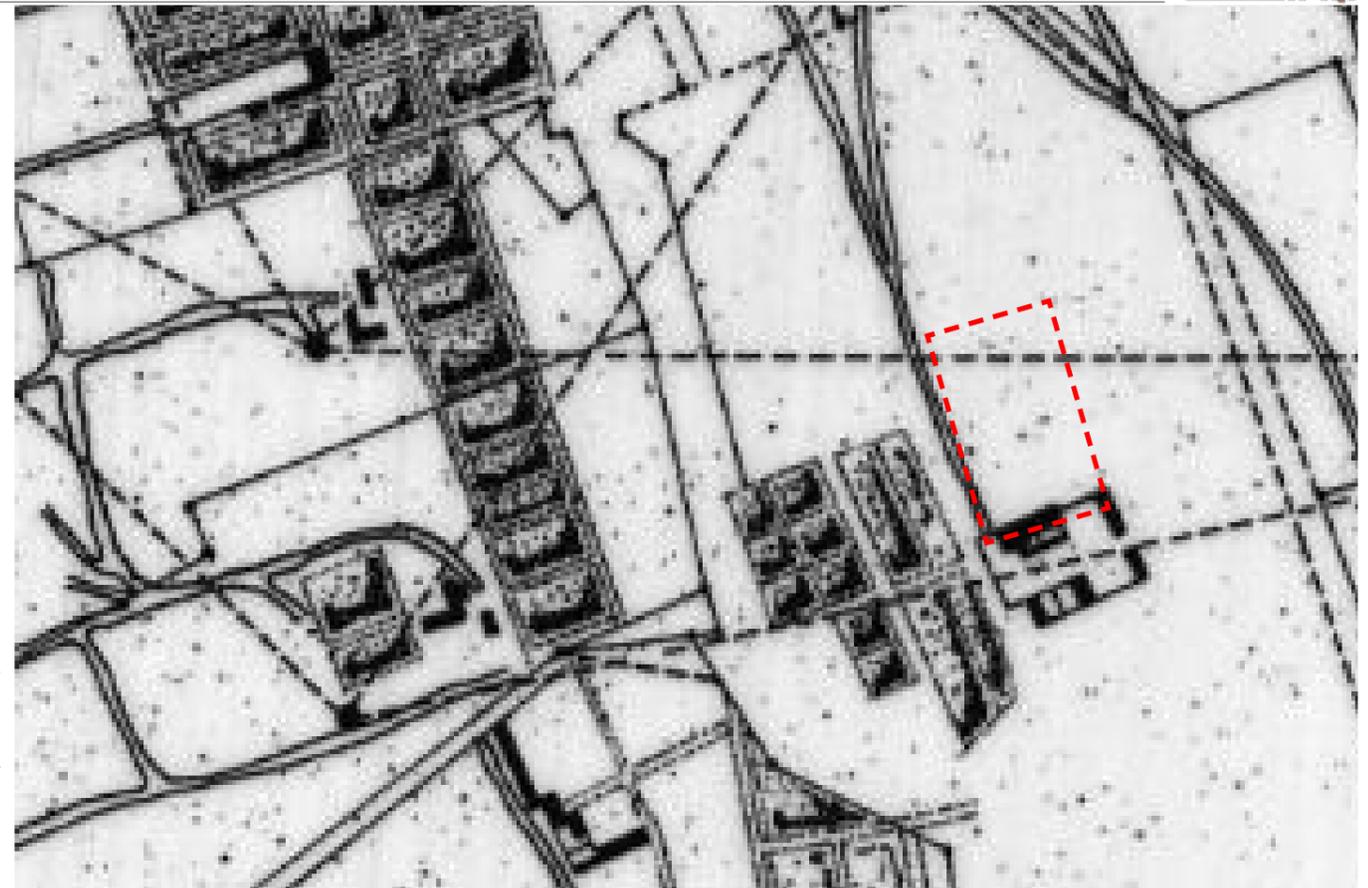
Figure 15. Thibault's survey of 1812 showing the Valkenburg werf and farmed fields along the Liesbeek, approximate location of subject site indicated in red (Attwell & Associates and ARCON, 2016: 33)

In 1791 land was deducted off by new owner, Jan Maurits Buyk, the deduction now housing St George's Grammar School. The remaining extent of Valkenburg was duly acquired in the early C19th by Cornelis Mostert who increased the property, and made extensive changes to the front of the house and other aspects of the werf between 1820 and 1830; the Royal Observatory was built on a deduction from Valkenburg in 1828. The werf is captured in Thibault's 1812 survey of the Cape which depicts the werf, enclosing ringmuur and several structures.

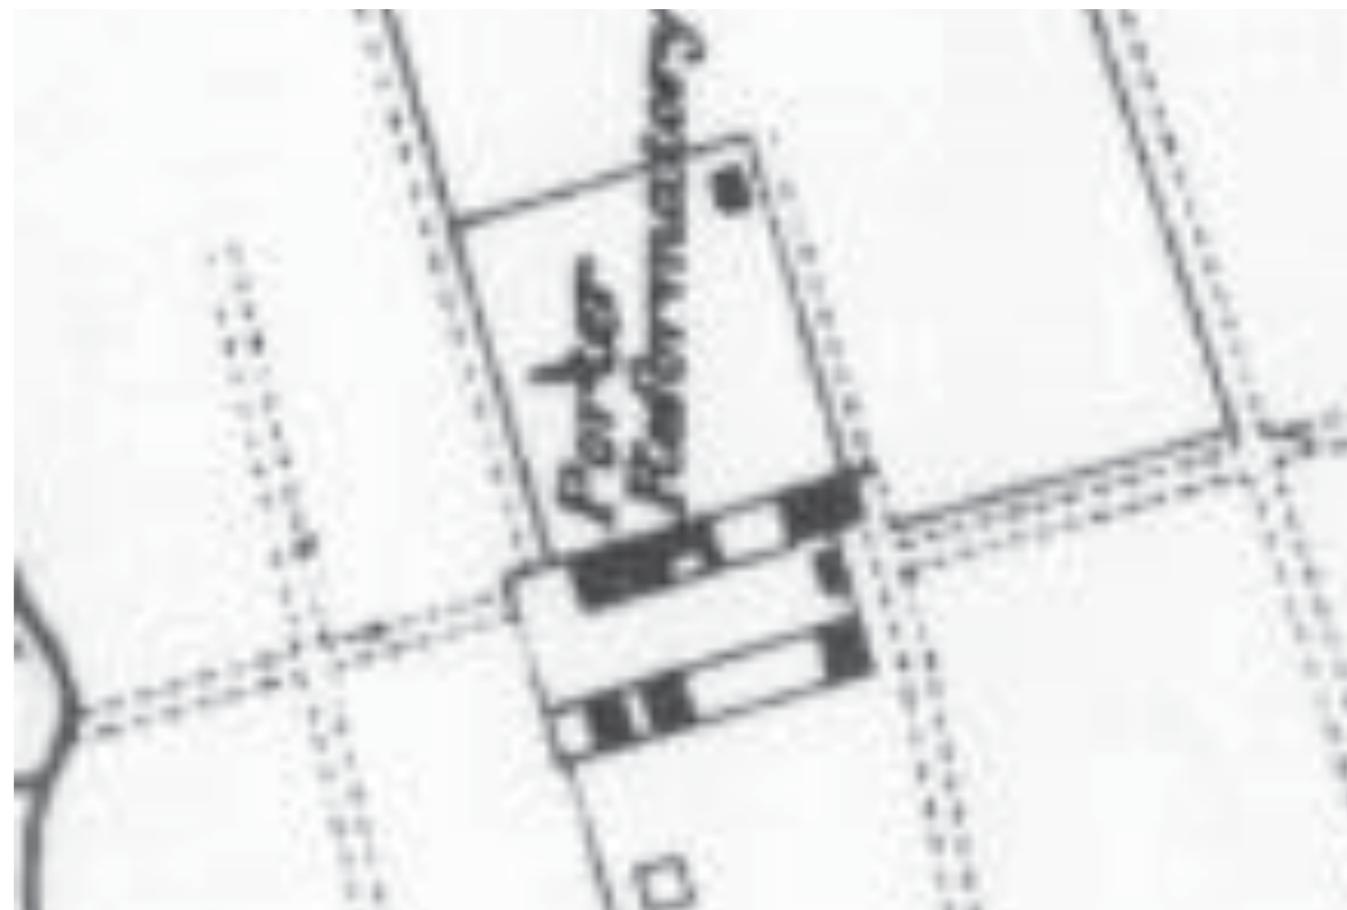
Figure 17. 1885 map by Boyle, showing the Mission Office structure (Attwell, 2016: 34)

The building that now houses the Mission Office is first mapped in 1885, in Boyle's Map of the southern Suburbs, and is again captured in the Mowbray survey of 1902-1909, where it is indicated as 'The Cottage' and shown in a large open garden, with a tennis court at the south western extent. The building to the north of Erf 160695 is indicated as the Isolation Ward, set in cultivated land, and the land to the east, labelled as Valkenburg Asylum Grounds indicates cabbage fields. At the south of Erf 160695 is the projecting northerly wing extending from the long north wing of the Valkenburg 'Old Asylum' complex, with small walled gardens to the west and an orchard to the east.

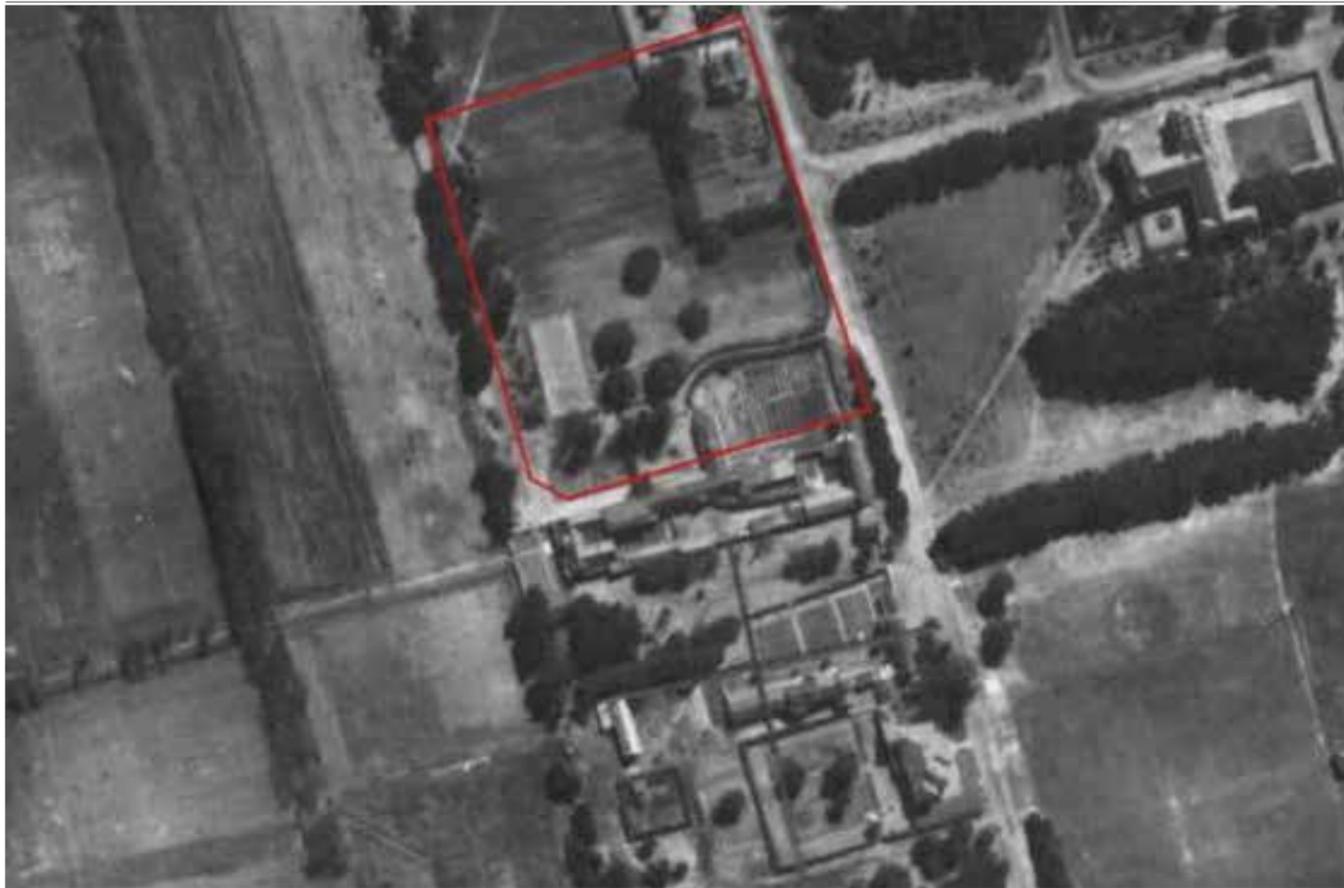
Figure 20. 1934 aerial, showing fields on Erf 160695, the tennis court bottom left and the projecting north wing of Valkenburg (Hislop, 2021: 18)

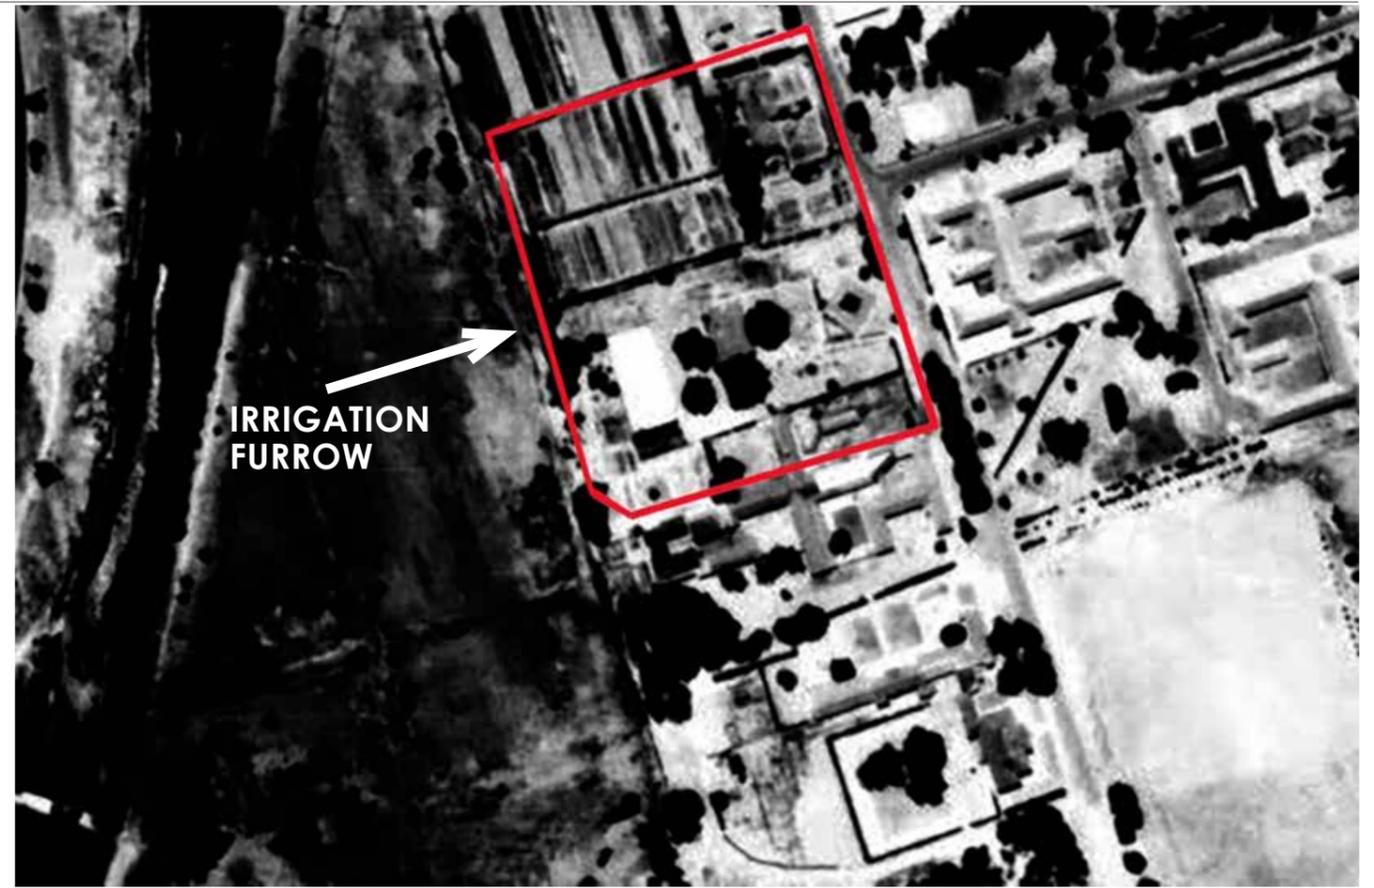
Figure 22. 1966 aerial showing increased cultivation on site, and extensive development of the southern part of site under structures and formal gardens (Hislop, 2021: 20)

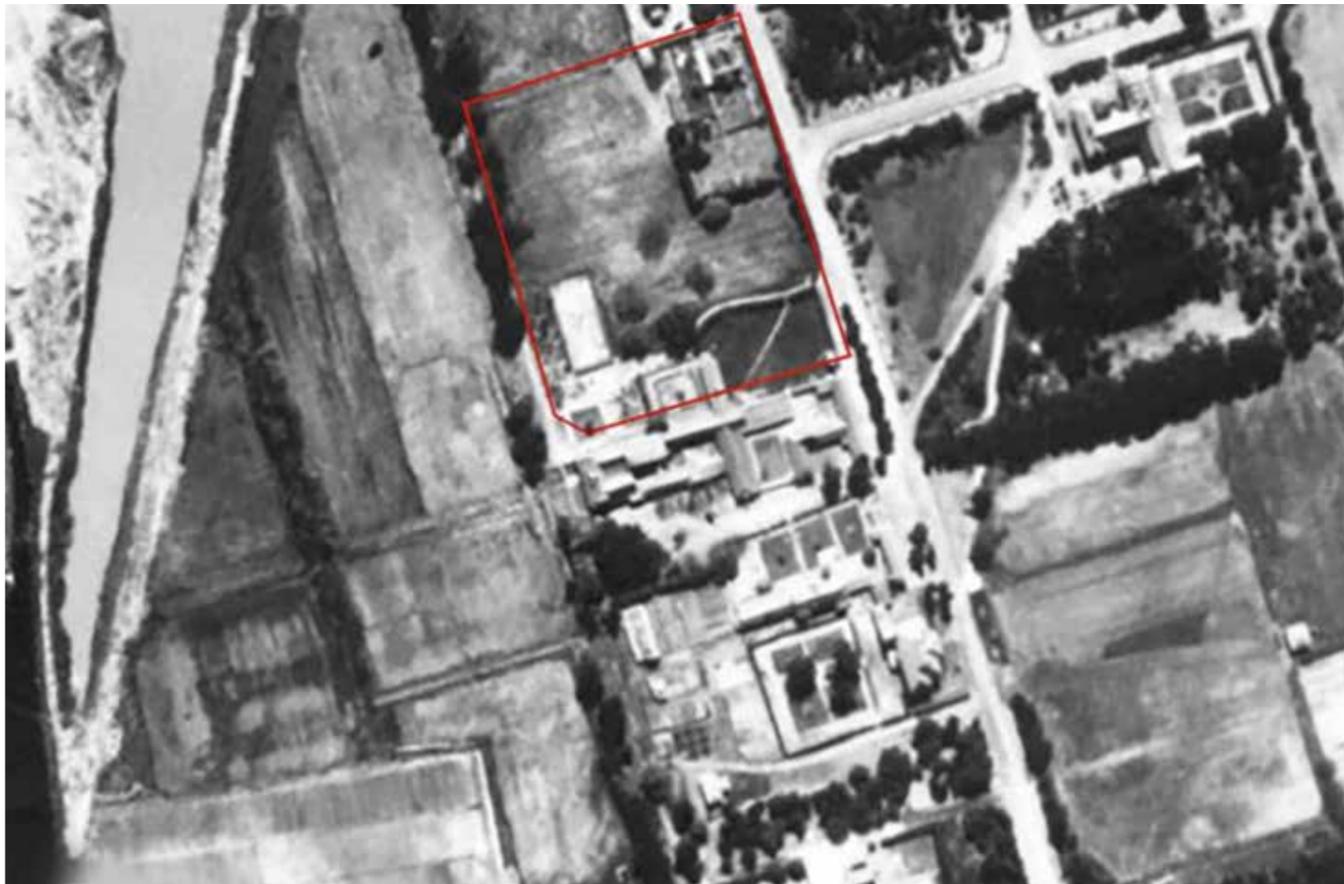
Figure 21. 1944 aerial largely unchanged from 1934 (Hislop, 2021: 19)

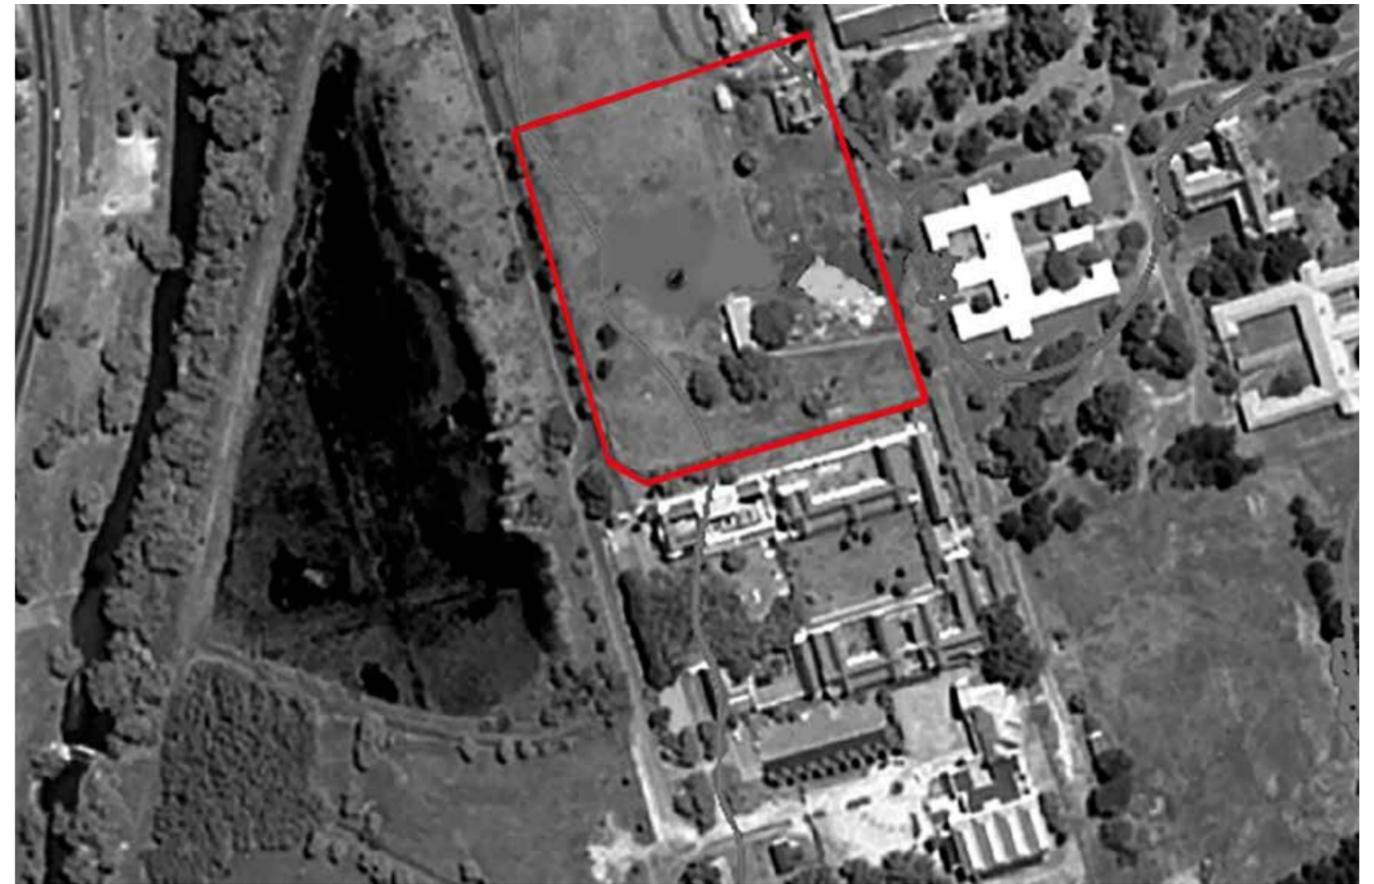
Figure 23. 2001 aerial showing Erf 160695 cleared aside from the structure between the trees and the pool and its adjacent building (Hislop, 2021: 22)
