# ARCHAEOLOGICAL IMPACT ASSESSMENT, 80 LIESBEEK AVENUE, ERF 160695, OBSERVATORY, CAPE TOWN

submitted in terms of Section 38(8) of the NHRA (1999) for  
80 LIESBEEK AVENUE, ERF 160695, OBSERVATORY, CAPE TOWN

Interim First Draft  
15 October 2021

Prepared by Katie Smuts of Rennie Scurr Adendorff for Vidamemoria Heritage Consultants

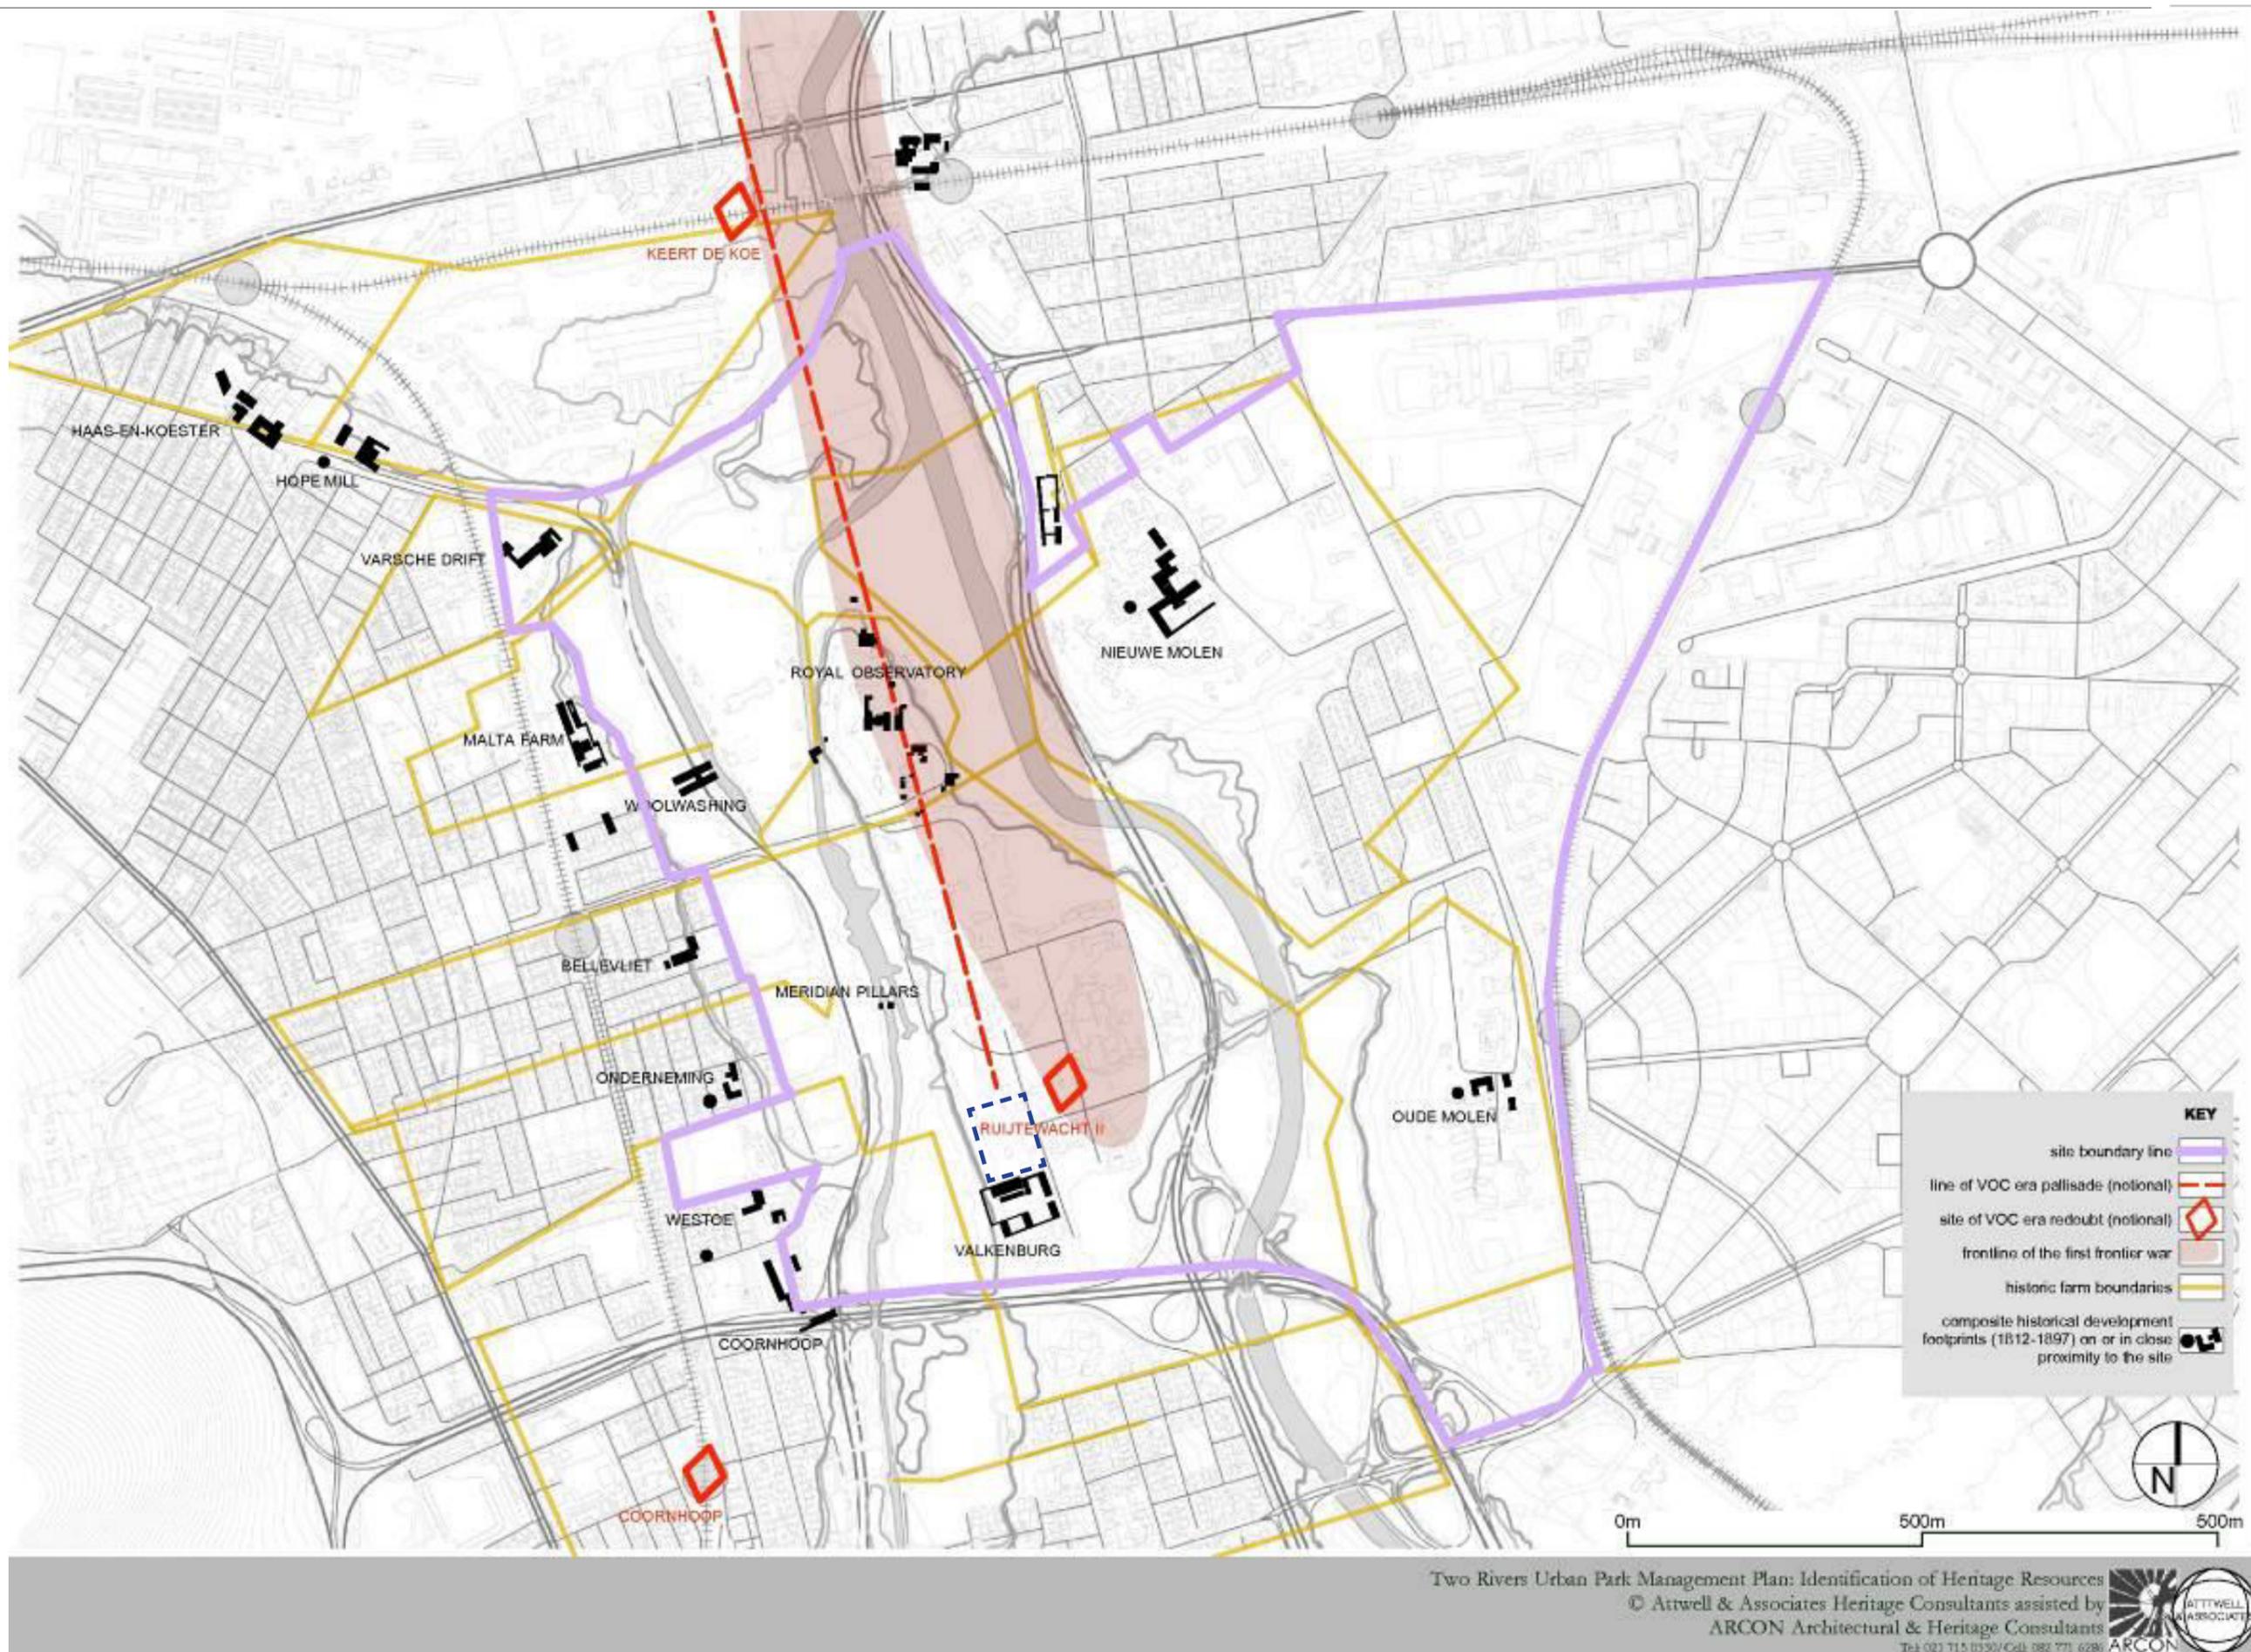
Figure 24. Historical Archaeological Potential Diagram; Erf 160695 indicated in blue (Attwell & Associates and ARCON, 2016: 43)

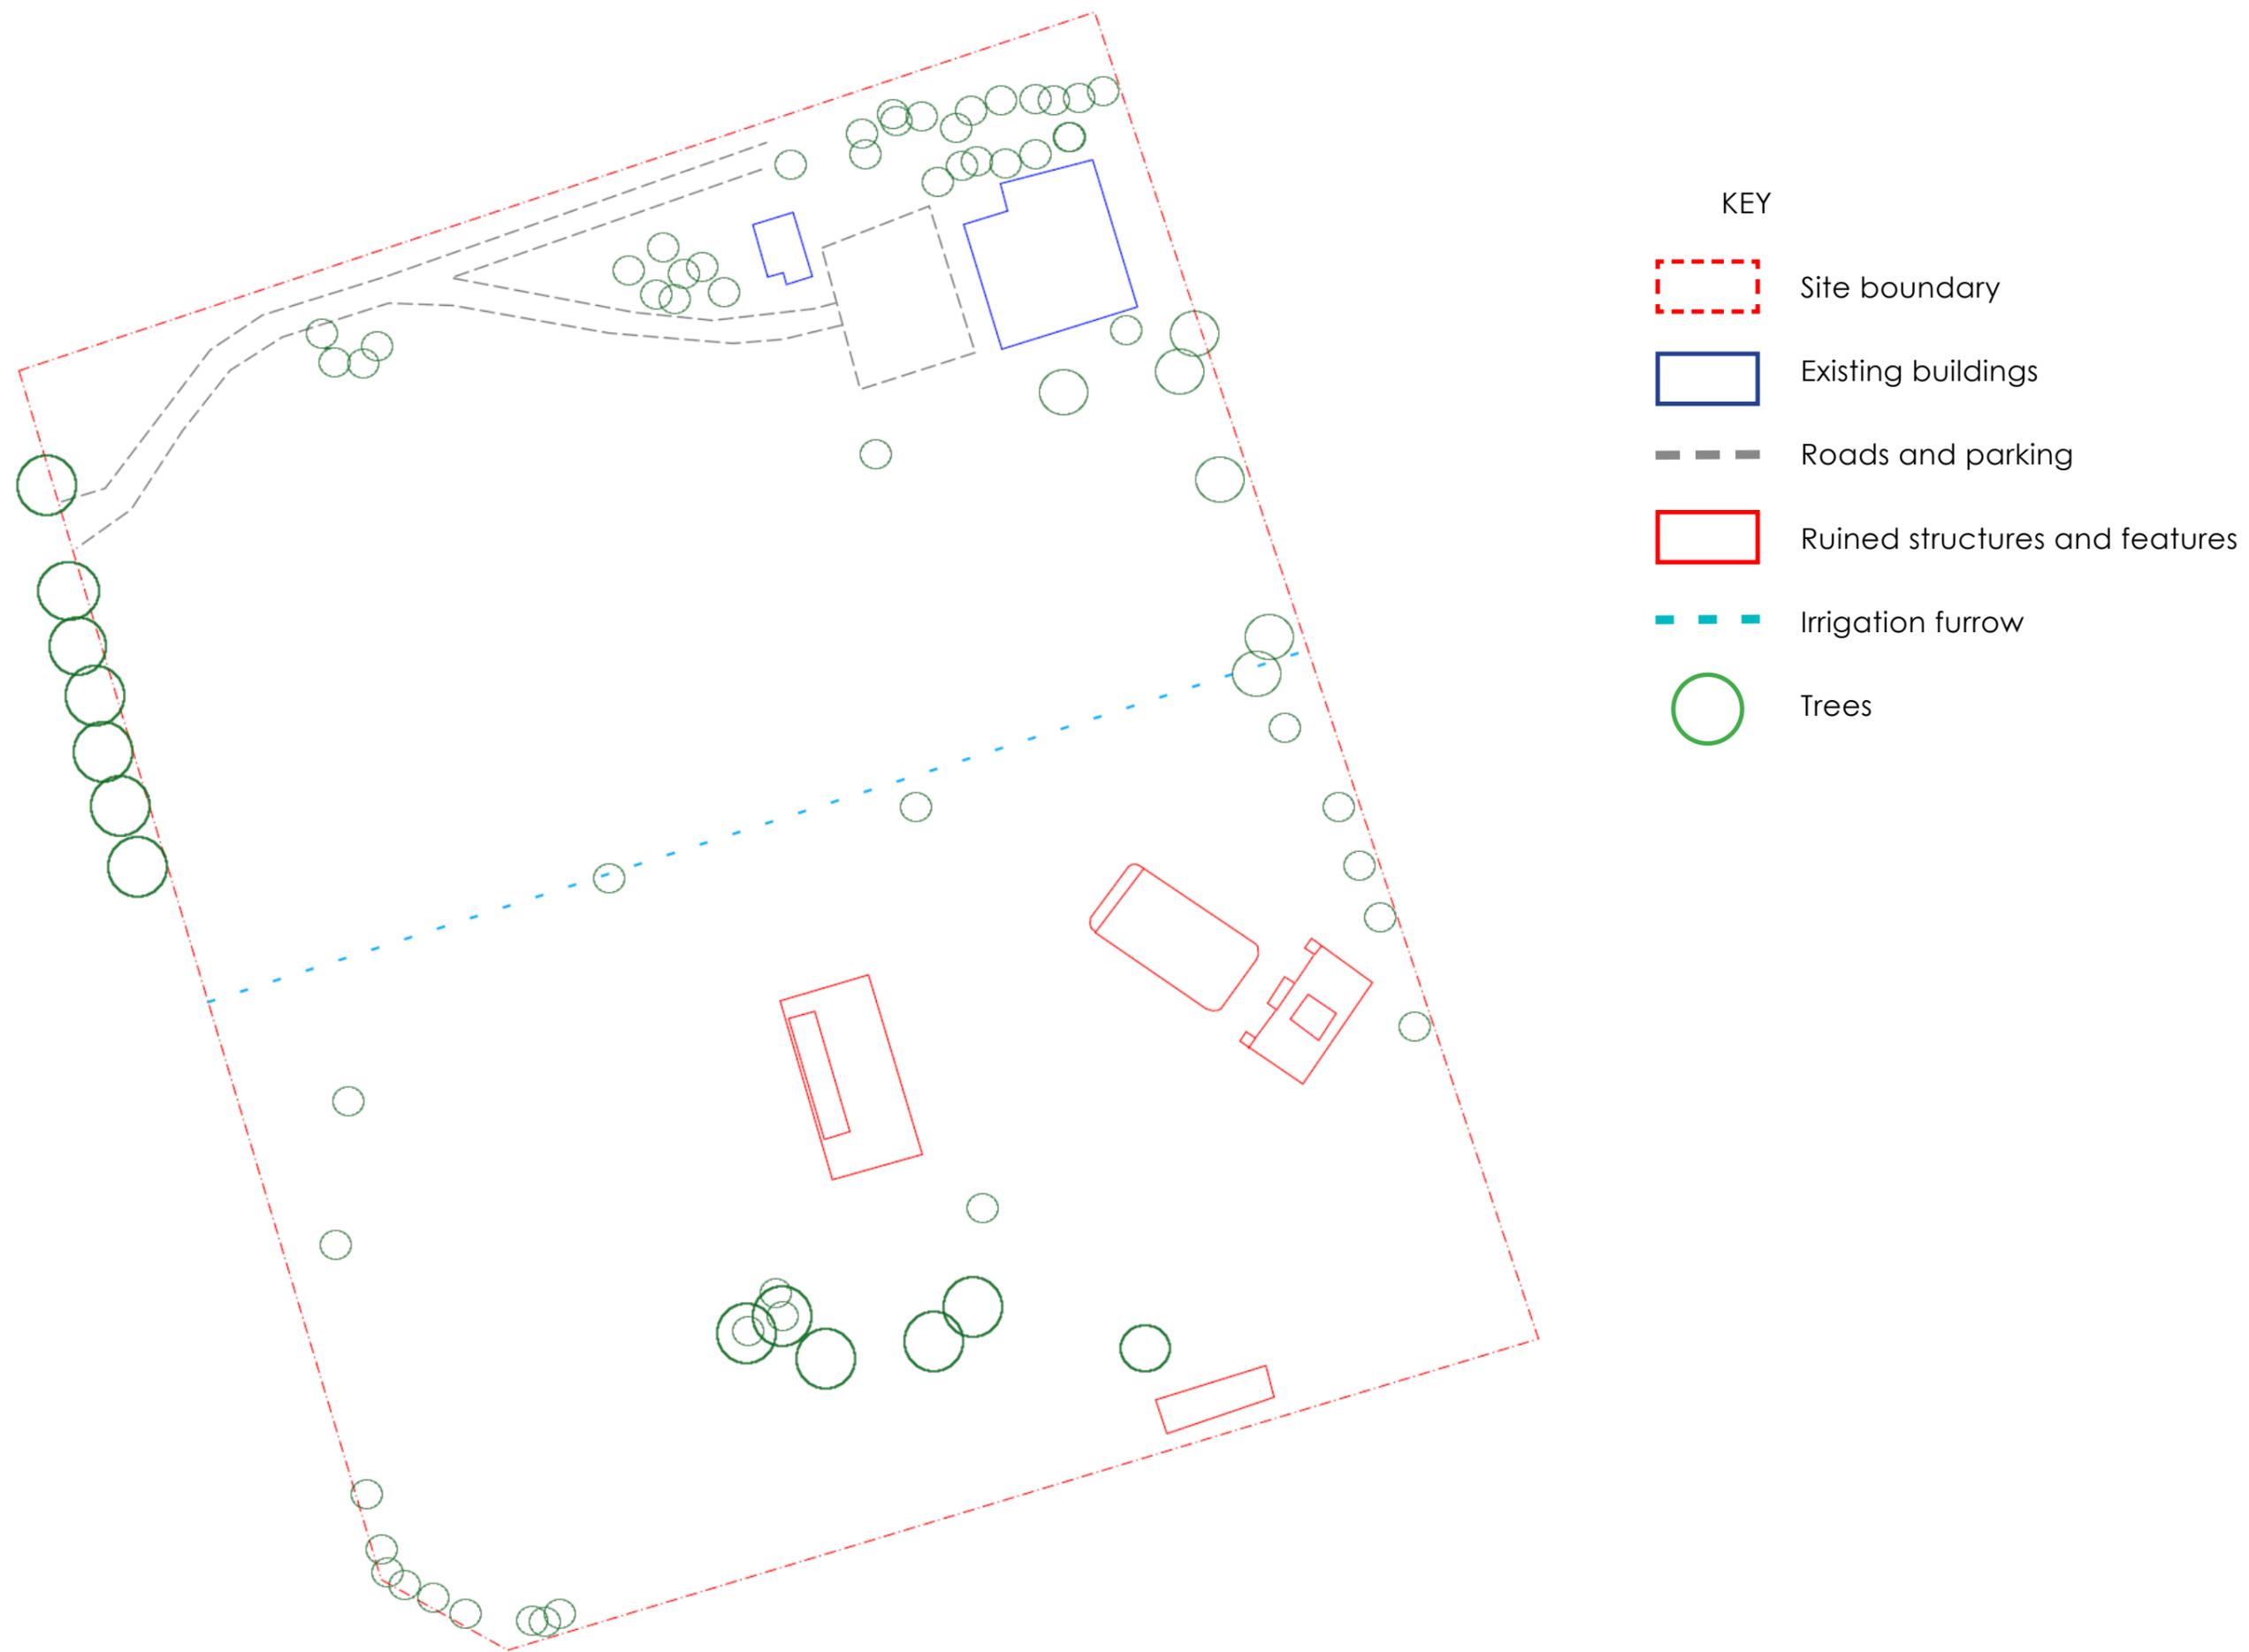
Figure 25. Site Survey (From African Consulting Surveyors, 2021 for ARUP (Pty) Ltd)

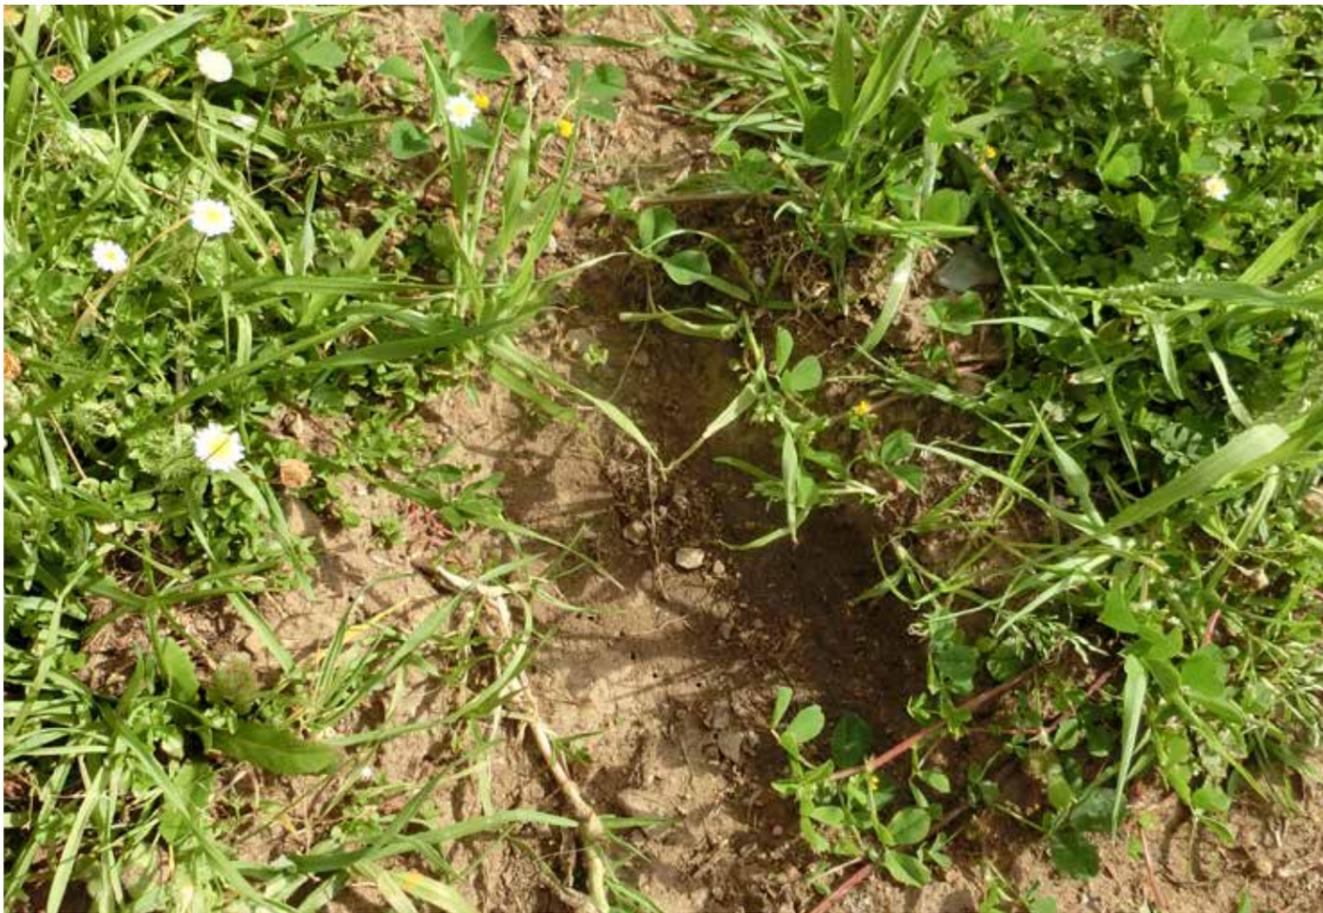
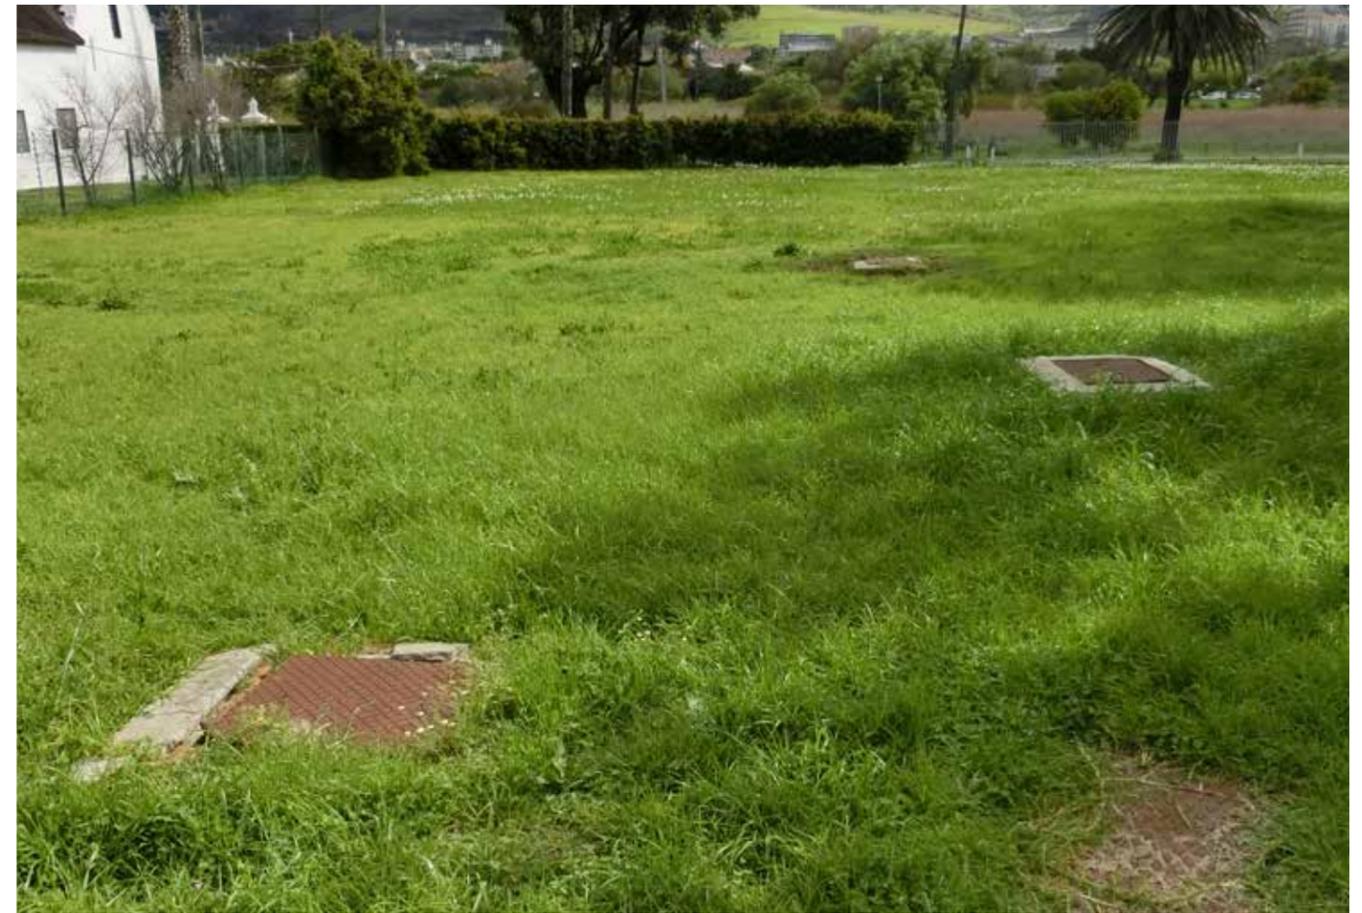
Figure 27. General condition of site with extensive services in southern extent (RSA, 2021)

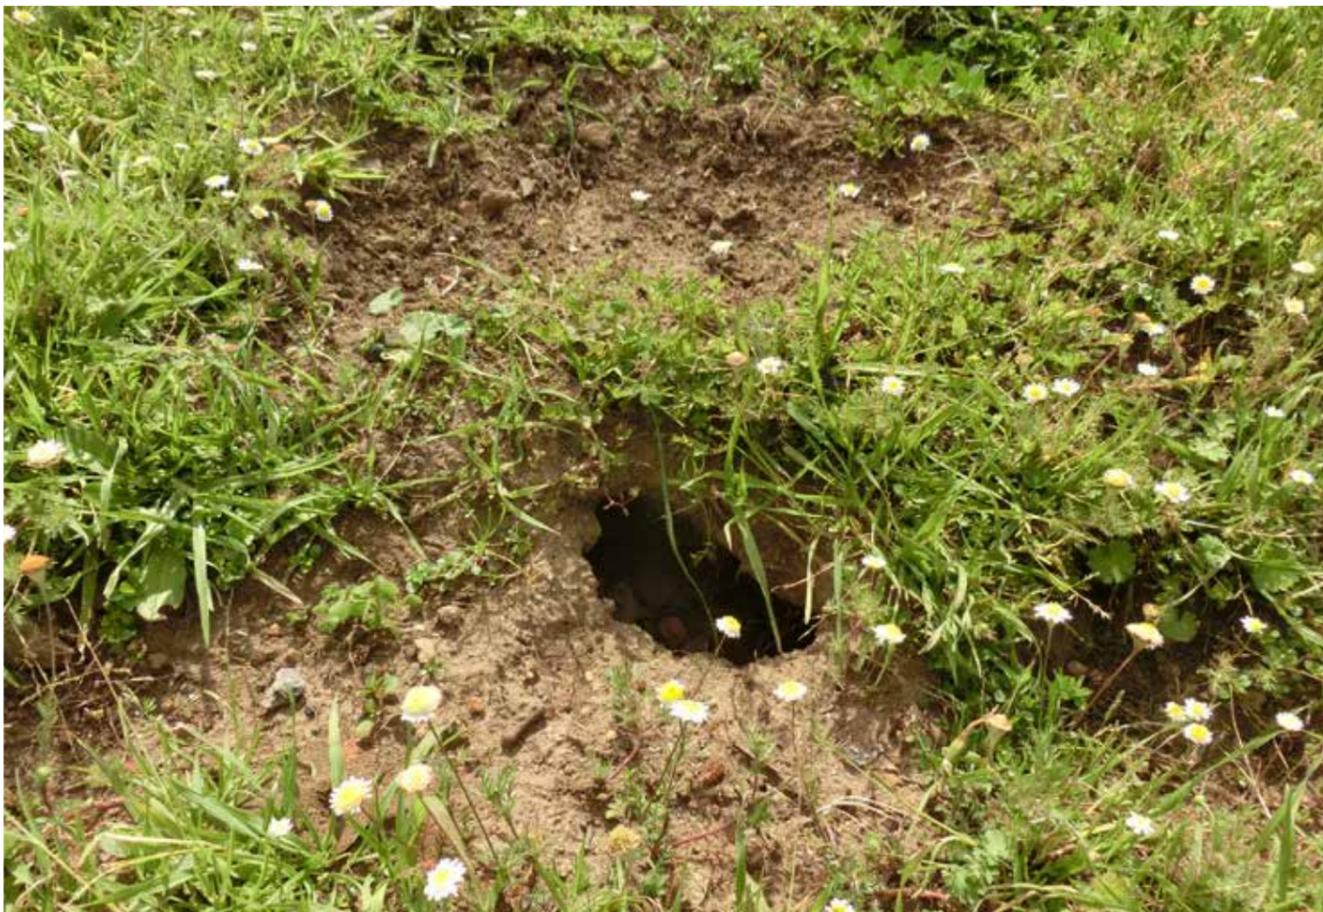
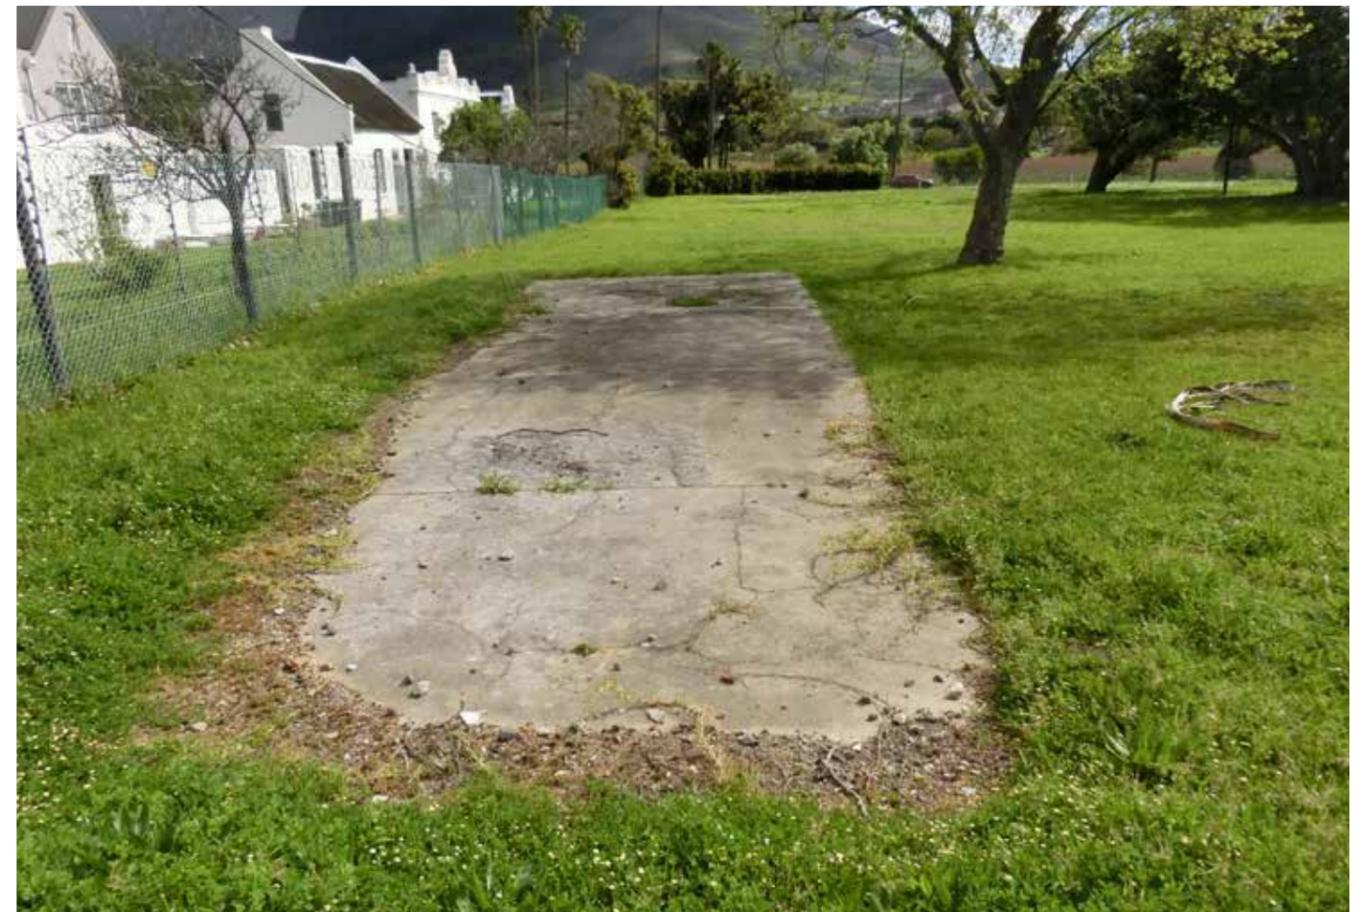
Figure 28. Unidentified concrete platform at southern boundary of site, view to east (RSA, 2021)

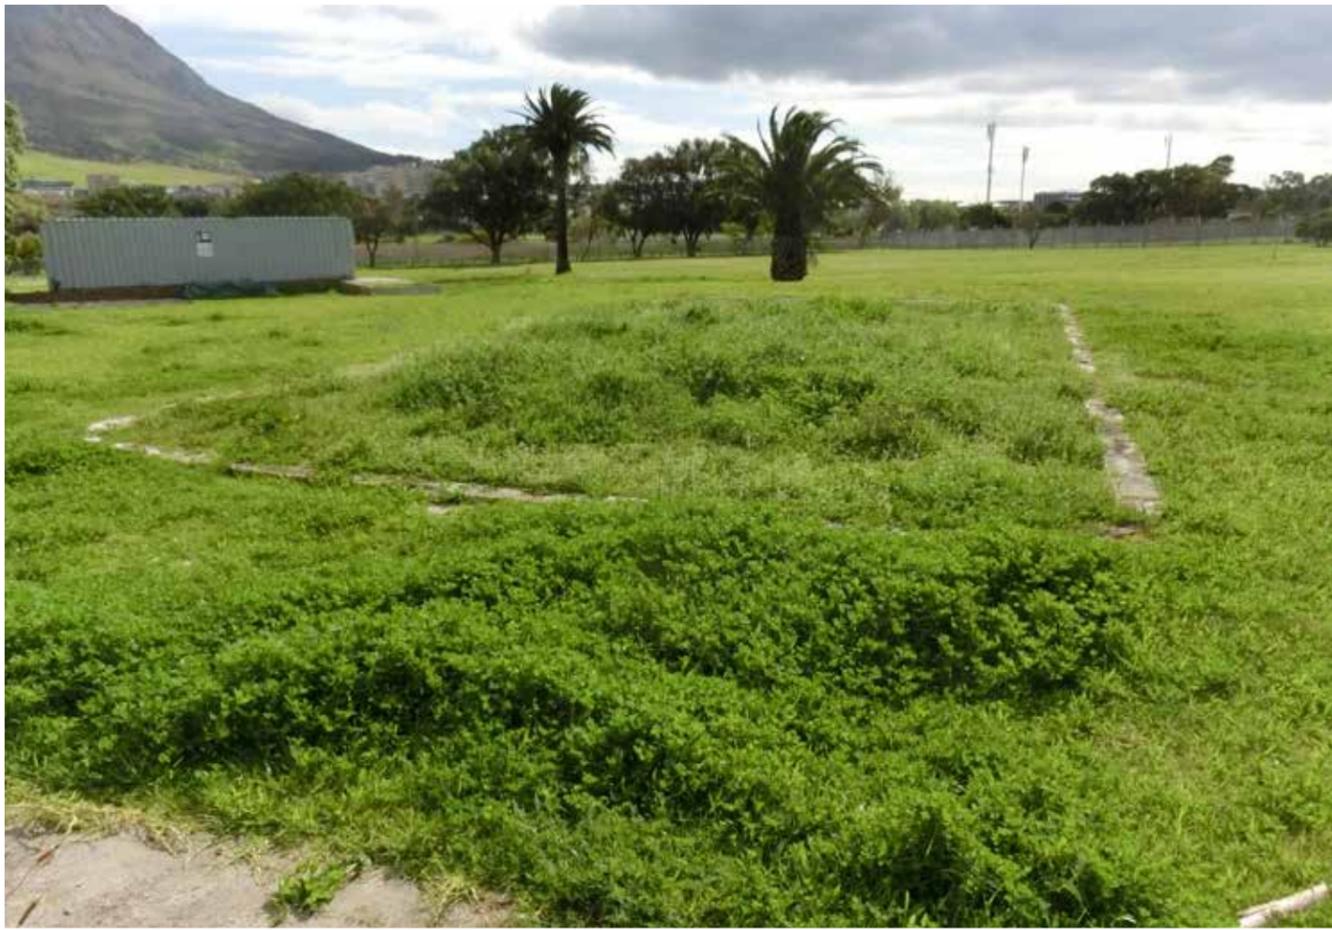
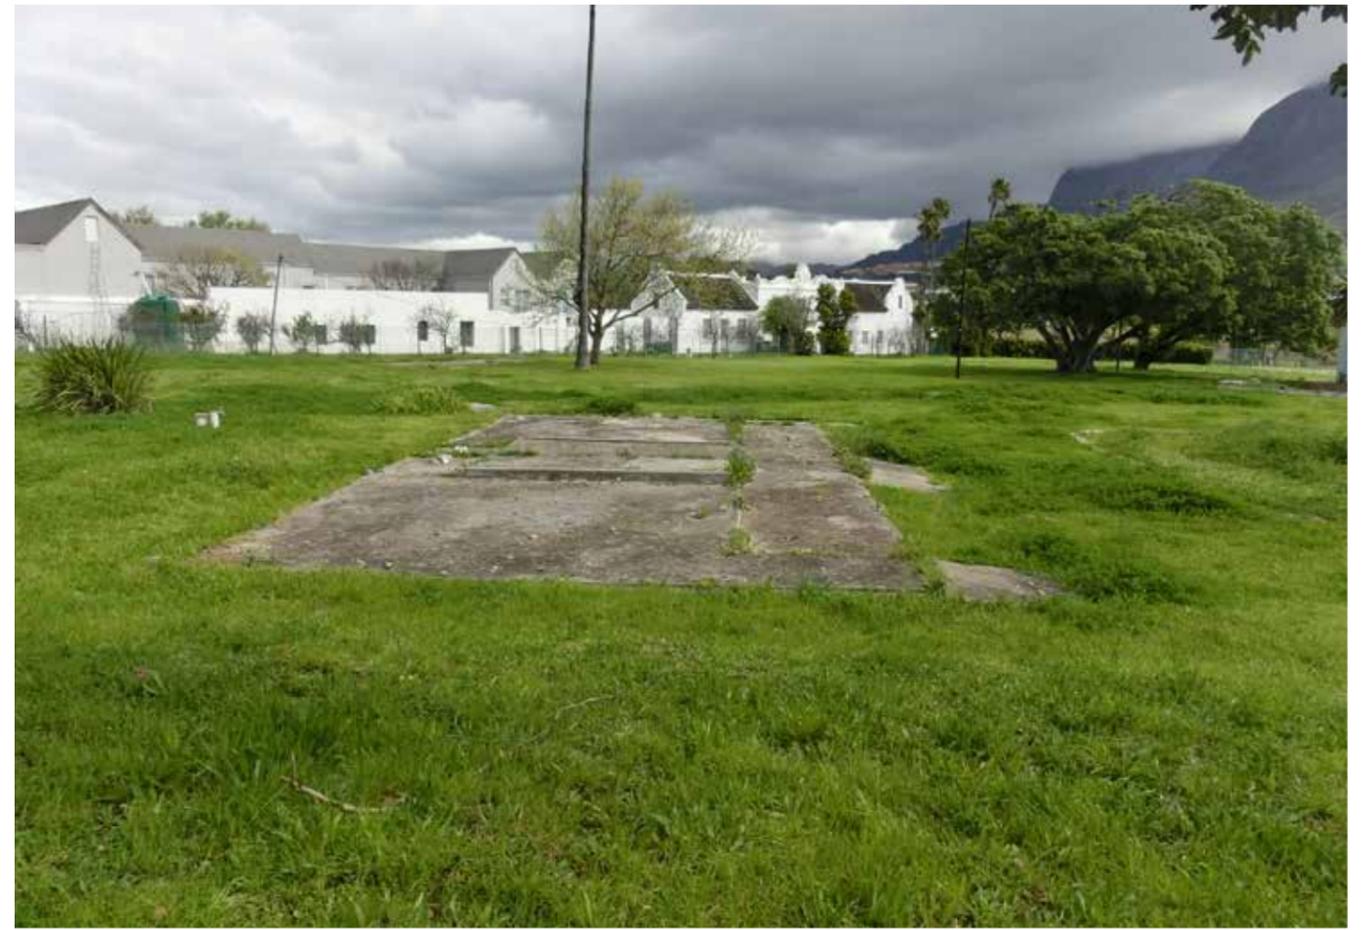
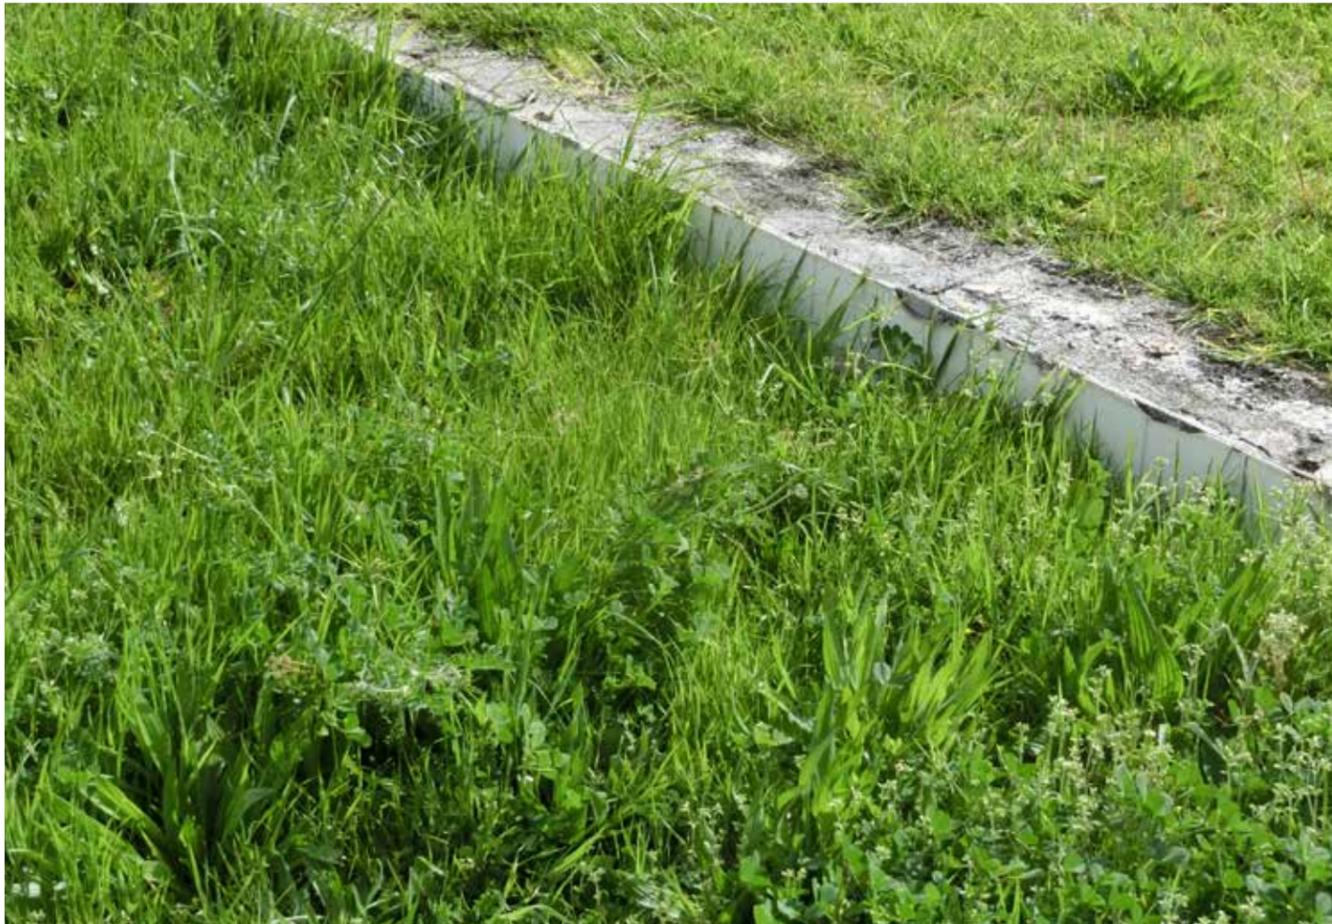
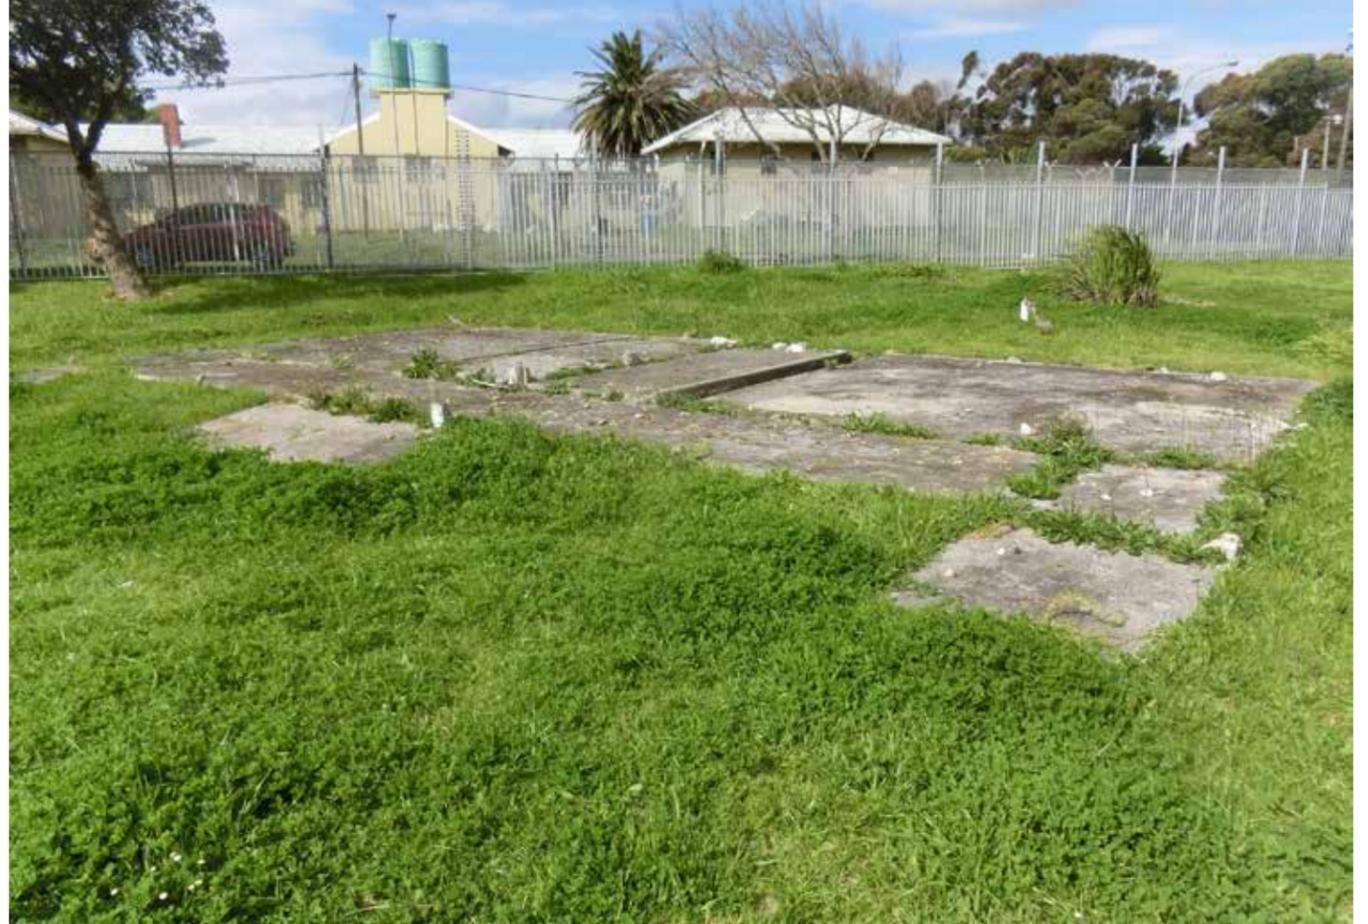
Figure 29. The remains of the filled in swimming pool, view to north (top left) and detail (below left), and the concrete platform of the adjacent structure, view to south west (top right) and south east (below right) (RSA, 2021)

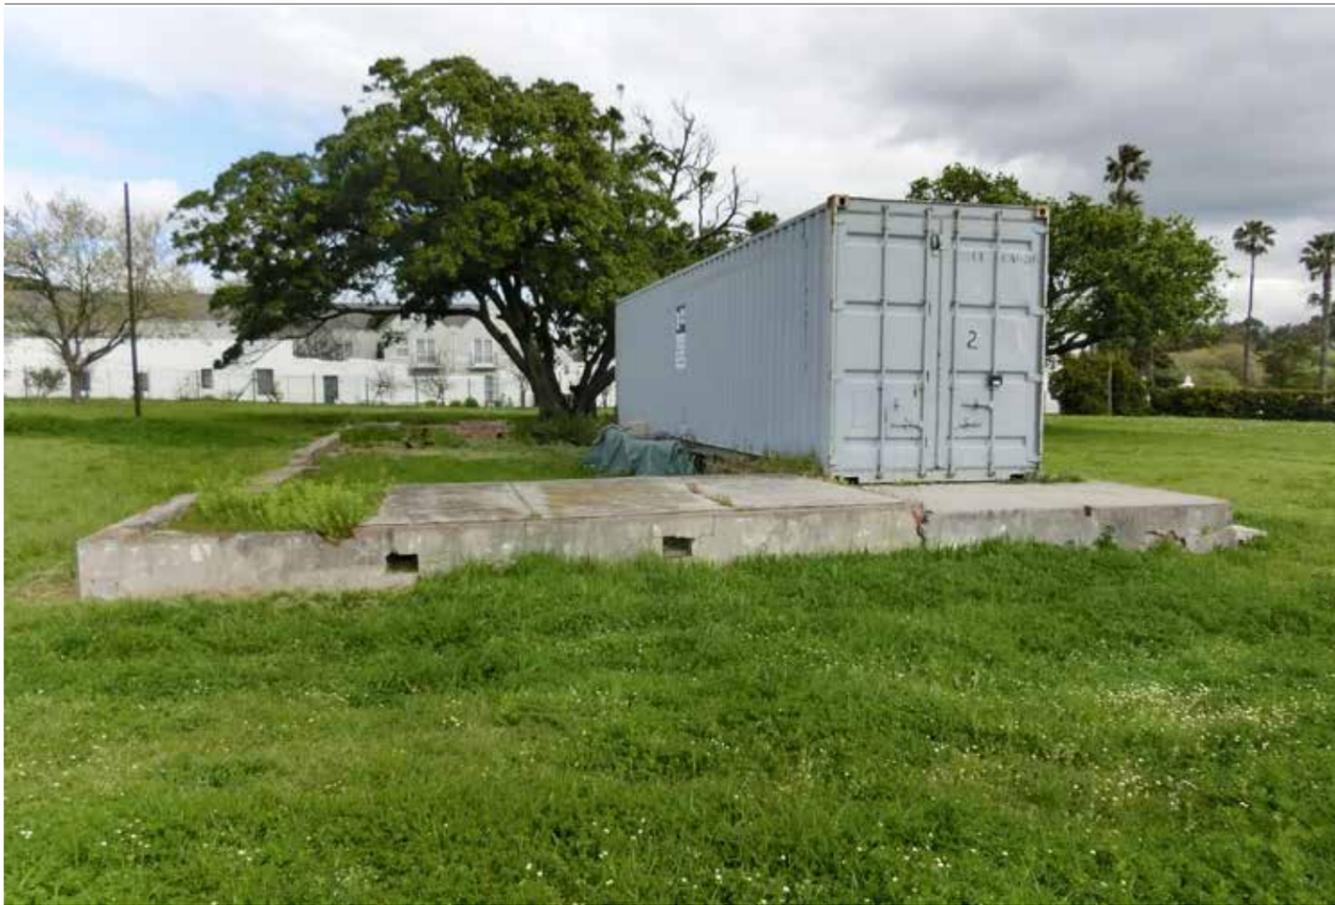
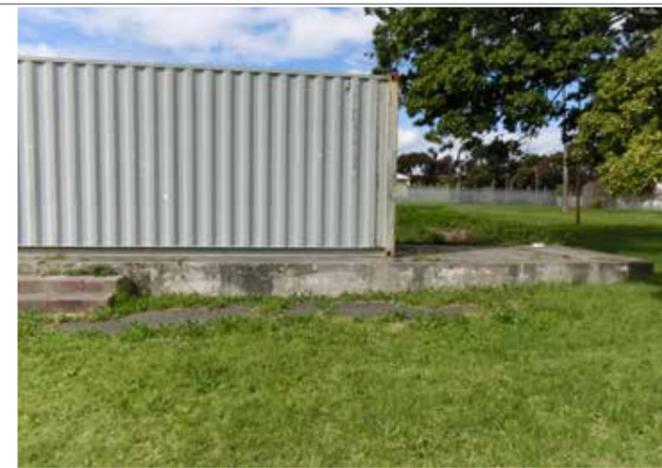
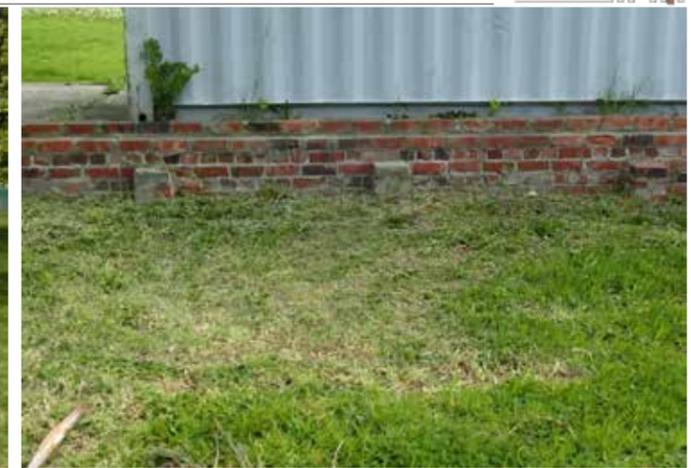
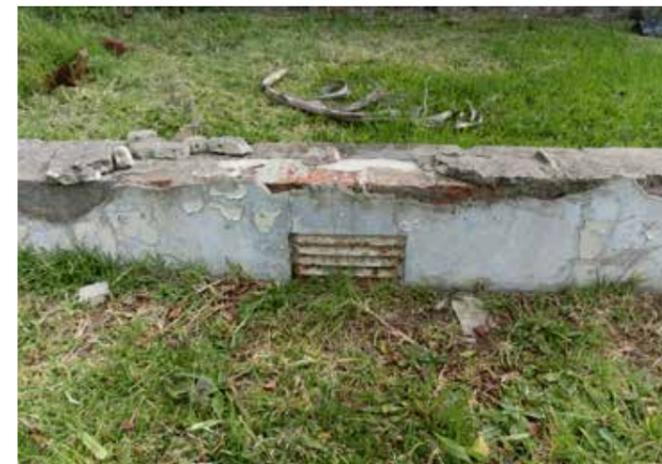
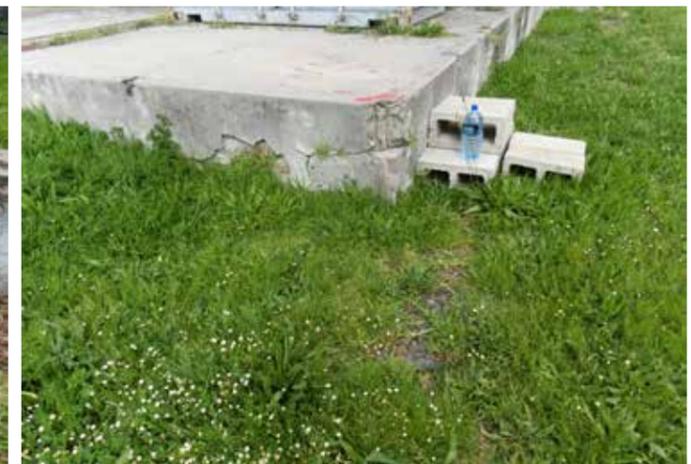
The footings found in the southern portion of site largely correspond with features noted in the 1966 aerial, although these are not present on the 1944 aerial. As ruined structures younger than 100 years, these similarly do not comprise archaeological features, but do form part of the site history and are, therefore, recorded as part of this assessment.

Figure 30. Storage container on brick and cement footings, view to south (RSA, 2021)

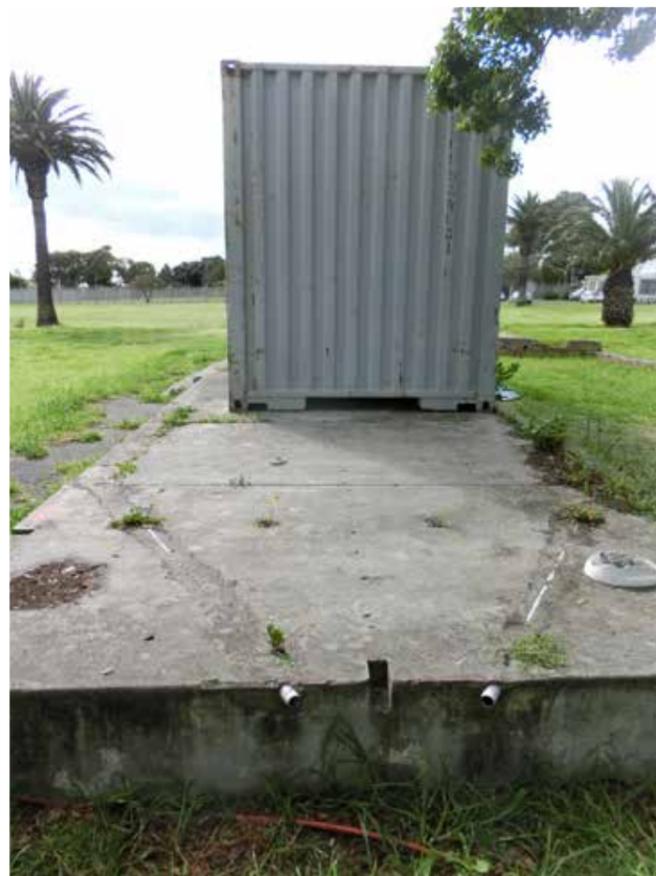
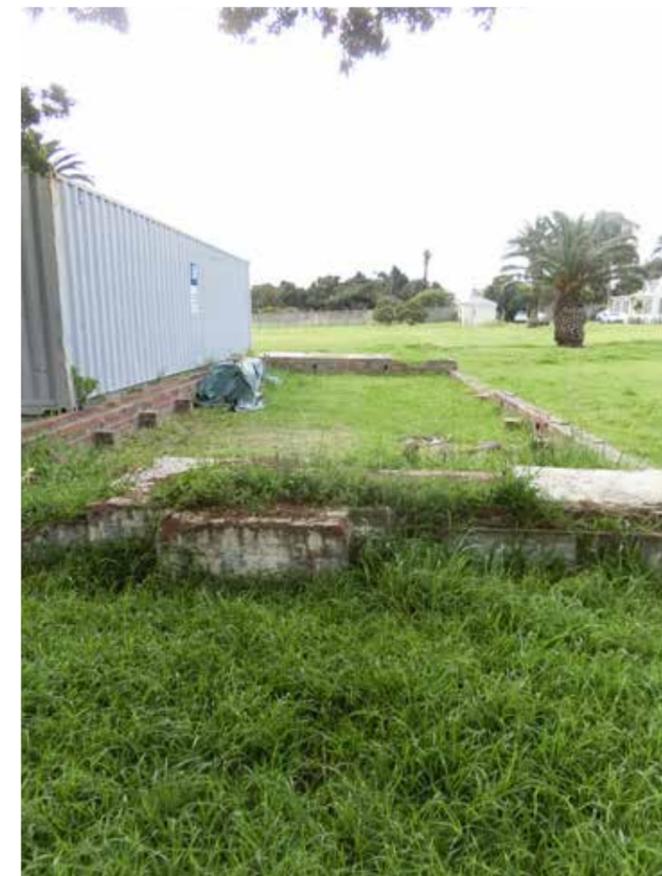
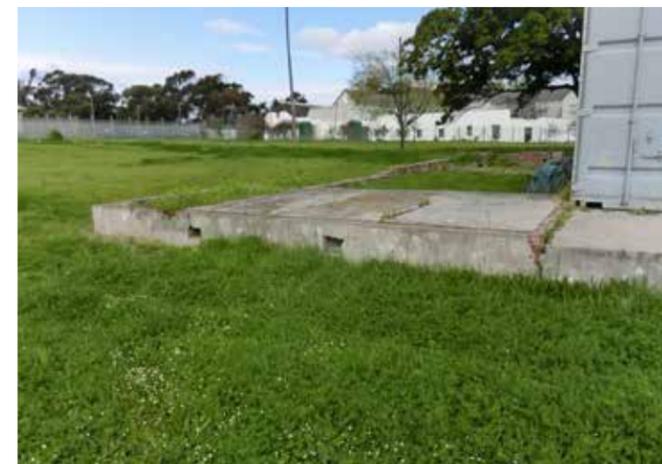
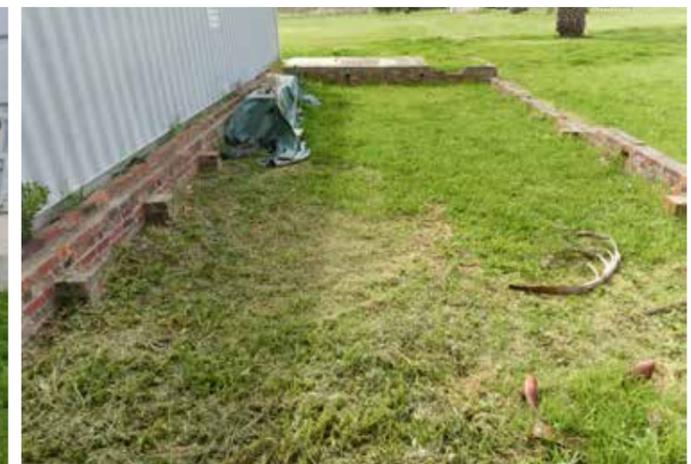
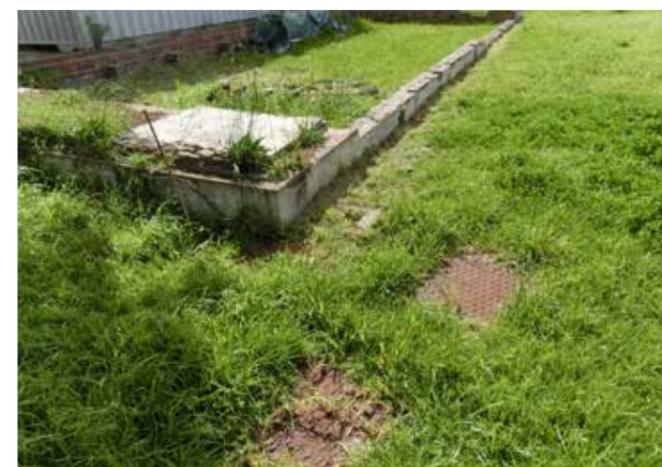
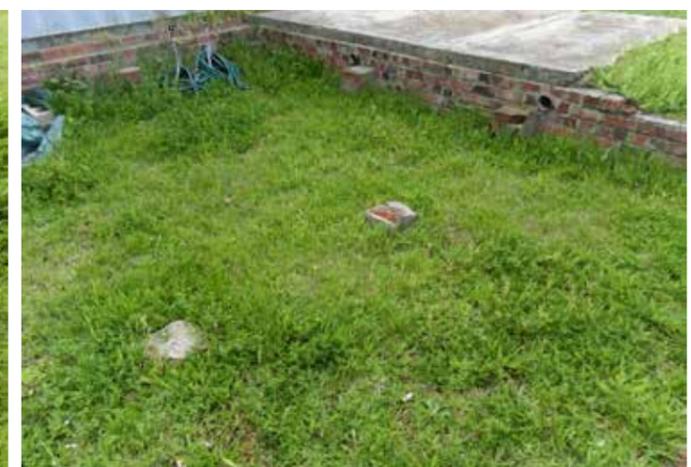
Figure 31. Storage container (left) and brick and cement footings (right), view to north (RSA, 2021)

Figure 32. Details of footings (RSA, 2021)
