# ARCHAEOLOGICAL IMPACT ASSESSMENT, 80 LIESBEEK AVENUE, ERF 160695, OBSERVATORY, CAPE TOWN

submitted in terms of Section 38(8) of the NHRA (1999) for  
80 LIESBEEK AVENUE, ERF 160695, OBSERVATORY, CAPE TOWN

Interim First Draft  
15 October 2021

Prepared by Katie Smuts of Rennie Scurr Adendorff for Vidamemoria Heritage Consultants

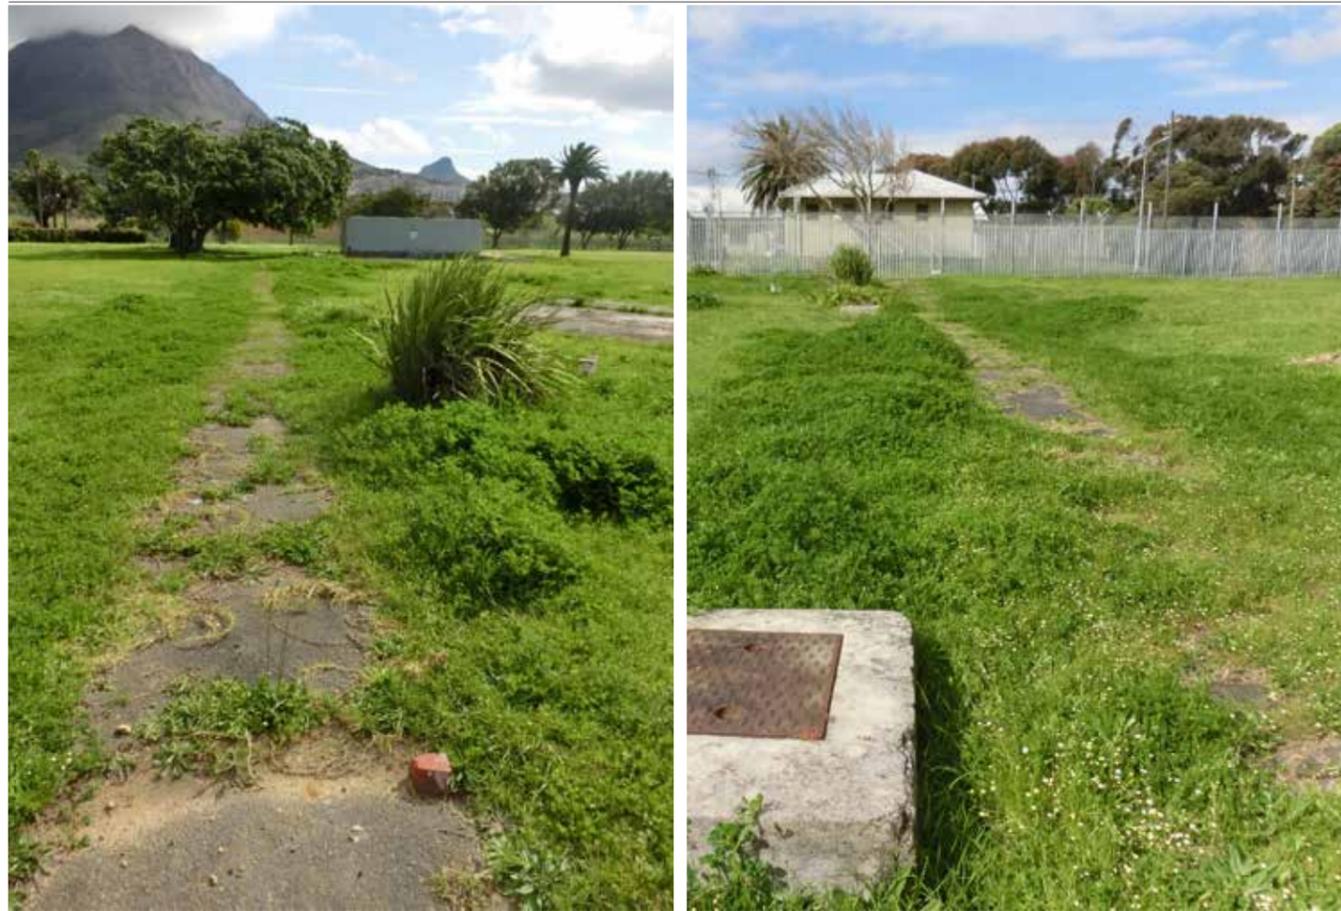
Figure 33. Driveway to storage container, view to west (left) and to east (right) (RSA, 2021)

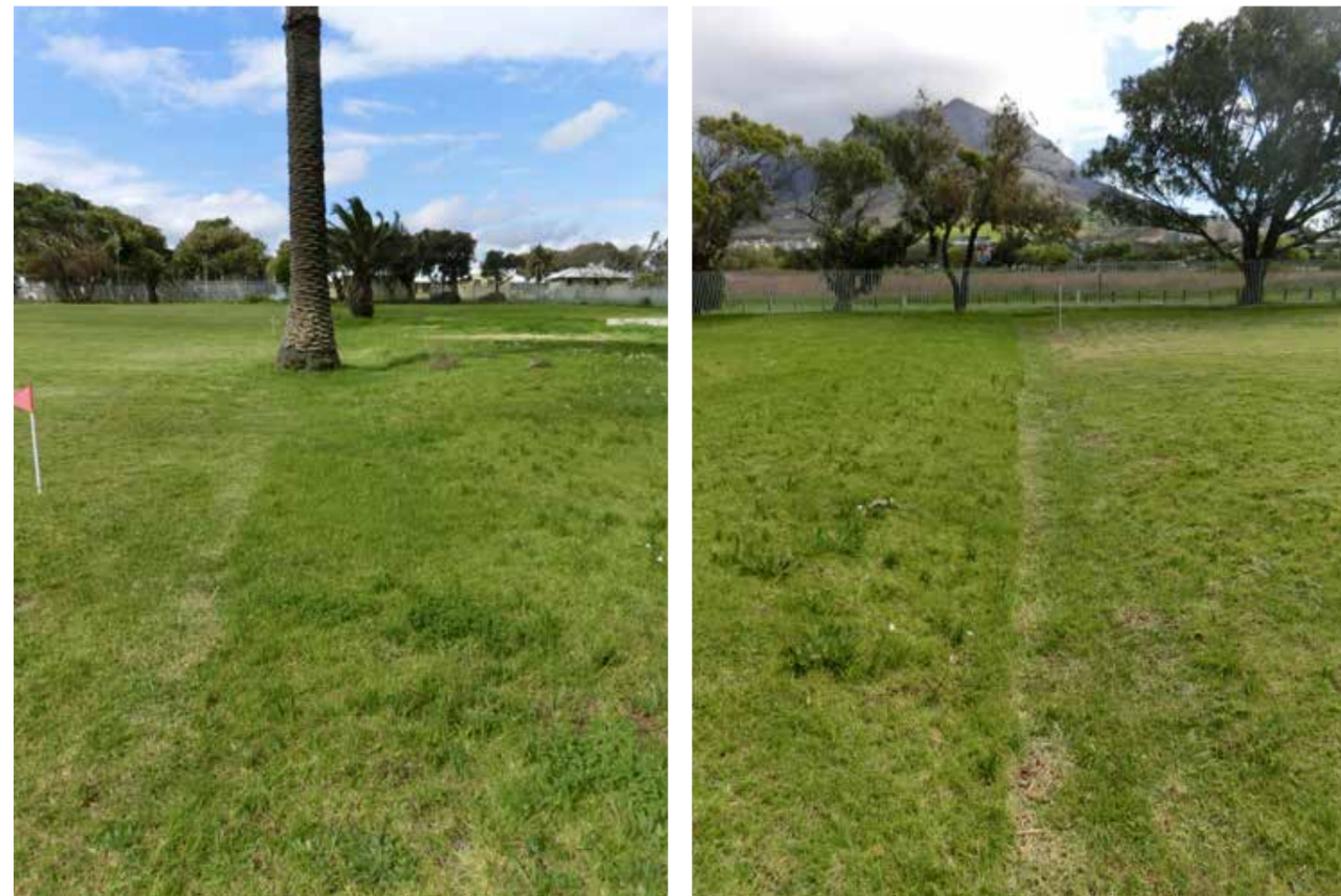
A ditch that transects site from west to east corresponds to the irrigation furrow visible on the 1966 aerial. This is considered an archaeological feature and part of the cultural landscape as this location aligns with the historic southern boundary of the Cottage garden as visible on the 1934 aerial.

Figure 34. Possible irrigation furrow, view to east (left) and west (right) (RSA, 2021)

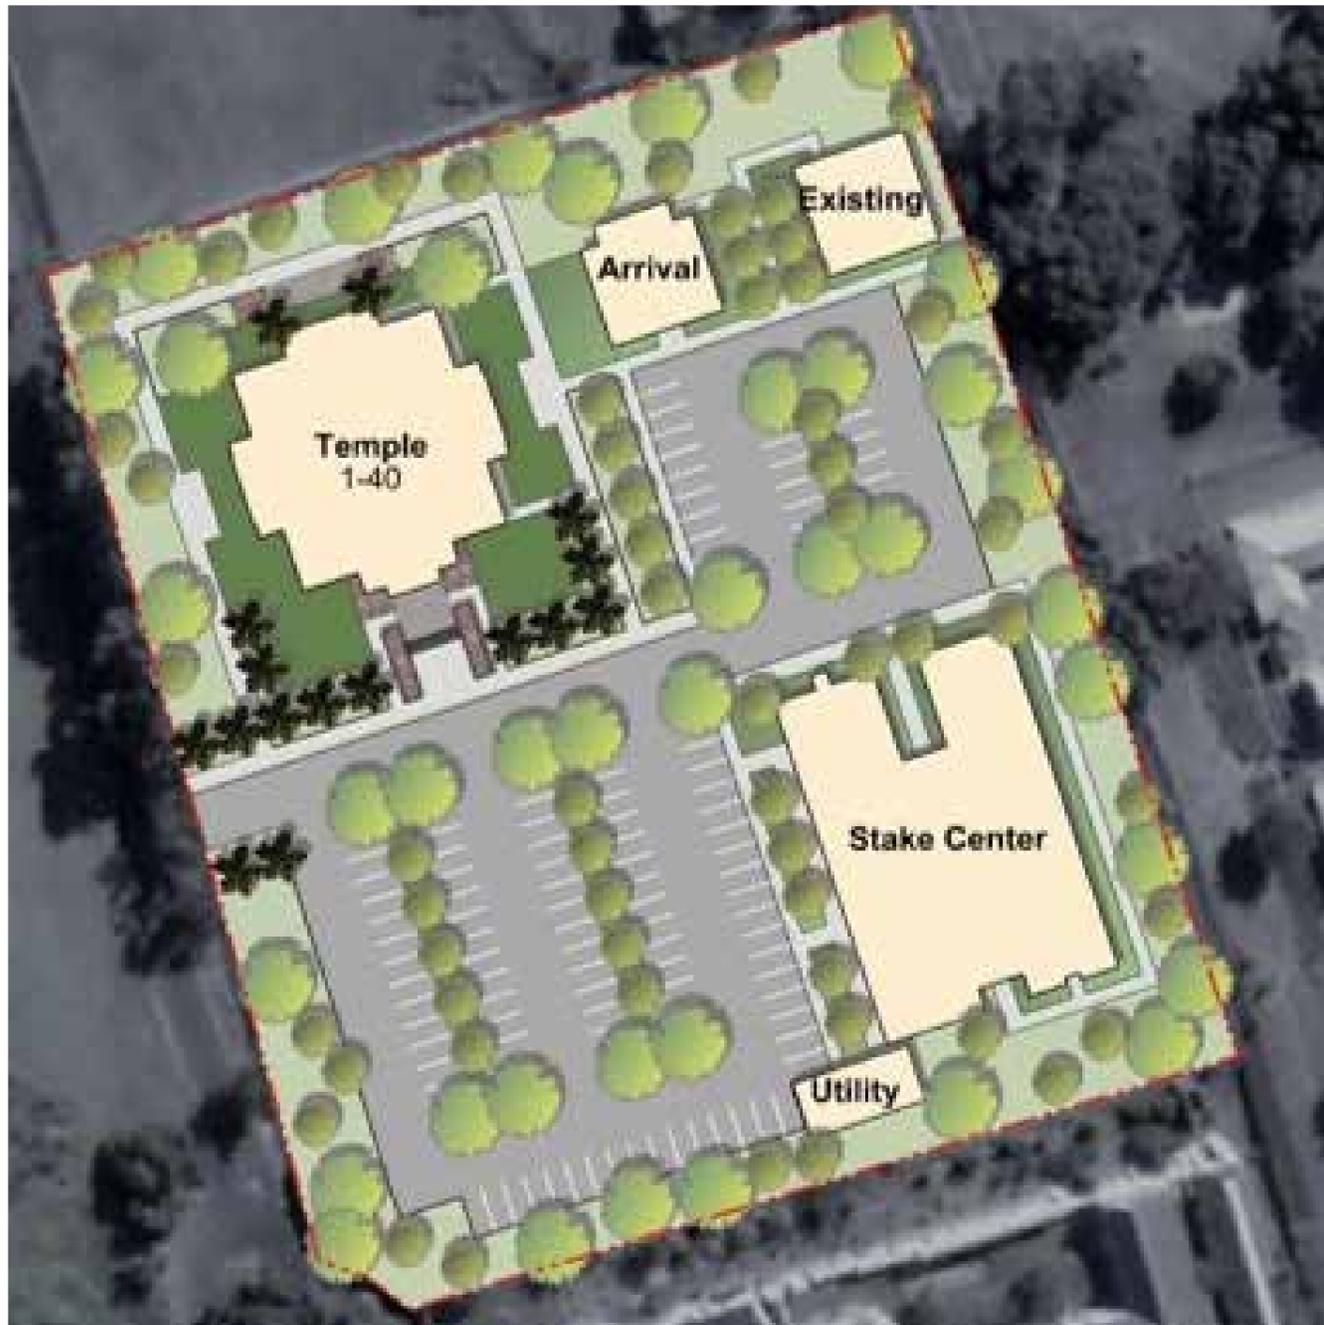
Figure 37. Proposed site plan (2021)

The proposal, at this stage, is for the development of a new temple and associated infrastructure for the Church of Jesus Christ of Latterday Saint on Erf 160695, Observatory. The facilities would accommodate a maximum of 560 people per day, either in small groups or individually.

In addition to the temple building itself, it is proposed to construct a stake (an administrative unit for multiple Latter Day Saint congregations), and a utility building. Two existing buildings, the current mission office and a smaller structure, will be renovated and redeveloped.
