# **Groundwater Impact Assessment for a Proposed Housing Development on Erf 6482, Grassy Park, Cape Town**

Prepared by  
**GEOSS**  
14 November 2024

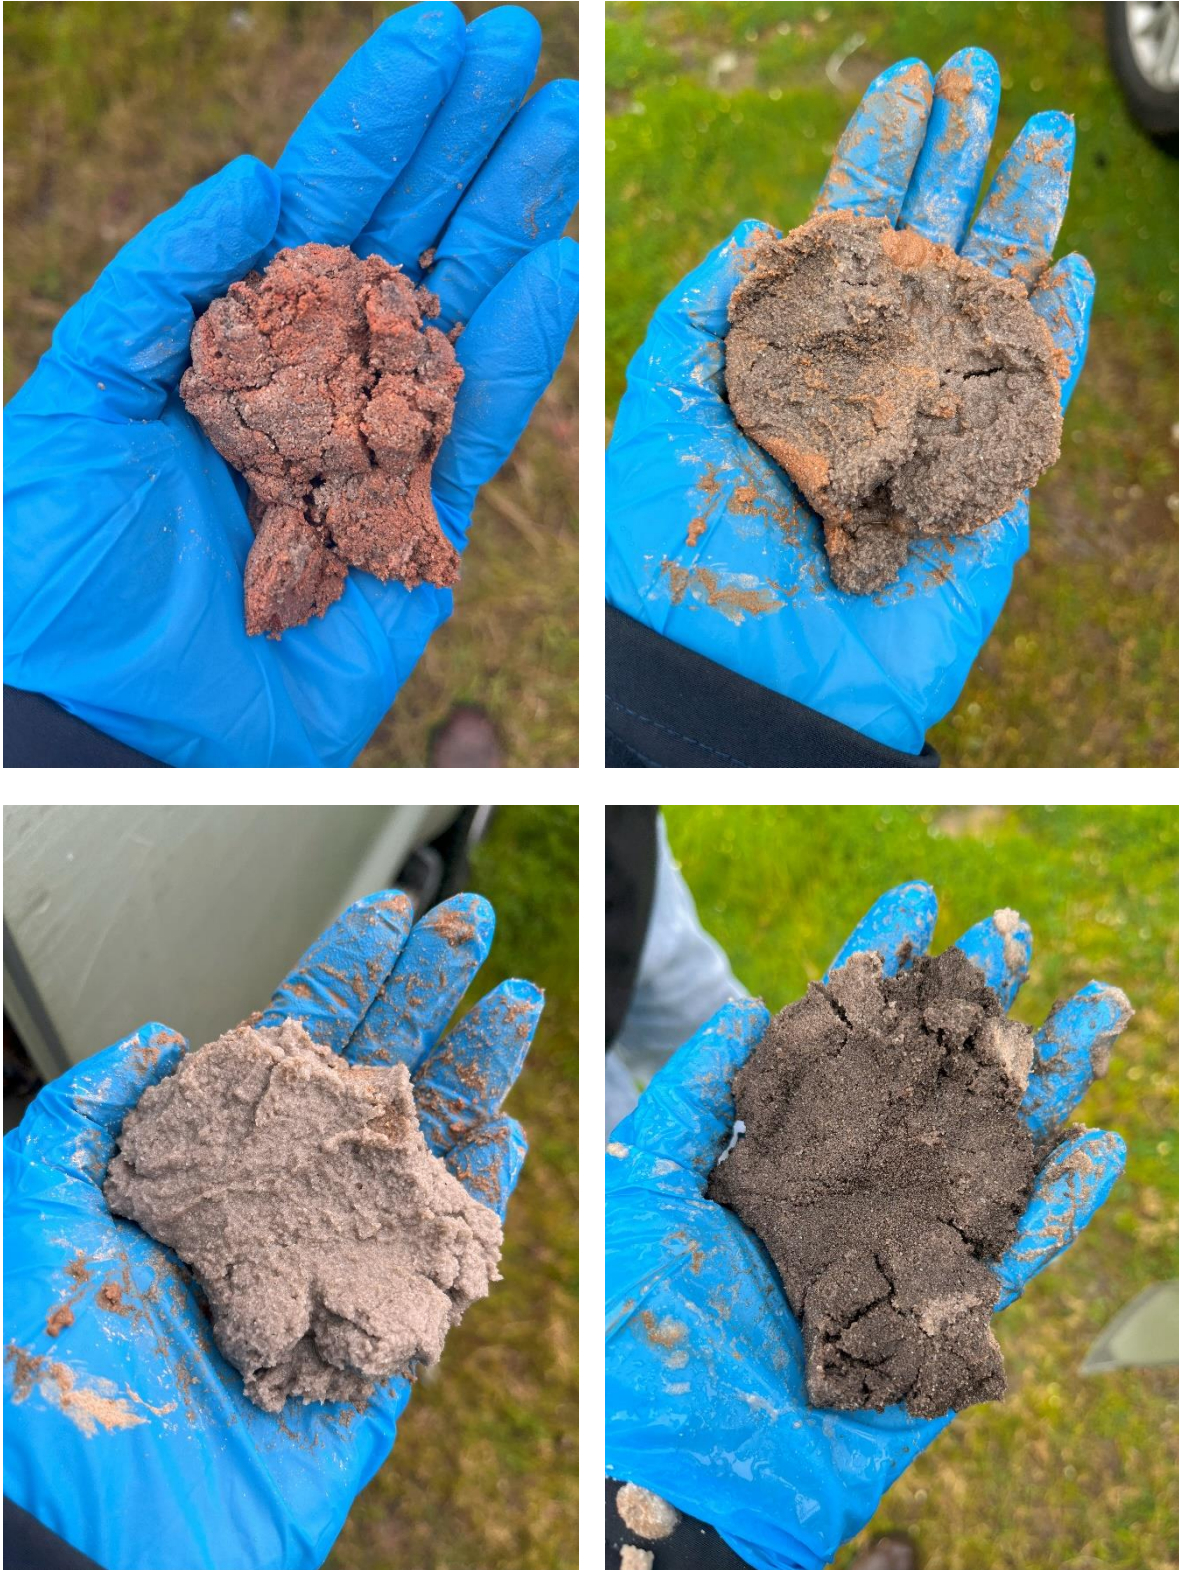
*Photo 1 - 4: Soil profiles encountered at PZ1*

| Unit | Depth (mbgl) | Description |
|---|---|---|
| Unit 4 | 1.42 to EOH | Dark-brown, wet, well-sorted, fine-grained, organic-rich soil. Hole collapse encountered in this layer. |

| Log of Piezometer No.: | | PZ1 | |
|---|---|---|---|
| <b>Unit 4:</b><br>1.42 - 1.52<br><br>Wet, well-sorted, dark brown, fine-grained, organic-rich sand. Moisture decreases with depth. | | | End Cap |

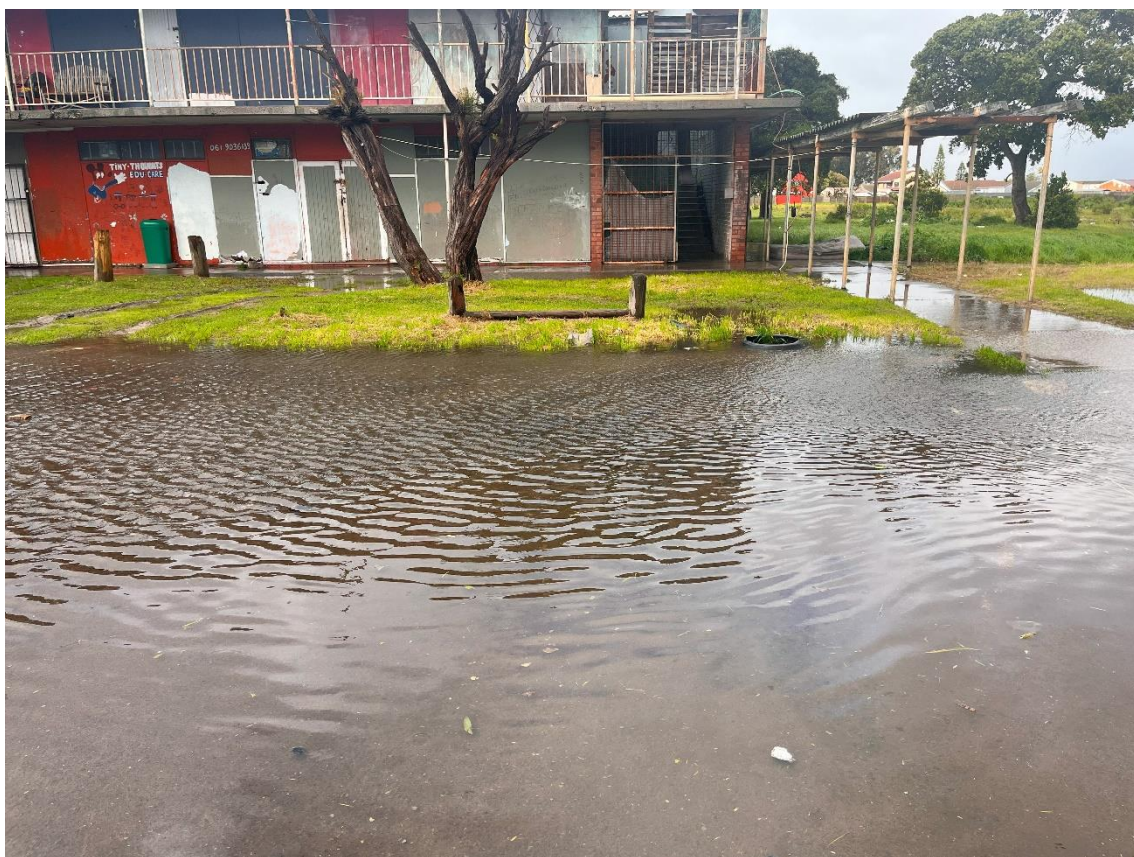
*Photo 6: Flooding noted on site on existing paved areas*

The site visit occurred in late-August 2024, towards the end of the wet season. The water table is expected to be still relatively shallow in comparison to the pre-winter season. During the site visit, flooding and ponding of water was noted across the property, in both paved and grassy areas. A large extent of the site is also noted to be covered with informally discarded waste, the full extent of which is unknown.

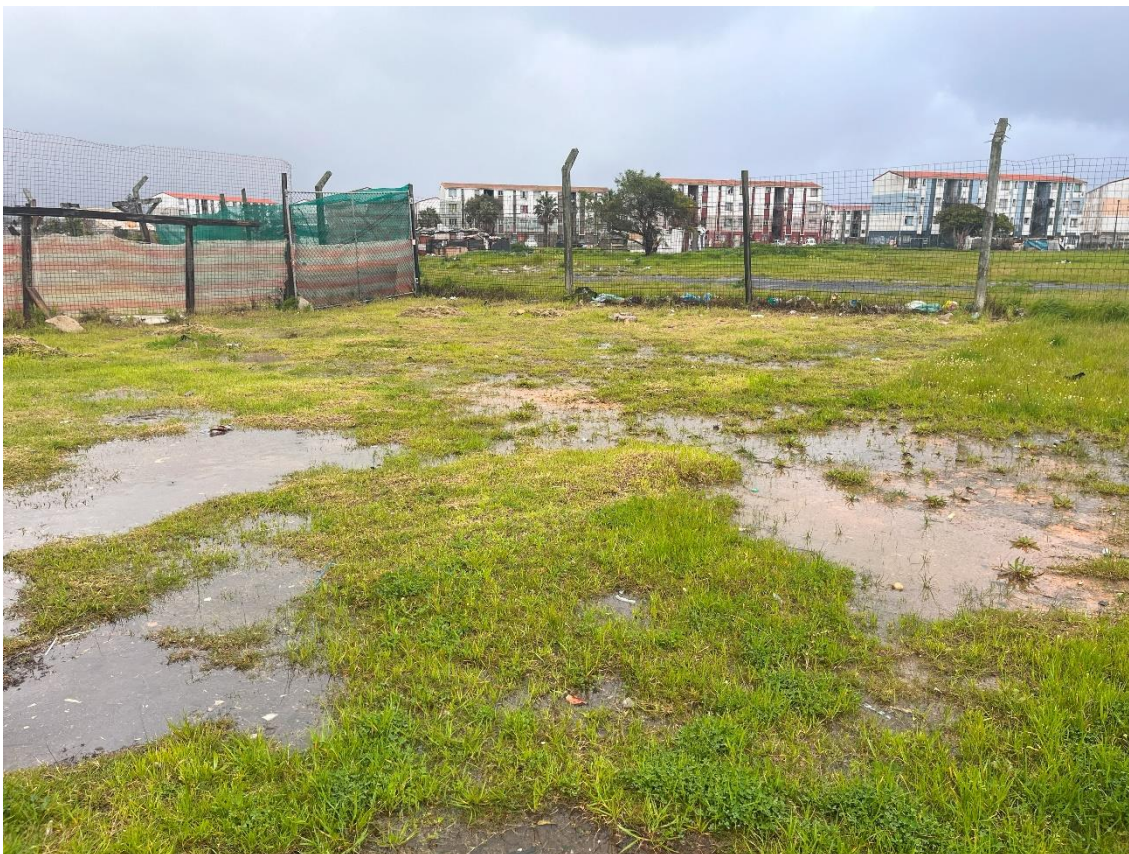
*Photo 7: Ponding noted on site on grassy area*
