GEOTECHNICAL ASSESSMENT OF THE ASBESTOS WASTE CONSOLIDATION SITE AT THE OLD EVERITE FACTORY BRACKENFELL, CAPE TOWN

- TOWARDS RE-ENGINEERING FOR LAND RELEASE -

Report Number J-531B-11

4 December 2011

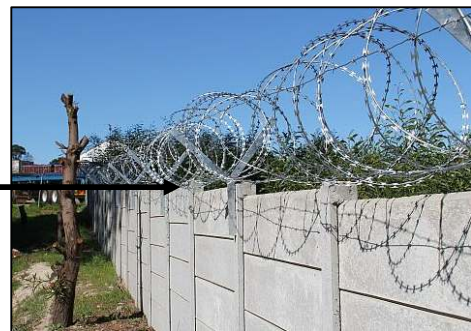
- ✚ repair to cut sections of fence – the fence was re-cut twice during the repair process, we suspect by the vagrants who set-up overnight shelters in the area,
- ✚ the installation of razor wire at main access points,
- ✚ repair of the security gate to the upper platform, to which a chain and lock were provided by MEGA.

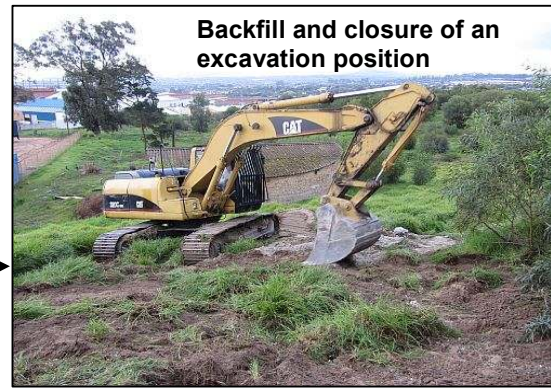
Cover material: Approximately 200 m³ of clean clayey SAND was imported by SSB Transport and used to cover the excavation positions to prevent the dispersal of any asbestos material that may have been exposed during the excavation process. An attempt was also made to close and cover with grass each excavation position – see photograph.

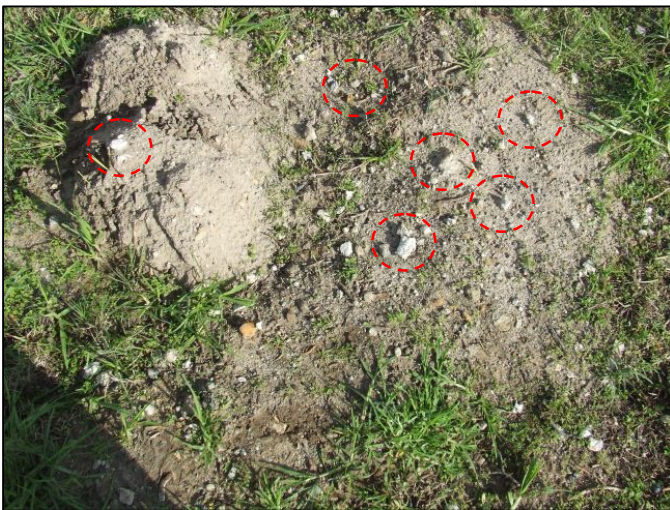
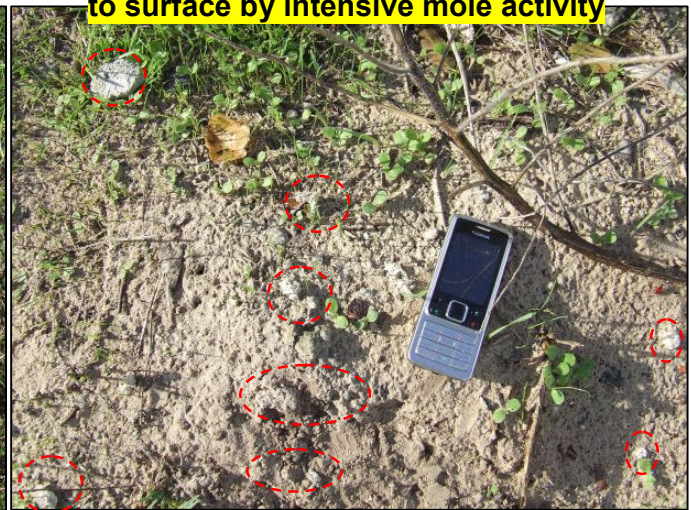
The conditions on site are not perfect in that the capping material installed in the early 2000 has been compromised by considerable mole activity, which has brought asbestos wastes to surface.
-

Asbestos fibrous sludges being brought to surface by intensive mole activity

- ☉ Cover the platform and embankment with a paving system that is robust enough so as not to allow moles to tunnel to the surface. This will involve minor reshaping of the embankment and forming some layerworks for paving or a cement stabilised sub-base layer above the asbestos wastes and below a vegetated cap layer.

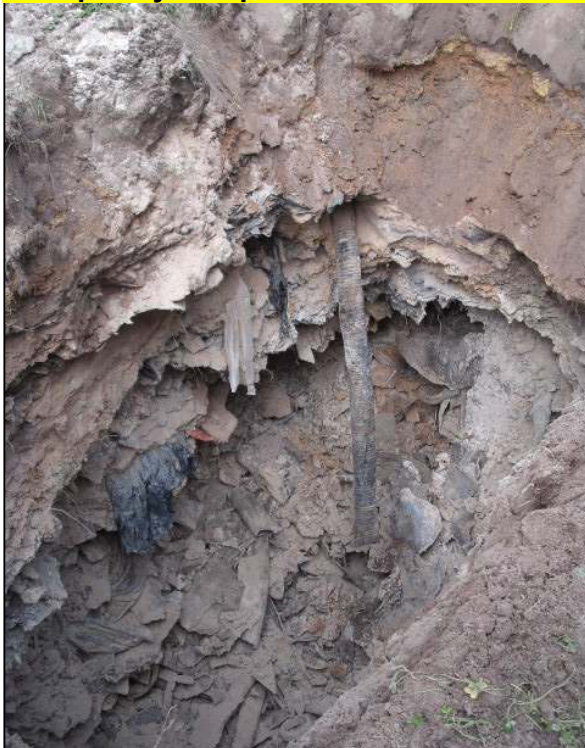
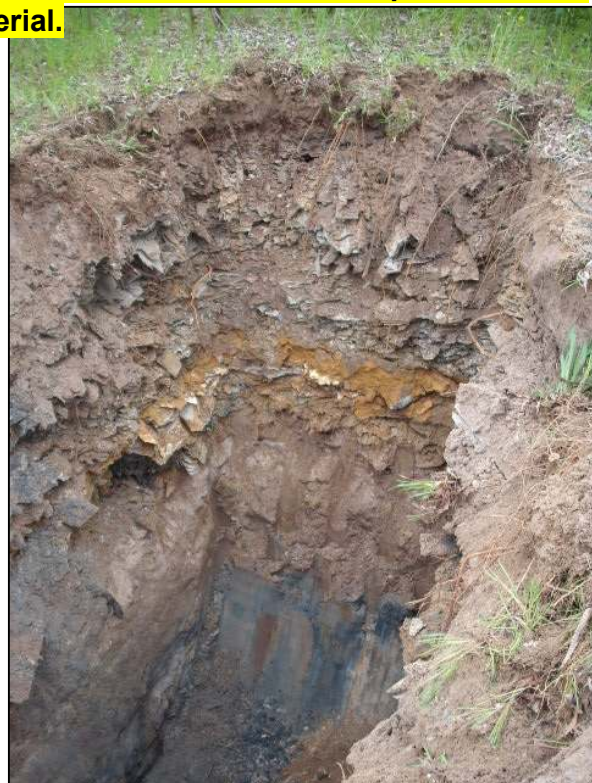
Two views of mixed asbestos wastes with little soil cover in the lower platform area. Note poorly compressed nature of the material.

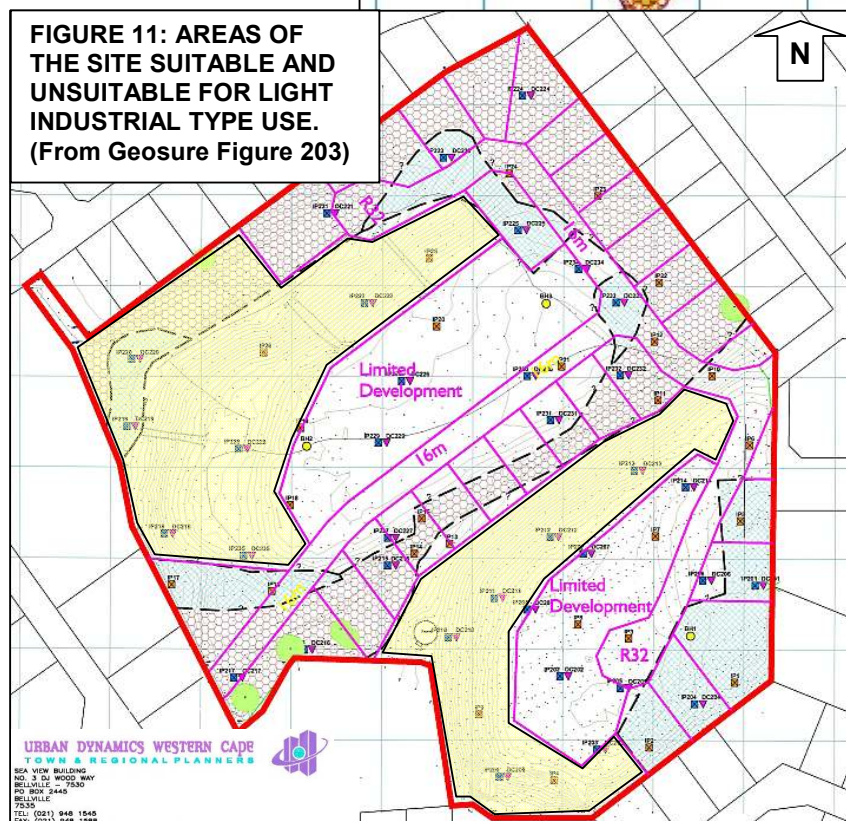
FIGURE 11: AREAS OF THE SITE SUITABLE AND UNSUITABLE FOR LIGHT INDUSTRIAL TYPE USE.
(From Geosure Figure 203)

With the restrictions on development in mind, UDWC revamped the conceptual layout to cater for the slopes and poor founding areas and came-up with layout 3 as shown in Figure 11 below.

- ☯ It restricts any development from the (yellow-shaded) slope areas,
- ☯ It allows 'limited use or development' of the top of the upper and lower platform areas, but away from the lip of the slopes of these areas. Limited development may include truck / vehicle parking or small storage type units as discussed earlier.
- ☯ It caters for ~28 small industrial type units.

Figure 11 conceptual layout is seen as a feasible compromise. It will however require some re-engineering of the platform slopes to (both) ensure their long-term stability and manage the mole damage factor with related asbestos exposure. However, as noted earlier, any re-engineering of the slopes, such as a stepped Loffelstein, may free-up some space for light units, such as mini-storage units in the 'limited use/development' areas, which could thus possibly be expanded. Thereby off-setting the cost of the slope re-engineering.
